September 22, 2022

Subject: Shoreline Monitoring of Archaeological Sites and Erosion Check on the Gile Flowage Storage Reservoir (FERC# 15055) in Iron County, Wisconsin.  
TRC Project No. 450488.0000  
WIARC No. 285

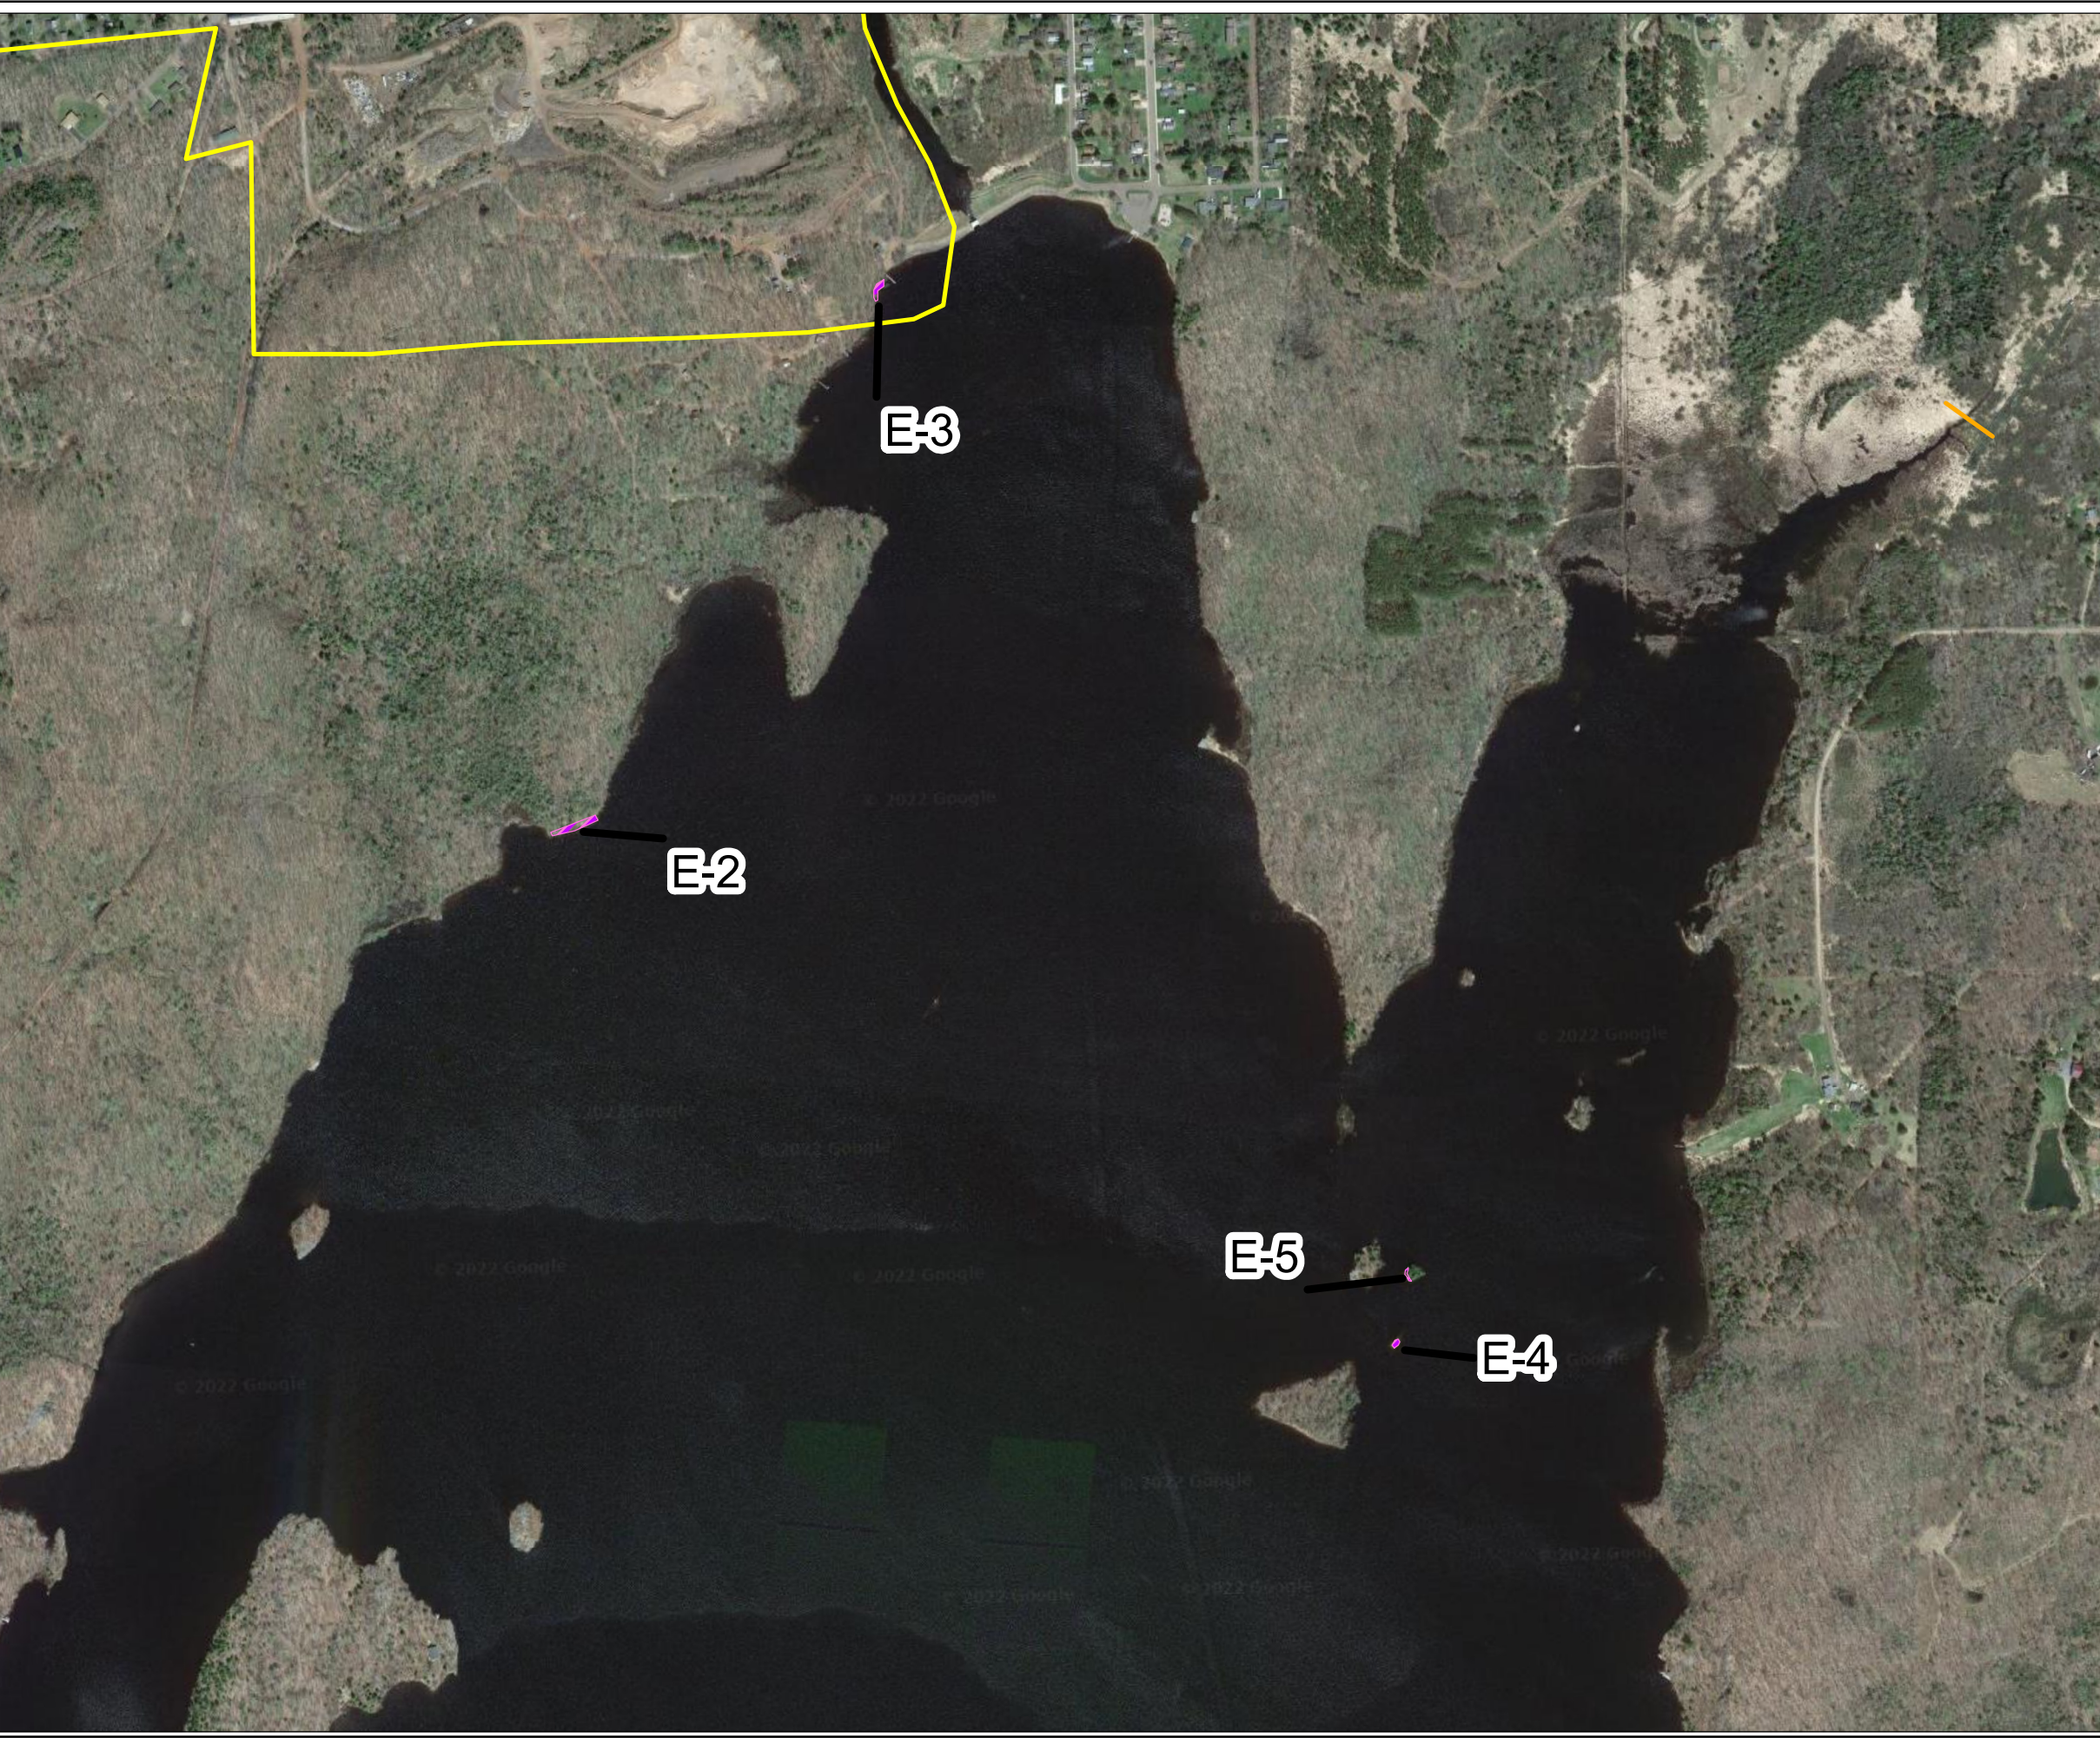
PROJECT:		<b>Xcel Energy Gile Flowage Archaeological Survey Iron County, WI</b>	
TITLE:		<b>Erosion Locations Map</b>	
DRAWN BY:	A.MCMAHON	PROJ NO.:	486101.0000.000
CHECKED BY:	R.KLABACKA-WILLIAMS	<b>FIGURE 4A</b>	
APPROVED BY:	A.VAN DYKE		
DATE:	SEPTEMBER 2022

Only one cultural resource site has been reported adjacent to the Reservoir, the Montreal Company Historic District (Figures 1, 2, 4A, 4B). An inspection was conducted at the location where the historic district boundary included the Reservoir shoreline (Figure 4A). Inspections were also performed at bank exposures<sup>1</sup> along the shoreline and at eroded areas. Five examples of erosion were observed during the survey (Figures 4A, 4B).

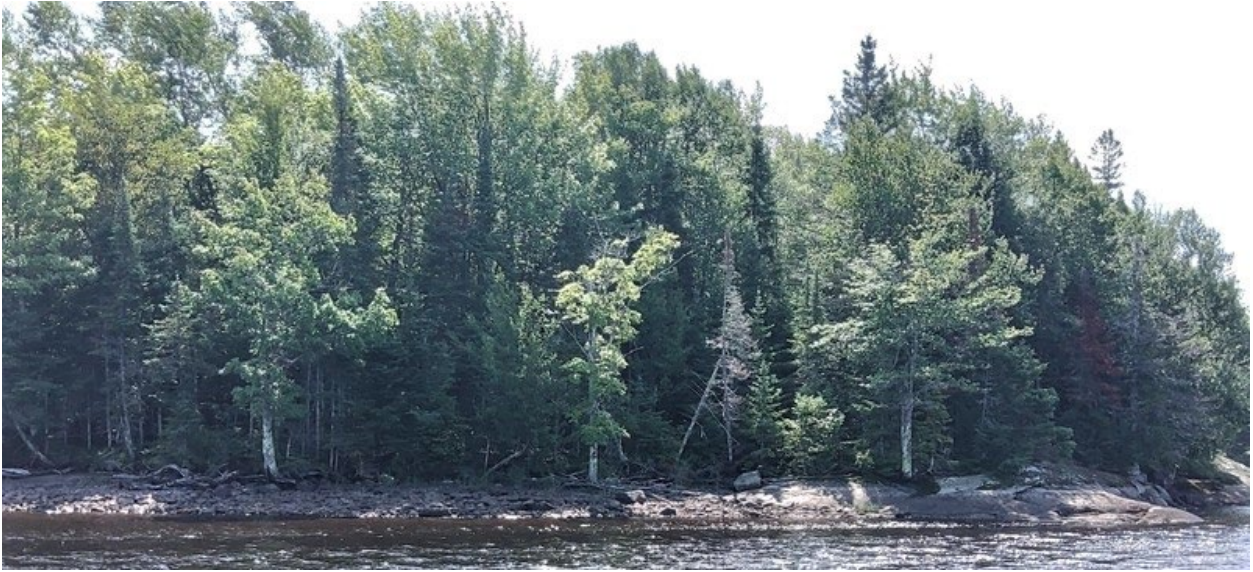
**Photo 1: Coniferous forest – view to south.**

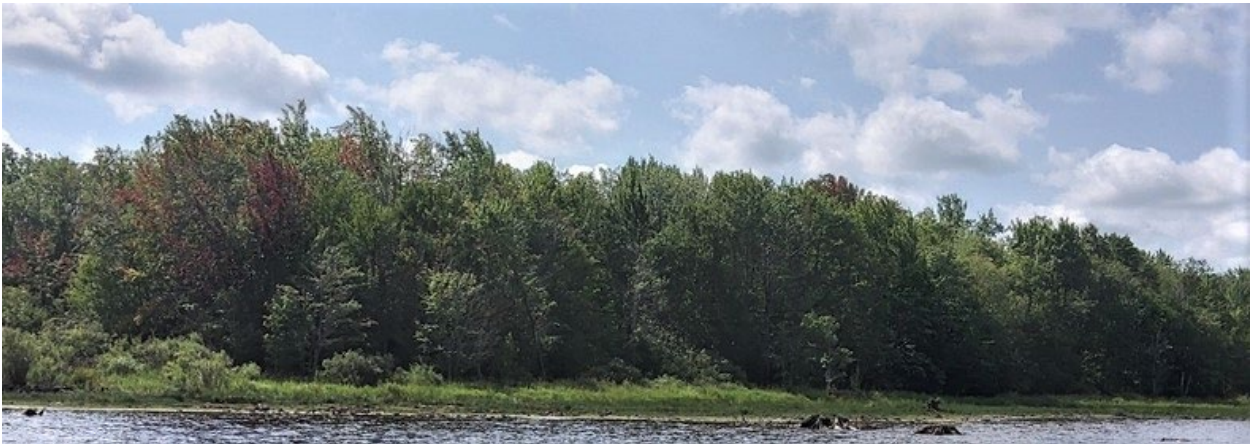
The GLO-mapped trail runs northwest-southeast and crosses an area below the Reservoir. The trail abuts the shoreline of the reservoir at two approximate locations (Figure 3). The shorelines at both locations are stable and well vegetated with pine, birch, maple, and oak. (Photo 2). No additional archaeological work is recommended at these locations.

**Photo 2: Riparian meadow; background – coniferous forest. View to south.**

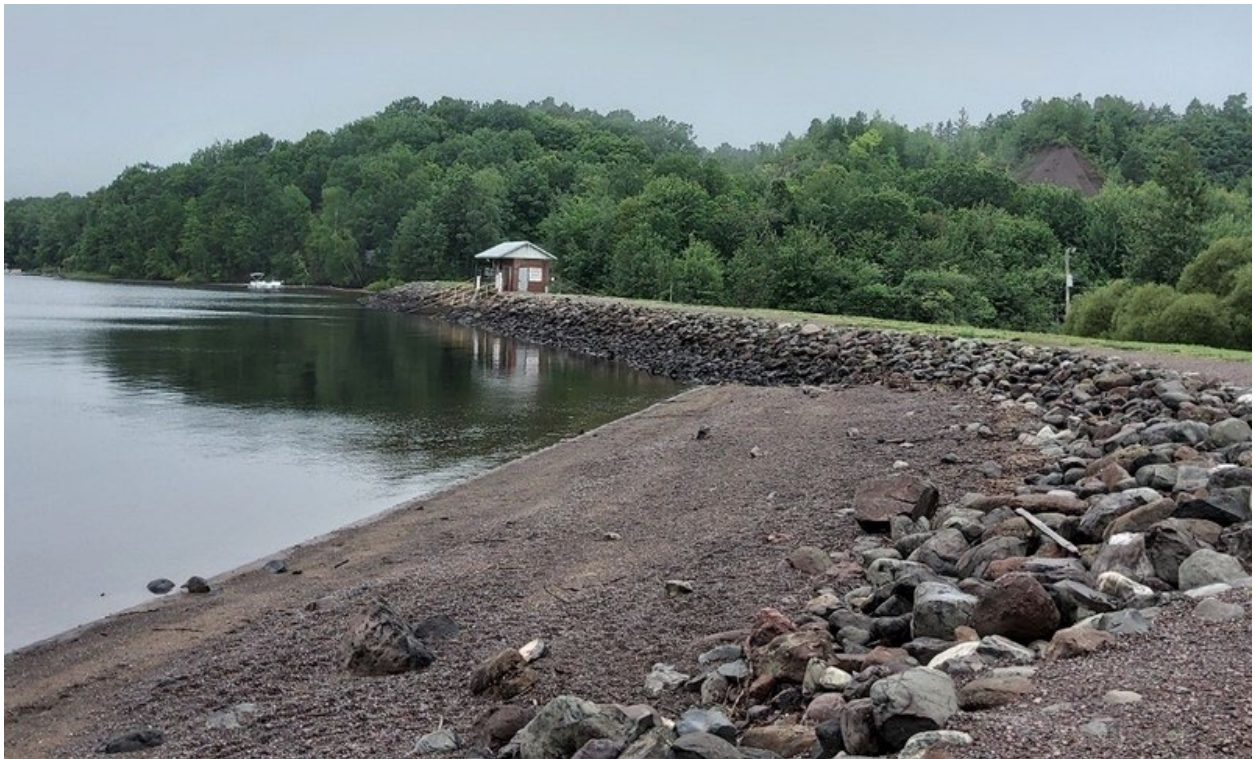
**Photo 7: Unvegetated rip rap armored shoreline with beach-like foreground. View to southwest.**

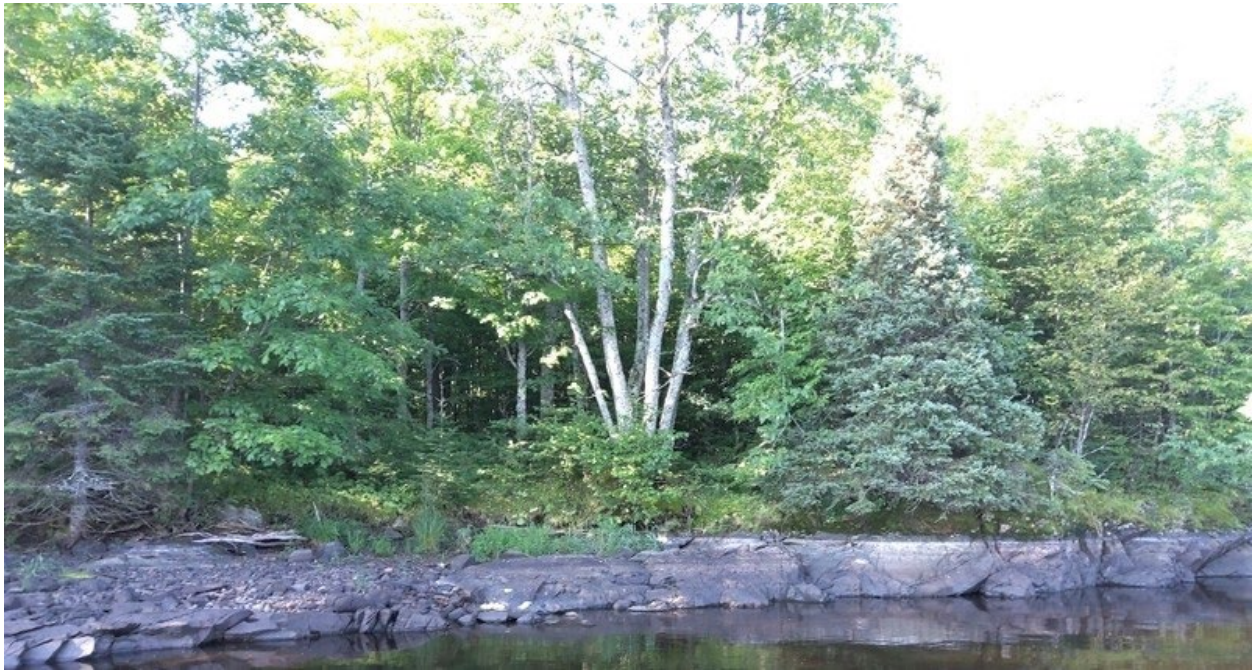
The remainder of the Reservoir's shoreline is well vegetated with stands of pine, birch, maple, and oak (Photos 1-10). Areas of exposed bedrock are visible along the shoreline at various locations as depicted in Photo 1 (right hand side) and Photo 10. The Reservoir elevation was three feet below normal pool so much of the exposed lake bottom revealed rock, gravel, or sand beaches where grasses had begun to grow on the newly exposed ground. There were a few areas of emergent vegetation, but most of the shoreline was forested to water's edge. No areas of rip rap or stabilization were noted.

**Photo 10: Exposed rock shoreline; mixed deciduous/coniferous forest behind it. View to south.**

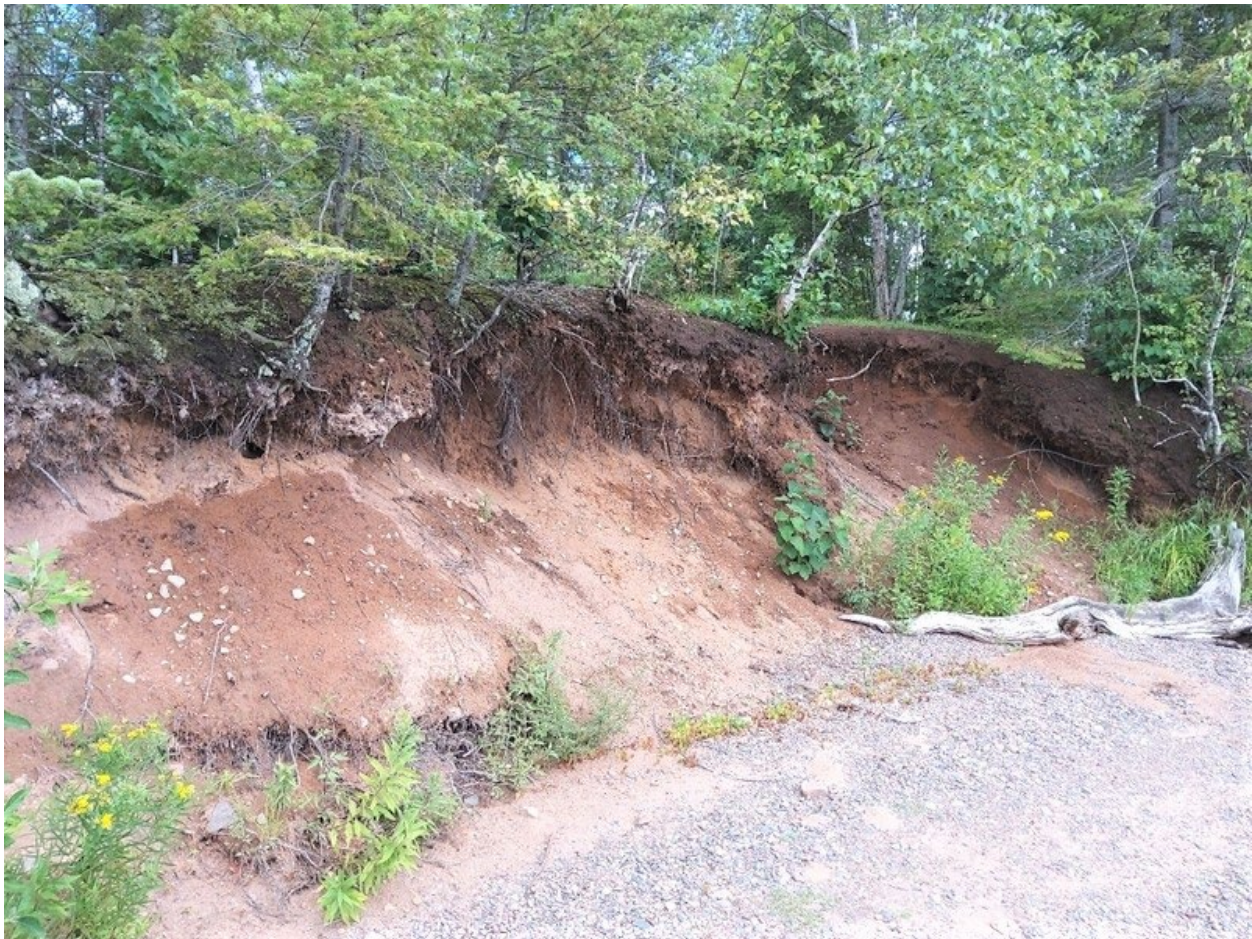
### **E-1**

Erosion area E-1 is on the shoreline of a small island (Photo 11). The site was surface collected at the water's edge, the exposed bank, and the slumped bank. There were no artifacts or archaeological deposits encountered. No additional archaeological work is recommended at this location.

**Photo 11: E-1 Mixed deciduous/coniferous forest behind erosion. View to northeast.**

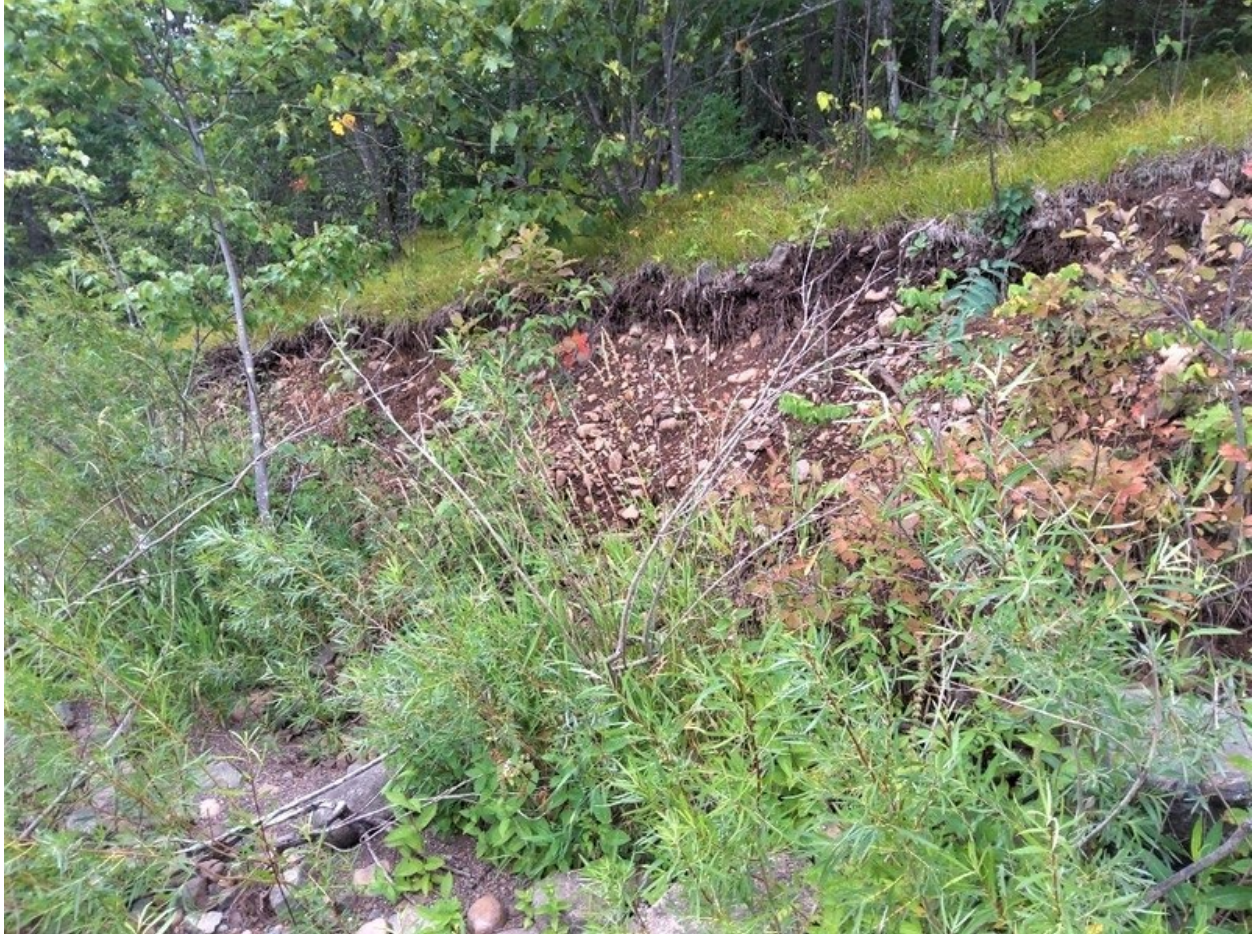
#### **E-2**

Erosion area E-2 is on the west shoreline of the reservoir (Photo 12). The area was surface collected at the water's edge, the exposed bank, and the slumped bank. No artifacts or archaeological deposits were encountered. The toe of the bank in this location is stable and well vegetated. No additional archaeological work is recommended at this location.

**Photo 12: Not a definable plant community - mix of woody and herbaceous plants starting to establish. View to northwest.**

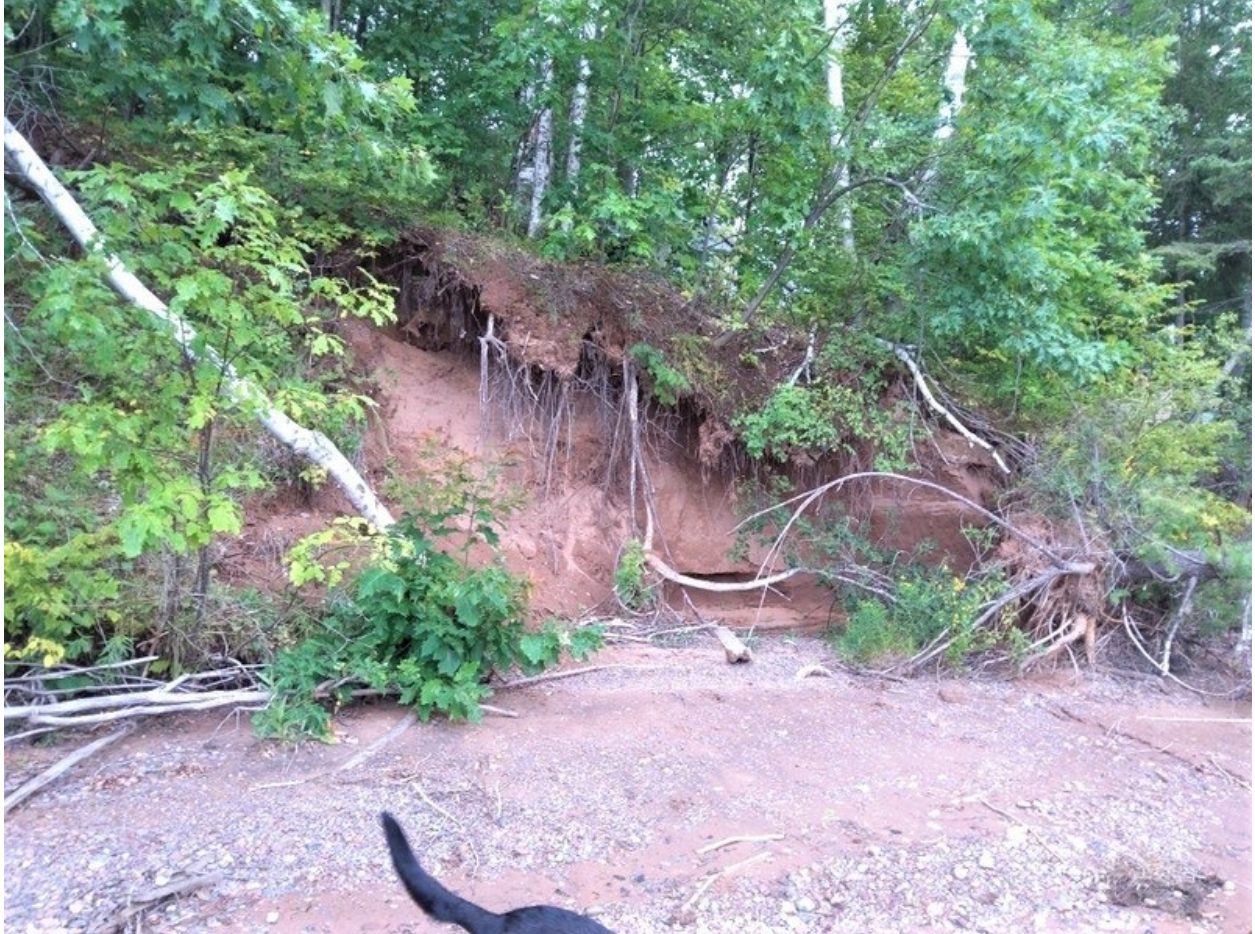
#### **E-3**

A small part of the WHPD-mapped MCLHD overlaps the Reservoir due west of the dam. This area is well vegetated with coniferous forest adjacent to the water. A small segment of this site shows erosion (E-3, Photo 13) and was surface collected at the water's edge, the exposed bank, and the slumped bank. No artifacts or archaeological deposits were noted. Since this area is within the WHPD-mapped MCLHD boundary, TRC recommends that this segment be monitored locally (e.g., NSPW operator) to determine if the exposure gets larger.

Site E-3 is along the reservoir shoreline near the west end of the west dike (Photo 13). The area was surface collected; however, no artifacts or archaeological deposits were encountered. No additional archaeological work is recommended at this location.

*Photo 13:* Tail of a dog on beach – foreground; mixed deciduous/coniferous forest on top of eroded bank. View to the northwest.

The single cultural resource site is designated as the Montreal Company Location Historic District. Most of the MCLHD shoreline is stable except for a small area designated as E-3. TRC recommends that NSPW monitor the erosion at site E-3 for any changes within 5 years of license issuance.

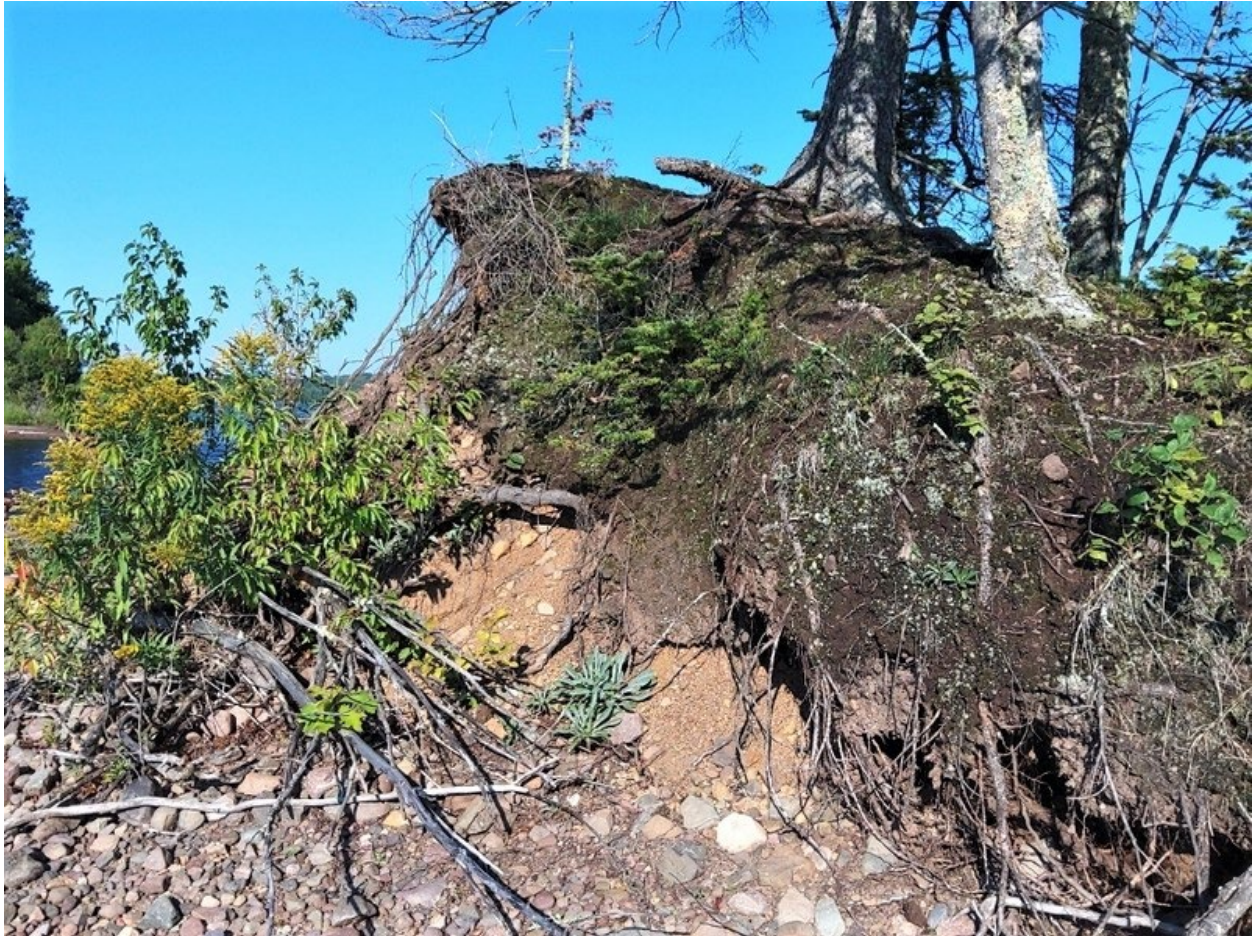
#### **E-4**

Erosion was observed along the entire shoreline of the small island where E-4 is located (Photo 14). At normal pool elevation, the island would only be about 3 sq. meters in size. However, since the Reservoir elevation was down approximately 3 feet from normal pool at the time of the survey, a greater area of the island was exposed. The site was surface collected; however, no artifacts or archaeological deposits were encountered. No additional archaeological work is recommended at this location.

**Photo 14: Mixed deciduous/coniferous forest on top of the eroded bank; willow growing in beach on the left. View to west.**

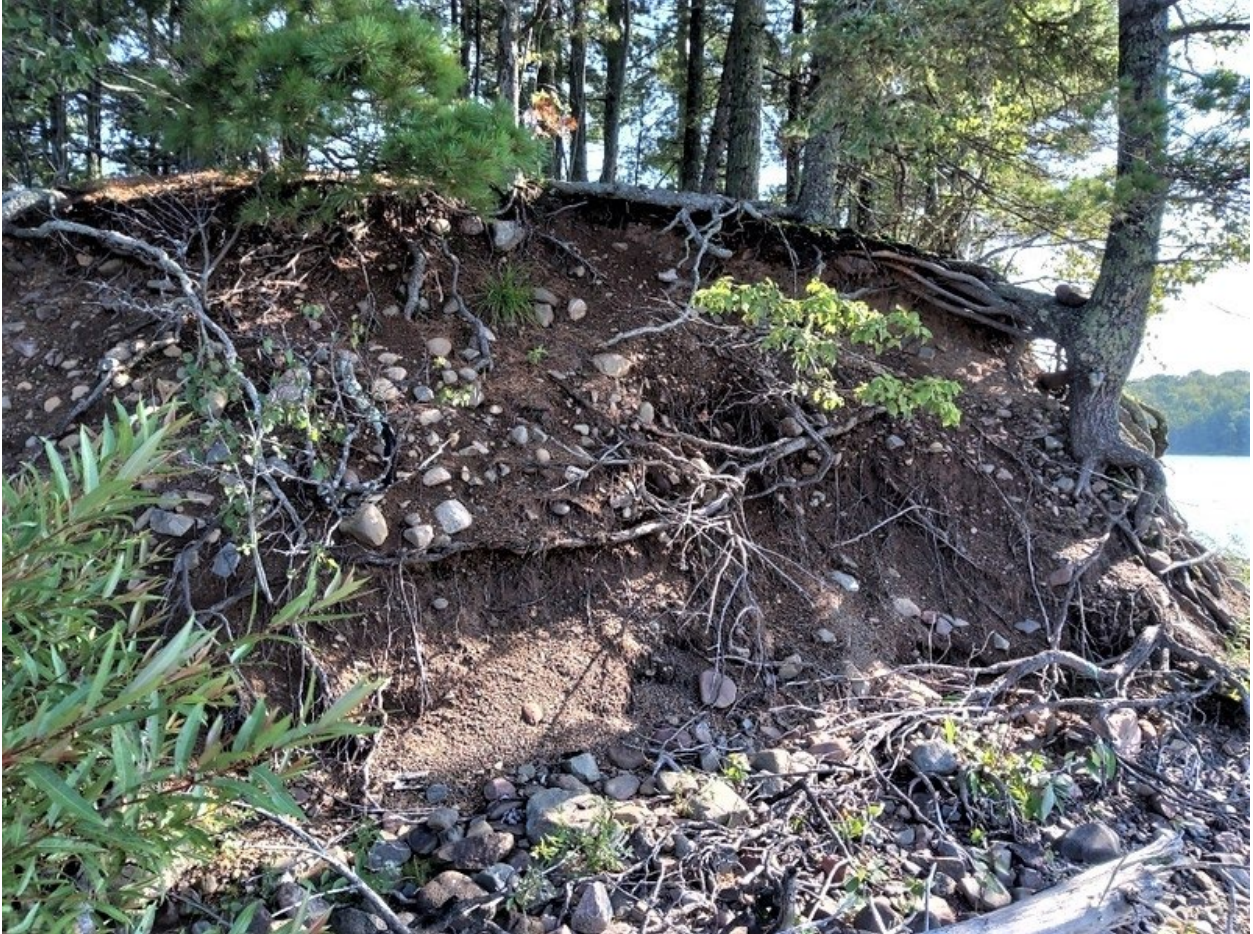
#### **E-5**

Erosion area E-5 is on the shoreline of a small island (Photo 15). The area was surface collected at water's edge, the exposed bank, and the slumped bank. No artifacts or archaeological deposits were encountered; therefore, no additional archaeological work is recommended at this location.

**Photo 15: Mixed deciduous/coniferous forest on top of eroded bank. View to northeast.**
