Aquatic and Terrestrial Invasive Species Study Report

Northern States Power Company
Gile Flowage Storage Project
Montreal, Wisconsin
GAI Project Number: R220323.01

September 2022

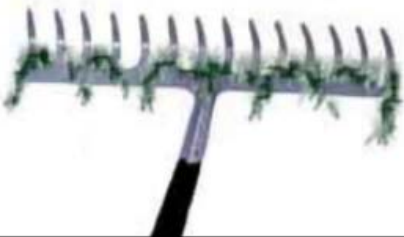
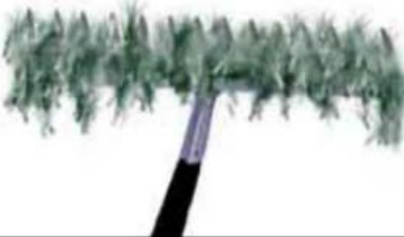
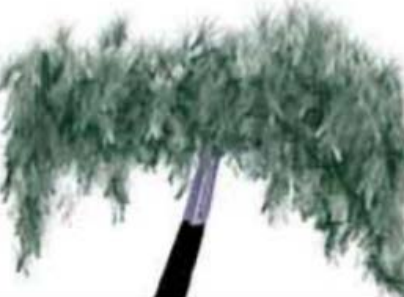
FIGURE 5 Rake Fullness per WDNR Protocol

Fullness Rating	Coverage	Description
1

<p>Only few plants. There are not enough plants to entirely cover the length of the rake head in a single layer.</p>
2

<p>There are enough plants to cover the length of the rake head in a single layer, but not enough to fully cover the tines.</p>
3

<p>The rake is completely covered and tines are not visible.</p>

Figure 5. Rake Fullness per WDNR protocol.

Illustration of rake fullness rating used during the survey, photo used from *Recommended Baseline Monitoring of Aquatic Plants in Wisconsin: sampling design, field and laboratory procedures, data entry and analysis, and applications*. PUB-SS-1068,WDNR 2019.

Points were sampled using a double-sided rake mounted on a pole. The rake was lowered until it rested gently on the lake bottom, twisted twice, then raised straight up out of the water. At each sampled point, aquatic plant species' presence and density were collected (Figures 3 and 4, Attachments A and B). Plant density was measured by rake fullness (Figure 5). Areas not captured by the point-intercept grid were monitored for the species listed in the WDNR aquatic invasive rapid response species list (WDNR 2016). No permanent vouchers were collected. Photos taken during the Study are included in Attachment C.

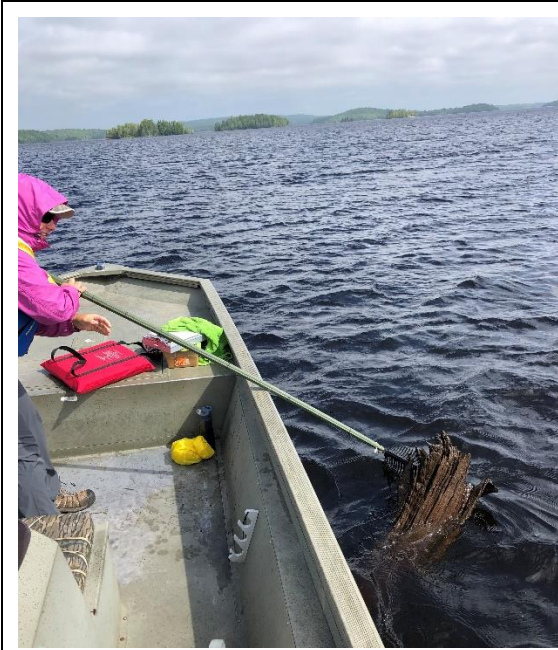
Woody debris on sampling rake at a sampling point during the June point-intercept survey
46.377152, -90.236264
June 14, 2022

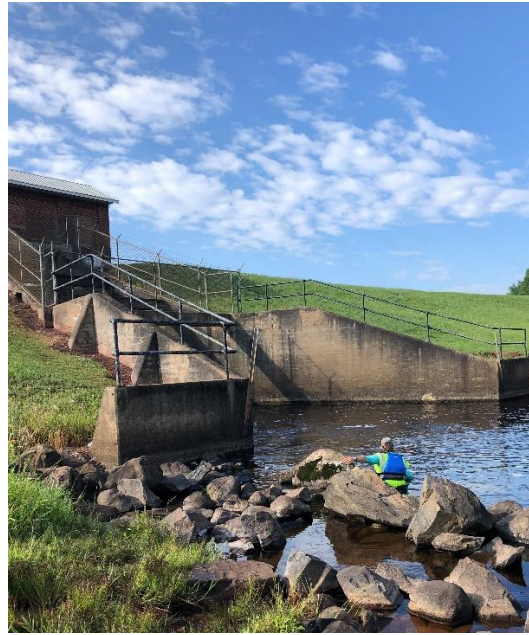
Gile tailwater sampling below the dam,
46.42594, - 90.22691
June 27, 2022

Shallow water and fast flows at the tailwater locations prevented the use of a boat, therefore, the sampling method was adjusted accordingly. The pool below the dam was accessed on foot. The plankton net was positioned in the current, such that the top of the net was submerged while the bottom of the net remained above the bottom substrate. The net was held in this position with water flowing through for two minutes to collect the water sample.

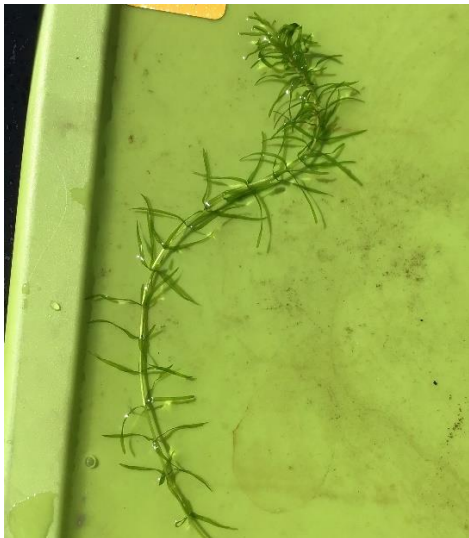
Slender waterweed (*Elodea nuttallii*),
46.41064, -90.2412027
June 22, 2022

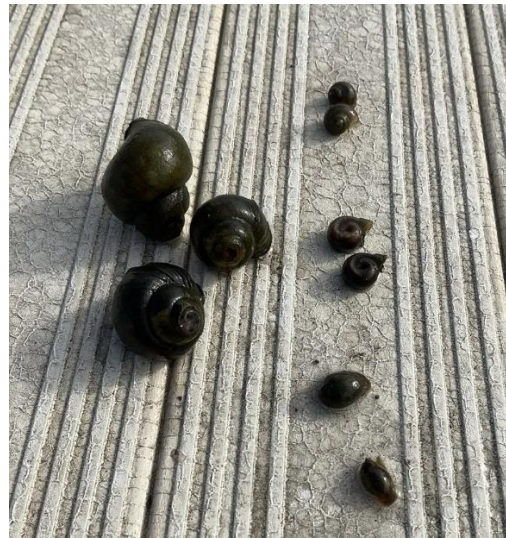
Invertebrates located by boat launch,
46.406794, -90.19317472
July 6, 2022

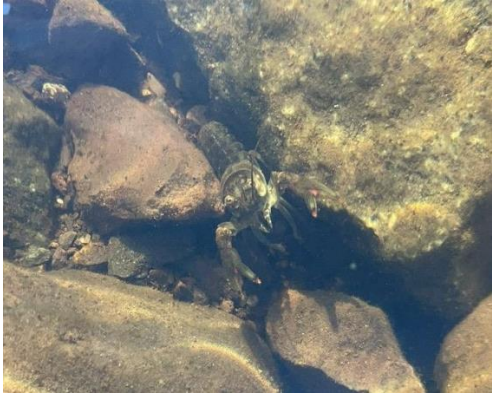
Northern clearwater crayfish by Hwy C boat launch,
46.406775, -90.193144
July 6, 2022

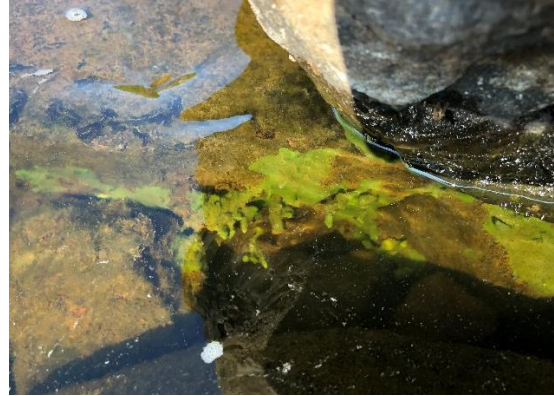
Freshwater sponge growing on rocks below the
dam, 46.42594, - 90.22691
July 27, 2022

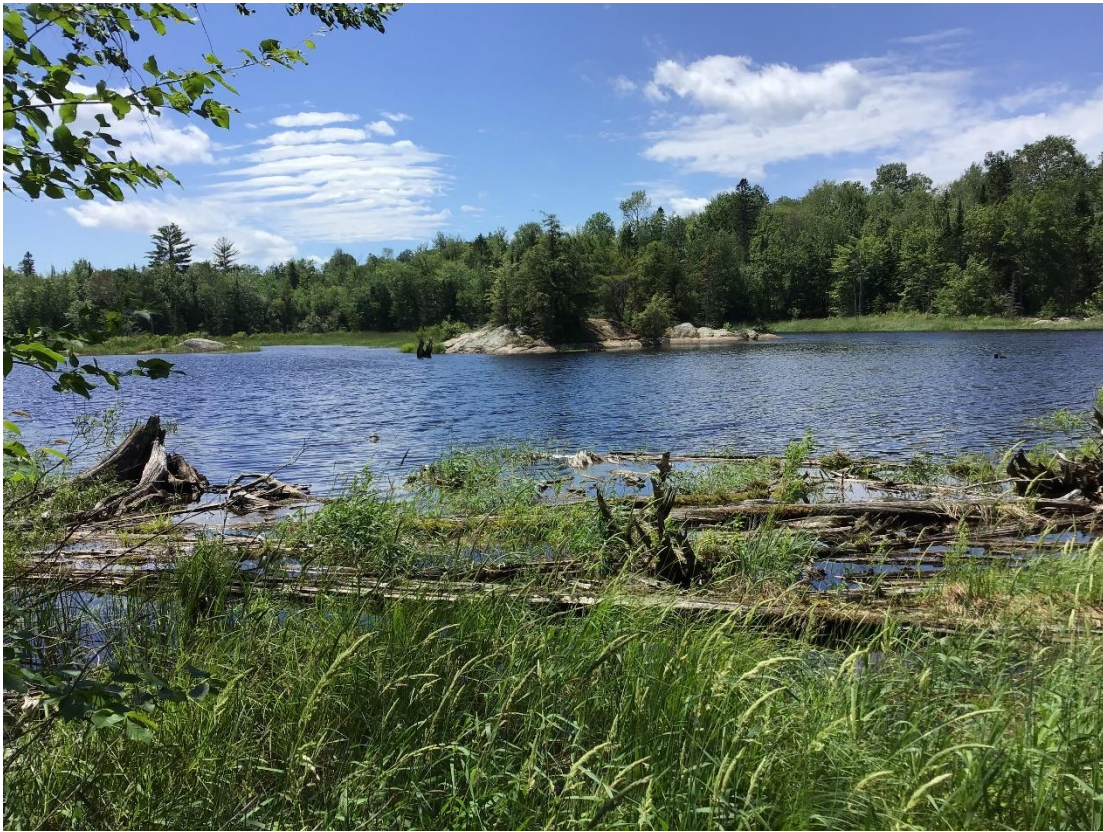
An example of the plentiful wildlife habitat and basking areas in one of the bays of Gile Flowage,
46.38025, -90.24320277, June 30, 2022
