# INITIAL STUDY REPORT

**Gile Flowage Storage Project (FERC Project No. 15055)**  
Minimum Flow Habitat Evaluation Study  
and  
Shoreline Stability Assessment

September 22, 2022

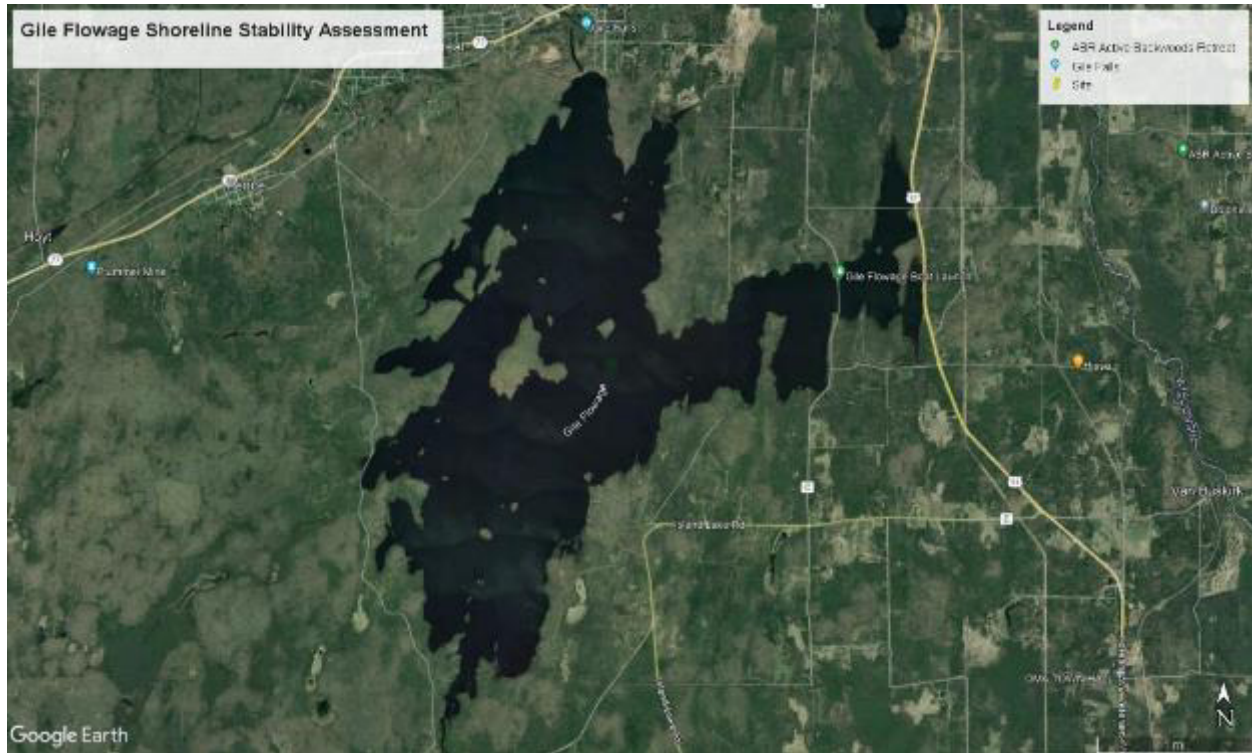
FIGURE 1. GILE FLOWAGE STUDY AREA

The Gile Flowage (Flowage) is located within the northern highland area of northern Wisconsin which is widely known for its forests, lakes, and wetlands. The Flowage is an approximately 3,200-acre reservoir formed by the impounding of the west branch of the Montreal River (FIGURE 1). The Flowage and the west branch of the Montreal River are located in the vicinity of the Gogebic and Trap Ranges (Wisconsin Geological & Natural History Survey (WGNHS) 2022) which form two conspicuous ridges in Iron and Ashland Counties in northern Wisconsin. Both ridges are composed of rock types that are more resistant to erosion than the rock that underlies the valley separating them. A thin layer of sediment deposited during the most recent glaciation covers the valley and parts of the ridges. This thin layer of sediment is exposed along the Flowage shoreline where erosion is present. The Flowage is situated on the southern ridge of the Gogebic Range and contains iron-rich rock that is approximately 1.9 billion years old. Bare rock faces and boulders are common along the shoreline of the flowage. Most, if not all, of the natural beaches on the flowage are made up of gravel and cobble. Swimming beaches, when present, appear to be man-made and represent a very small portion of the overall shoreline. The West Branch of the Montreal River flows through the northern ridge, (Trap Range) which is distinctly different in composition from the southern ridge; it is composed of younger volcanic rock, consisting primarily of basaltic-lava flows that are approximately 1.1 billion years old.

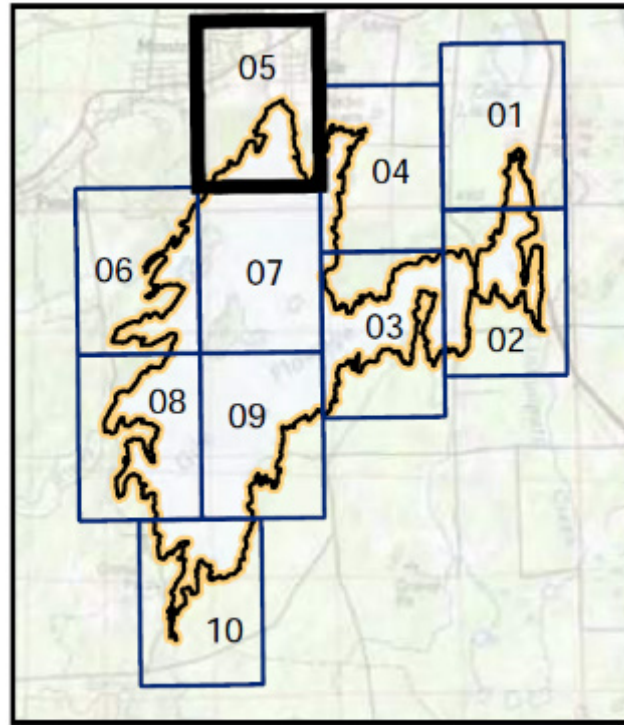
FIGURE 2. GILE FLOWAGE OUTLINE AND GRID PATTERN USED IN THE SHORELINE STABILITY ASSESSMENT (MAP SHEETS 1 THROUGH 10)

The Shoreline Stability Assessment (stability assessment) was conducted on August 9 and 29, 2022. The entire shoreline of the Flowage, including the islands, was assessed via boat by slowly cruising along the shoreline. The backwater areas east of County Hwy C were assessed from the shoreline along County Hwy C, Knights Road and U.S. Hwy 51 (Map sheets 01 and 02). The field crew assessed only those areas that appeared to have exposed eroded soil along the shoreline. Erosion or bank instability was defined as evidence of soil movement or slumping. Bare rock areas or gravel areas were not assessed (using the data sheet) but were observed. Areas of erosion, when identified, were described by number and zone (e.g., Zone 10; site Number 1). An outline of Gile Flowage and the 10 grid (zone) patterns (Map Sheets) are shown in FIGURE 2. Raw field data scoresheets are shown in Appendix A.

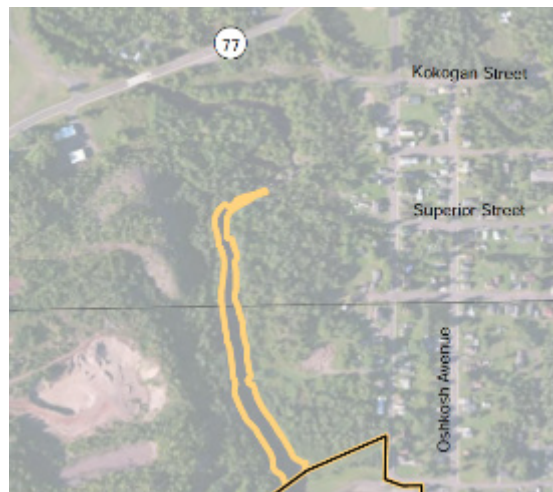
FIGURE 3. PROJECT AREA DOWNSTREAM OF THE GILE DAM INCLUDED IN THE SHORELINE STABILITY ASSESSMENT.

The stability assessment also included a survey of the project area downstream of Gile Dam (FIGURE 3). When erosion was identified, the location was photographed and recorded with a handheld GPS. Each erosion site was assigned an intensity score that was recorded on a field form. A single form was completed for each erosion site as shown in FIGURE 4.

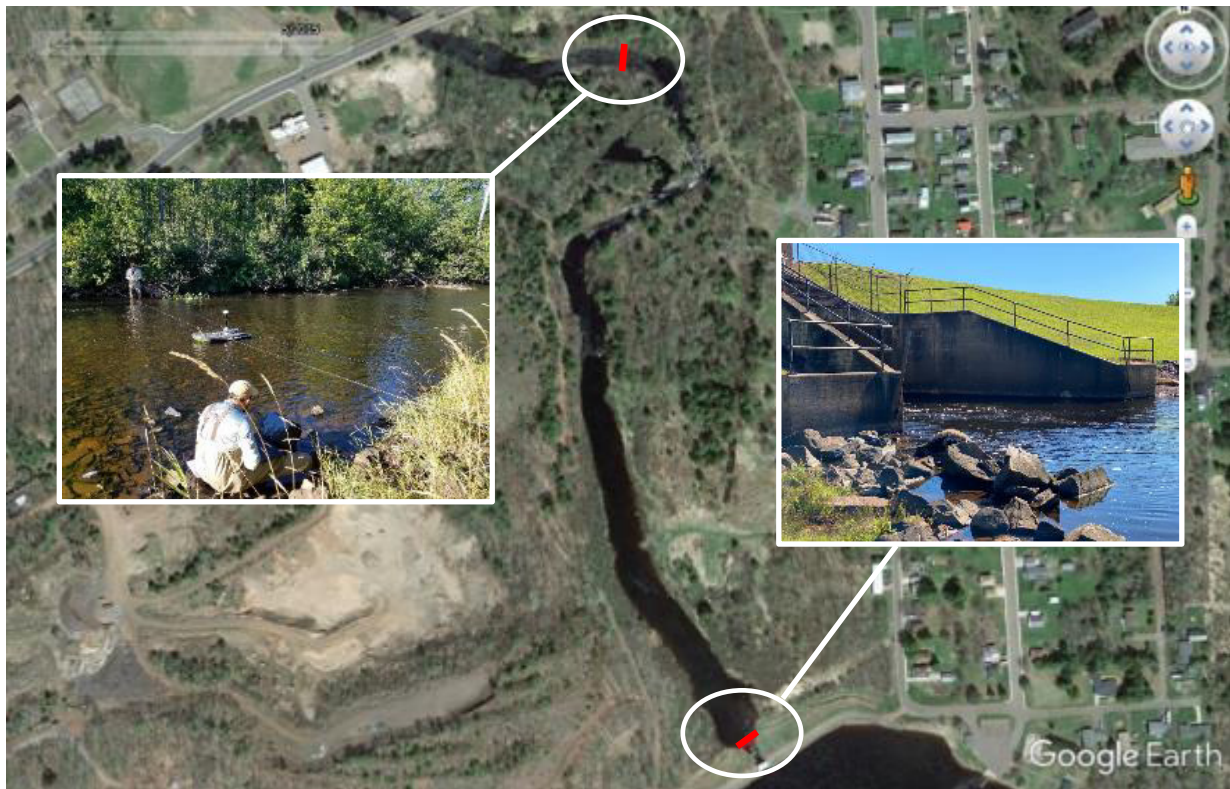
FIGURE 5. LOCATIONS OF STREAM FLOW MEASUREMENTS DURING GILE HABITAT STUDY

During the course of collecting the first set of habitat data, GLEC used a SonTek River Surveyor to verify the 12 cfs minimum flow from the dam when the sluice gate was closed as far as possible<sup>1</sup>. Flow measurements just below the dam, as well as 0.44 miles downstream (FIGURE 5), revealed that the discharge was actually much closer to the anticipated highest study flow of 36 cfs. The average of the measured flows equaled 35.25 cfs. As such, the full suite of habitat data was collected only at the high study flow (36 cfs) until such a time when lower flows can be produced.

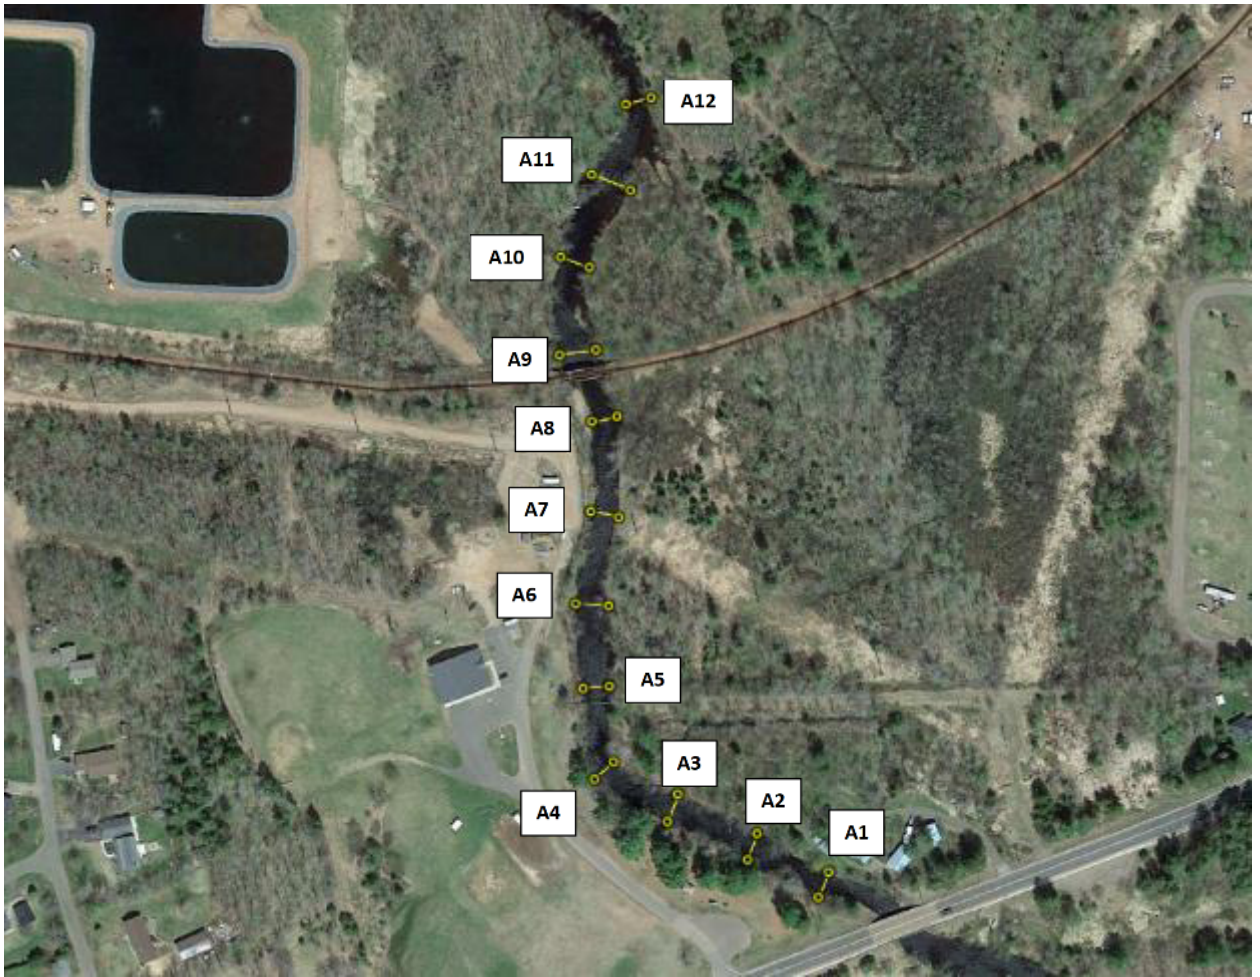
FIGURE 7. APPROXIMATE LOCATION OF TRANSECTS A1-A12 DOWNSTREAM OF HIGHWAY 77 ON THE WEST BRANCH OF THE MONTREAL RIVER

Habitat sampling at each reach was conducted following WI DNR Guidelines for Evaluating Habitat of Wadable Streams (2002). At each study reach, the mean stream width (MSW) was determined and the reach length was calculated as 35 times the MSW. Within each reach, 12 transects were established (FIGURE 7 and FIGURE 8). The first (most upstream) transect was established 1 MSW from the upstream end of the study reach and subsequent transects were spaced 3 MSW apart (approximately 45 meters in both reaches). At each transect, the following data was collected:

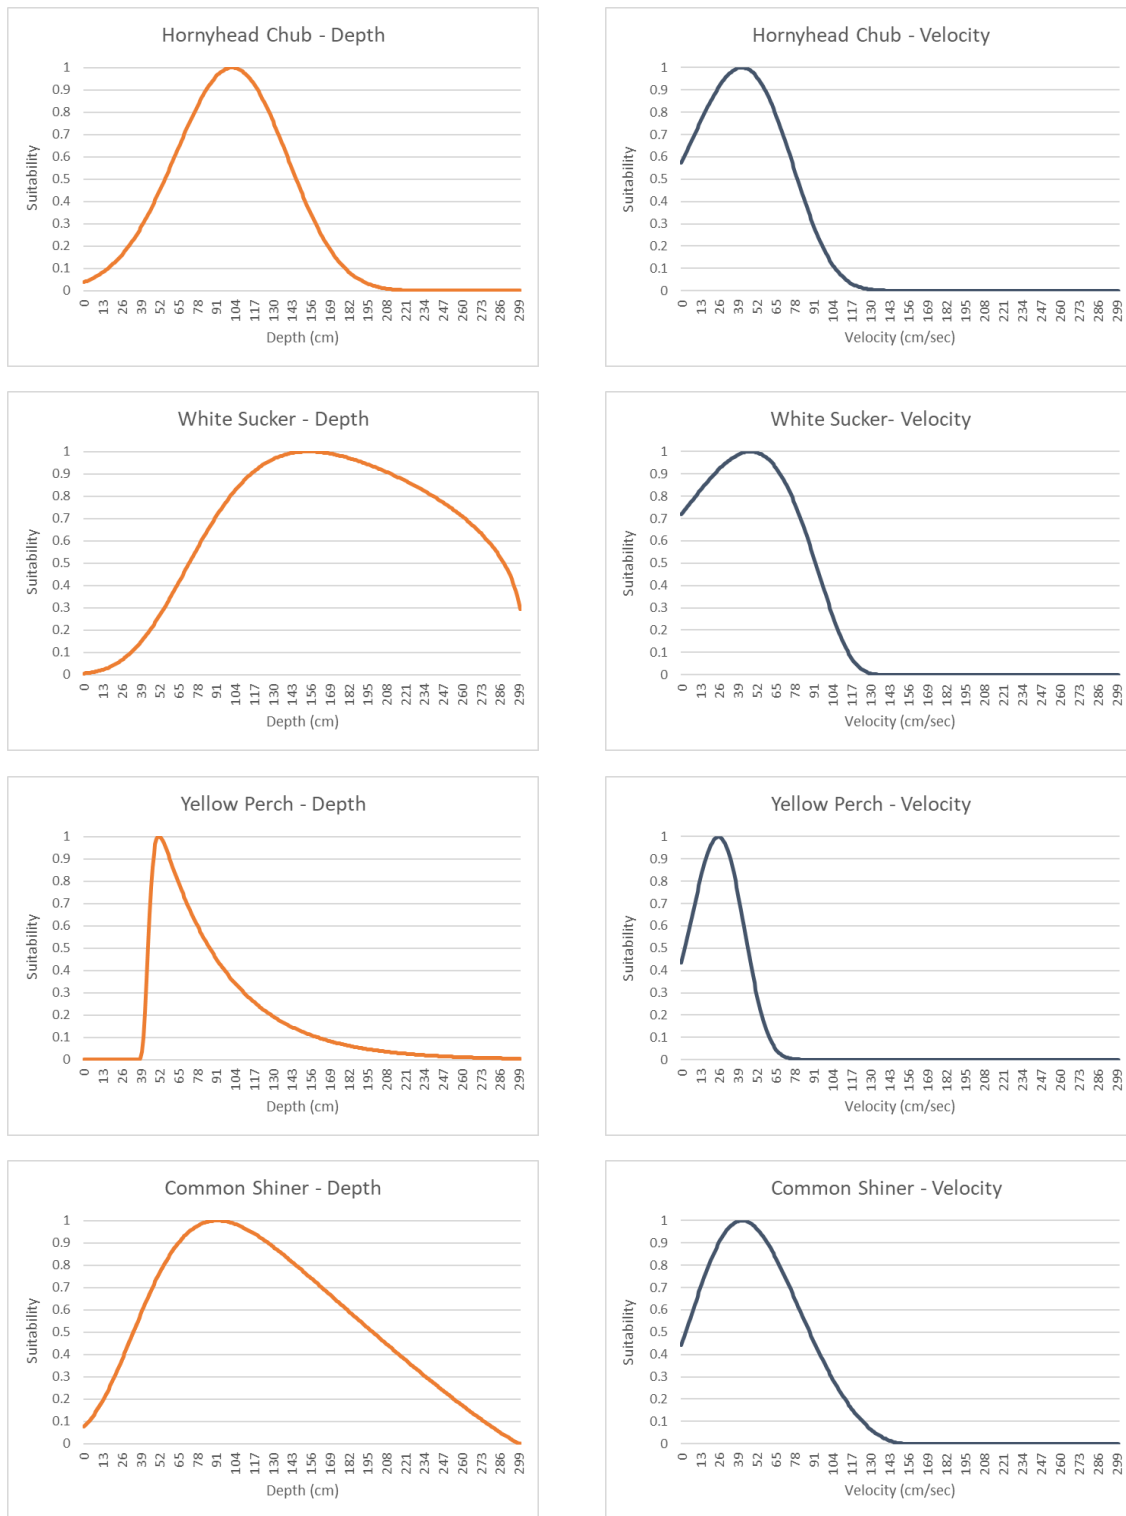
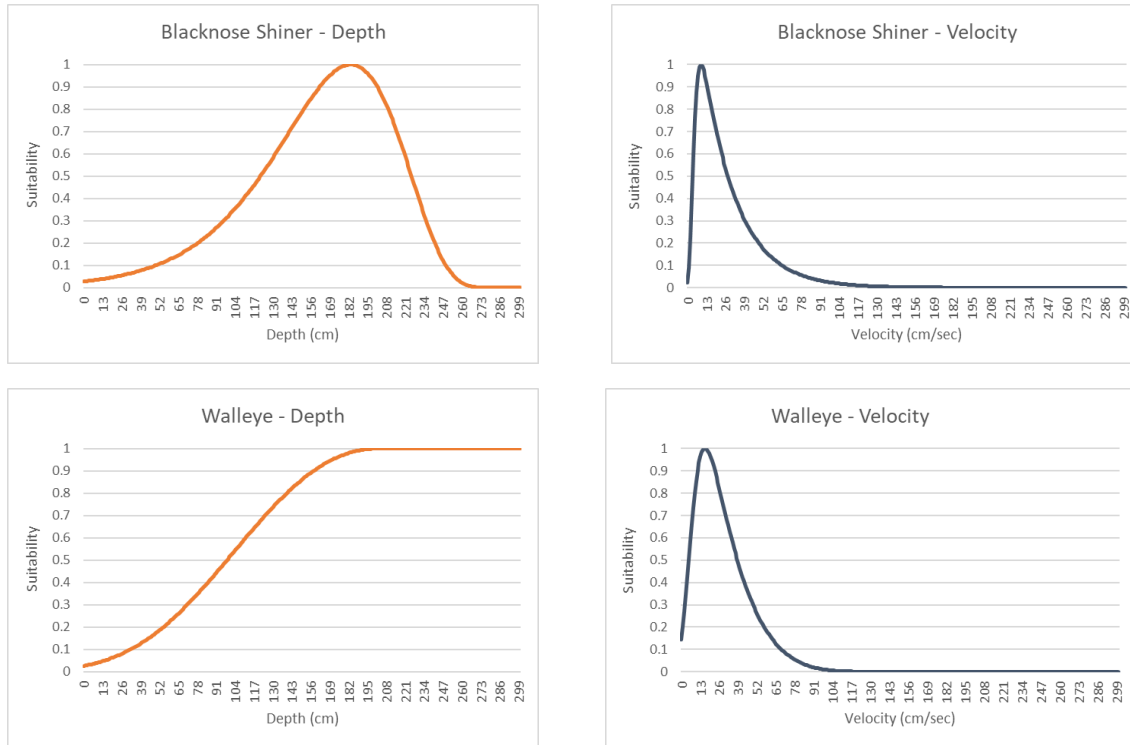
FIGURE 9. HABITAT SUITABILITY CURVES FOR DEPTH AND VELOCITY OF THE 10 MOST COMMON SPECIES IN THE GILE FLOWAGE MINIMUM FLOW HABITAT EVALUATION STUDY REACHES.

\* Habitat suitability curves for pumpkinseed were not available, so the curves for bluegill were used instead

Habitat suitability formulas for depth and velocity were applied to each of the ten most common fish species observed during the study to calculate an overall suitability value (TABLE 5 and TABLE 6.).

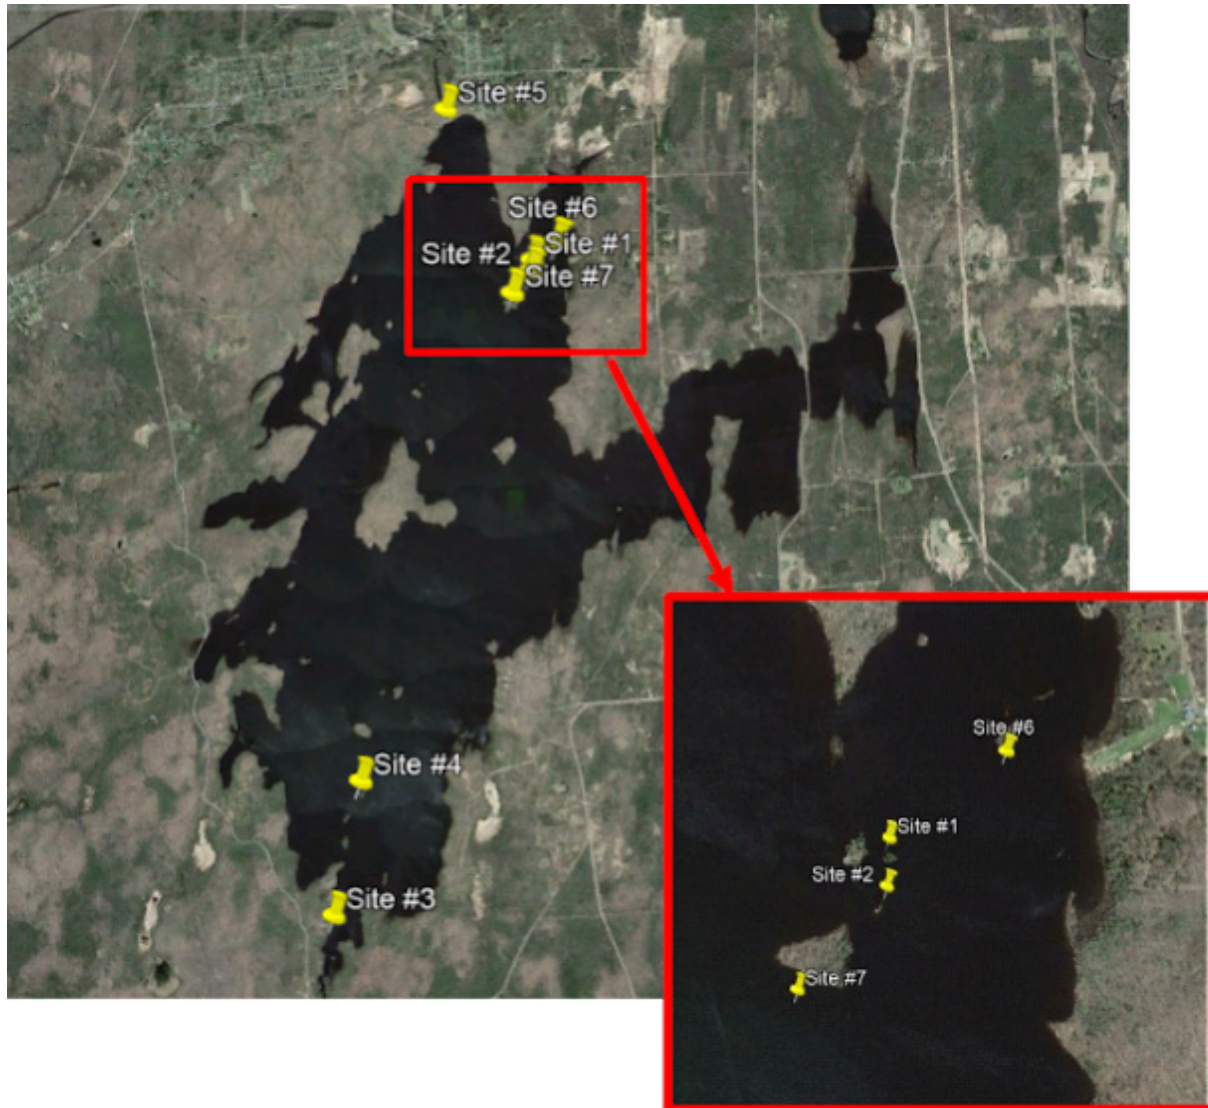
FIGURE 10. SHORELINE STABILITY ASSESSMENT SITES IN THE GILE FLOWAGE.

Seven shoreline sites and the downstream project area were scored using the Wisconsin Erosion Intensity Score worksheet. Six sites located on the Flowage appeared to have significant active erosion with evidence of soil movement or slumping (Sites 1, 2, 4, 5, 6 and 7). Site #3 was assessed to evaluate the worksheet scoring at a non-erosional site for comparison. In addition, specific attention was given to the assessment of roadsides, manmade beaches, docks or otherwise developed shorelines for evidence of soil movement or slumping. On the Flowage, none of the developed shorelines showed any evidence of erosion. A list of the sites assessed using the Erosion Intensity Score worksheet is provided in TABLE 3 and their locations are shown in FIGURE 10. Photographs of each site are provided in FIGURE 13 through FIGURE 19. The field data worksheets are included in Appendix A.

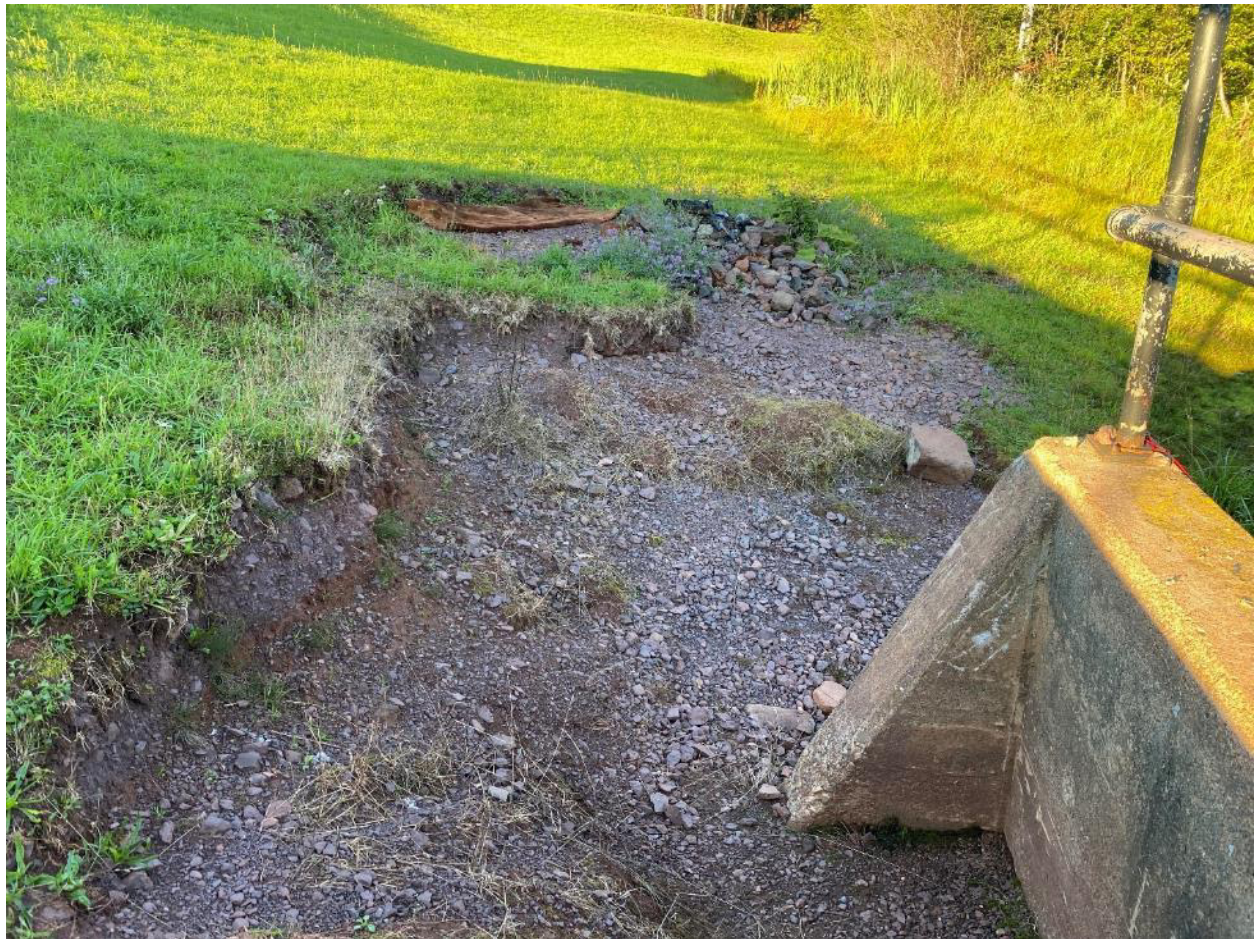
FIGURE 11. AREA OF INTEREST ON THE LEFT EMBANKMENT (WEST WINGWALL) FACING DOWNSTREAM AT THE TOW OF THE EMBANKMENT (August 30, 2022).

There was one small area with evidence of shoreline erosion in the tailrace. That area is located on the west bank at the toe of the water control structure, adjacent to the west wingwall downstream of the dam gatehouse. It appears that human traffic, and possibly high springtime flows, have scoured the bank and exposed the soil adjacent to the concrete wingwall (FIGURE 11). Given the location of the area of interest, an Erosion Intensity work sheet was not completed. There were no other erosion sites identified in the project area downstream of the dam. A typical depiction of the downstream project area is shown in FIGURE 12.

Five of the six erosion sites identified were located on small islands within the flowage where the erosion was limited to the thin soil layer atop the bedrock. One site (Site #5) was located along the northwest shoreline of the flowage near the dam. Although located away from the dam and in a wooded area, this site did exhibit significant soil movement and warrants further investigation. The small area of interest in the tailrace also deserves further attention due to its proximity to the dam structures.

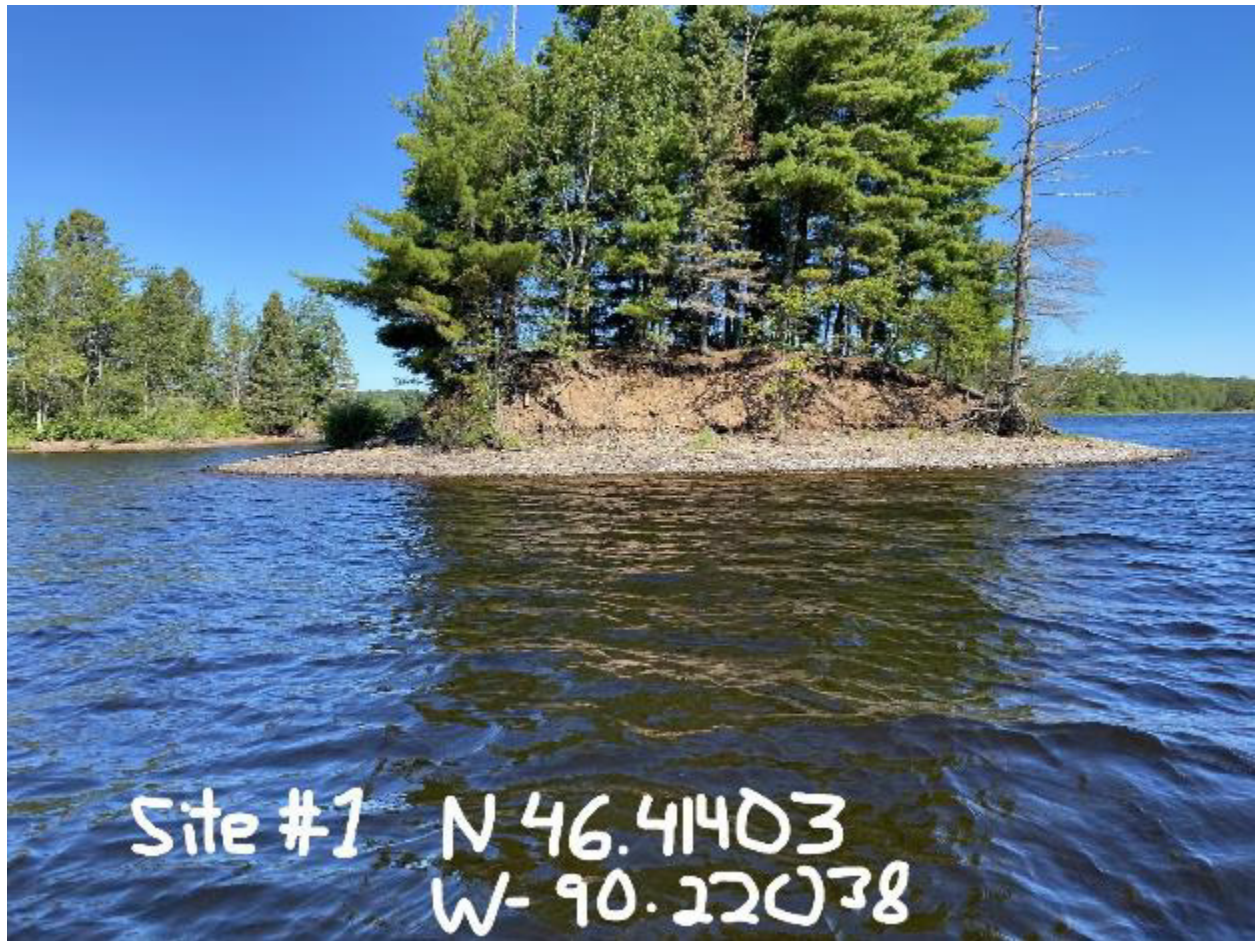
FIGURE 13. SITE #1 FROM THE 2022 GILE FLOWAGE SHORELINE STABILITY ASSESSMENT.

Five of the six sites identified with erosion were located on small islands within the Flowage (Sites 1, 2, 4, 6 and 7). One site (Site #5) was located along the northwest shoreline near the dam. In each instance, the erosion features appeared to be above the waterline.

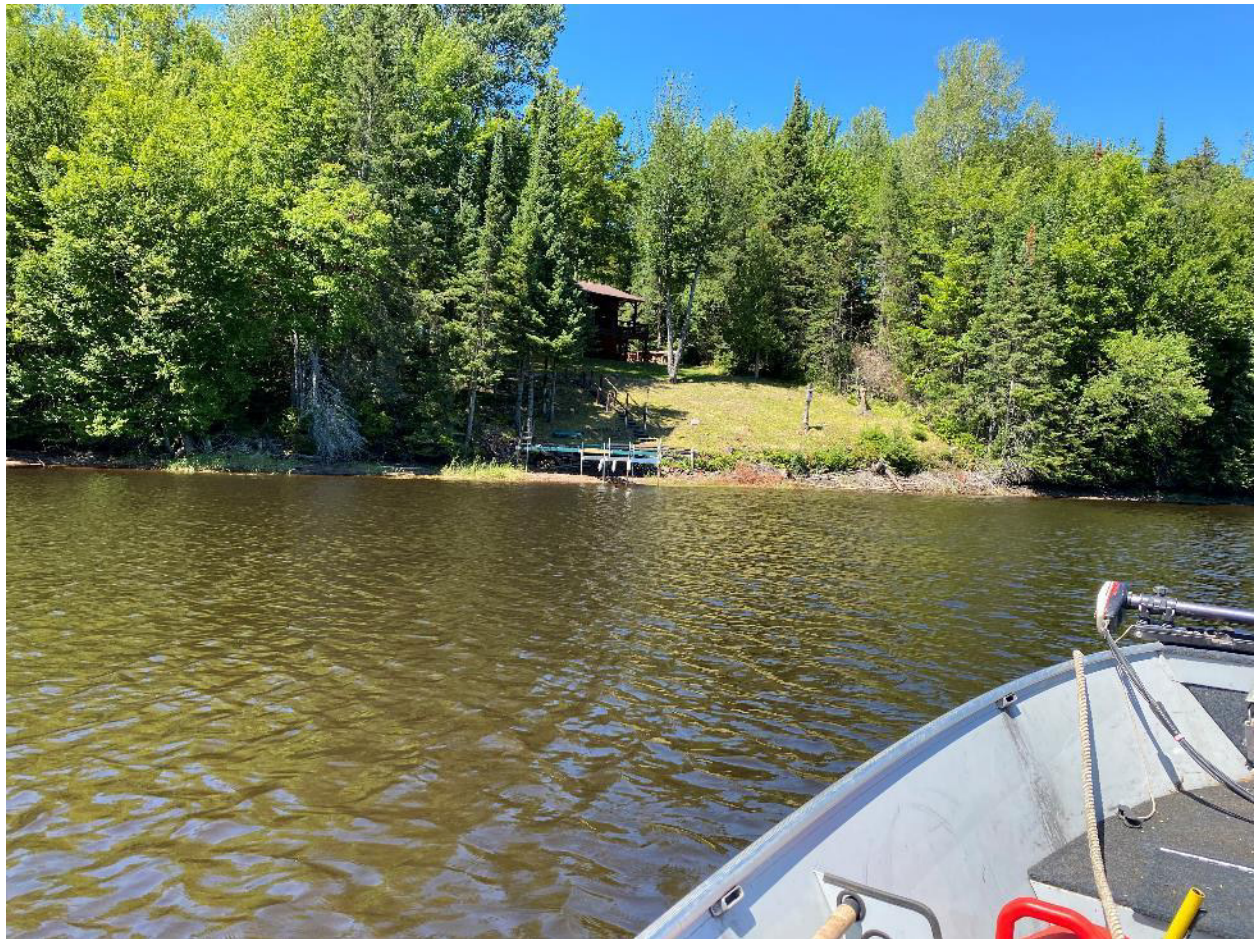
FIGURE 15. SITE #3 FROM THE 2022 GILE FLOWAGE SHORELINE STABILITY ASSESSMENT.

<sup>@</sup> Site #3 was not an area of concern nor an erosional site.

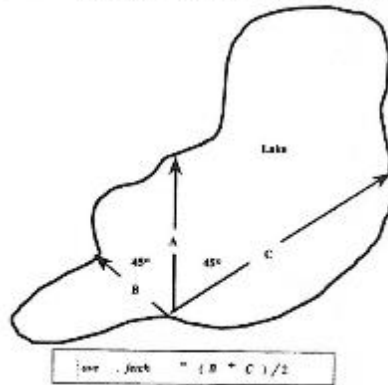
<sup>1</sup> Average fetch: The following diagram describes the calculation of average fetch.
