# STUDY REPORT CONSULTATION

Project: 2400100-192923.01 **White River, Hayward and Trego Relicensi**

### Notification about File Transfer **Hayward and Trego Study Reports**

# Hayward and Trego Aquatic and Terrestrial Species Study Report Photo Log

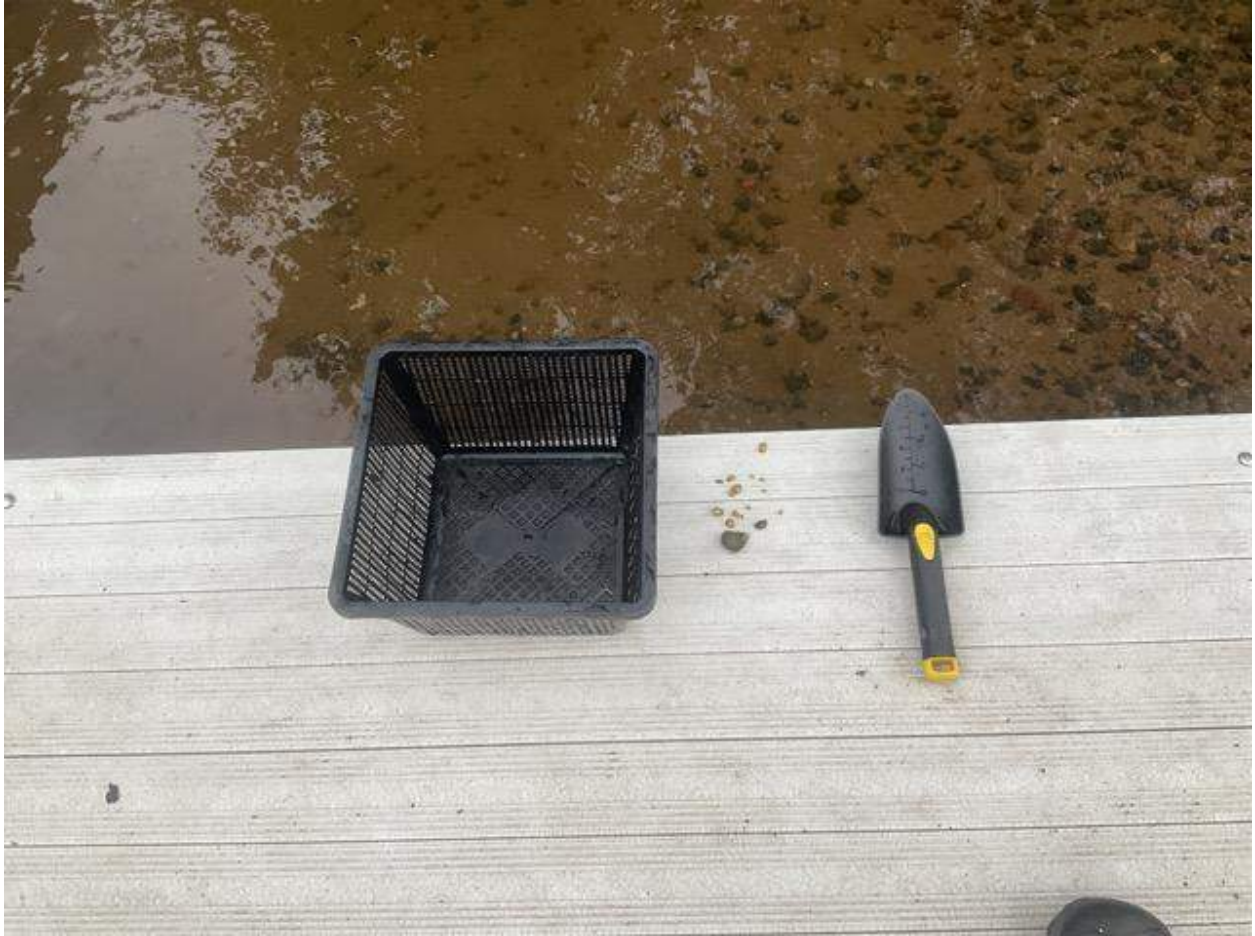
**FIGURE 10**  
**Sediment Sampling Equipment**

Figure 10. Sediment sampling equipment.

10-inch Tetra Pond Planter Basket, with 1/32-inch mesh, and garden trowel

To monitor for invasive macroinvertebrates, sediment samples were collected at public boat launch sites at Hayward and Trego lakes (Figures 1 and 2). A trowel was used to scoop approximately six inches of sediment into a 10-inch Tetra Pond Planter Basket, with a 1/32<sup>nd</sup> inch mesh (Figure 10). Fine sediment was flushed out of the basket and the remaining materials were examined for Asian clam (*Corbicula fluminea*), faucet snail (*Bithynia tentaculata*), New Zealand mud snail (*Potamopyrgus antipodarum*), Malaysian trumpet snail (*Melanoides tuberculata*), rusty crayfish (*Orconectes rusticus*), and other invasive macroinvertebrates. The areas in the vicinity of these access sites were also visually examined for live snails, crayfish, and shells.

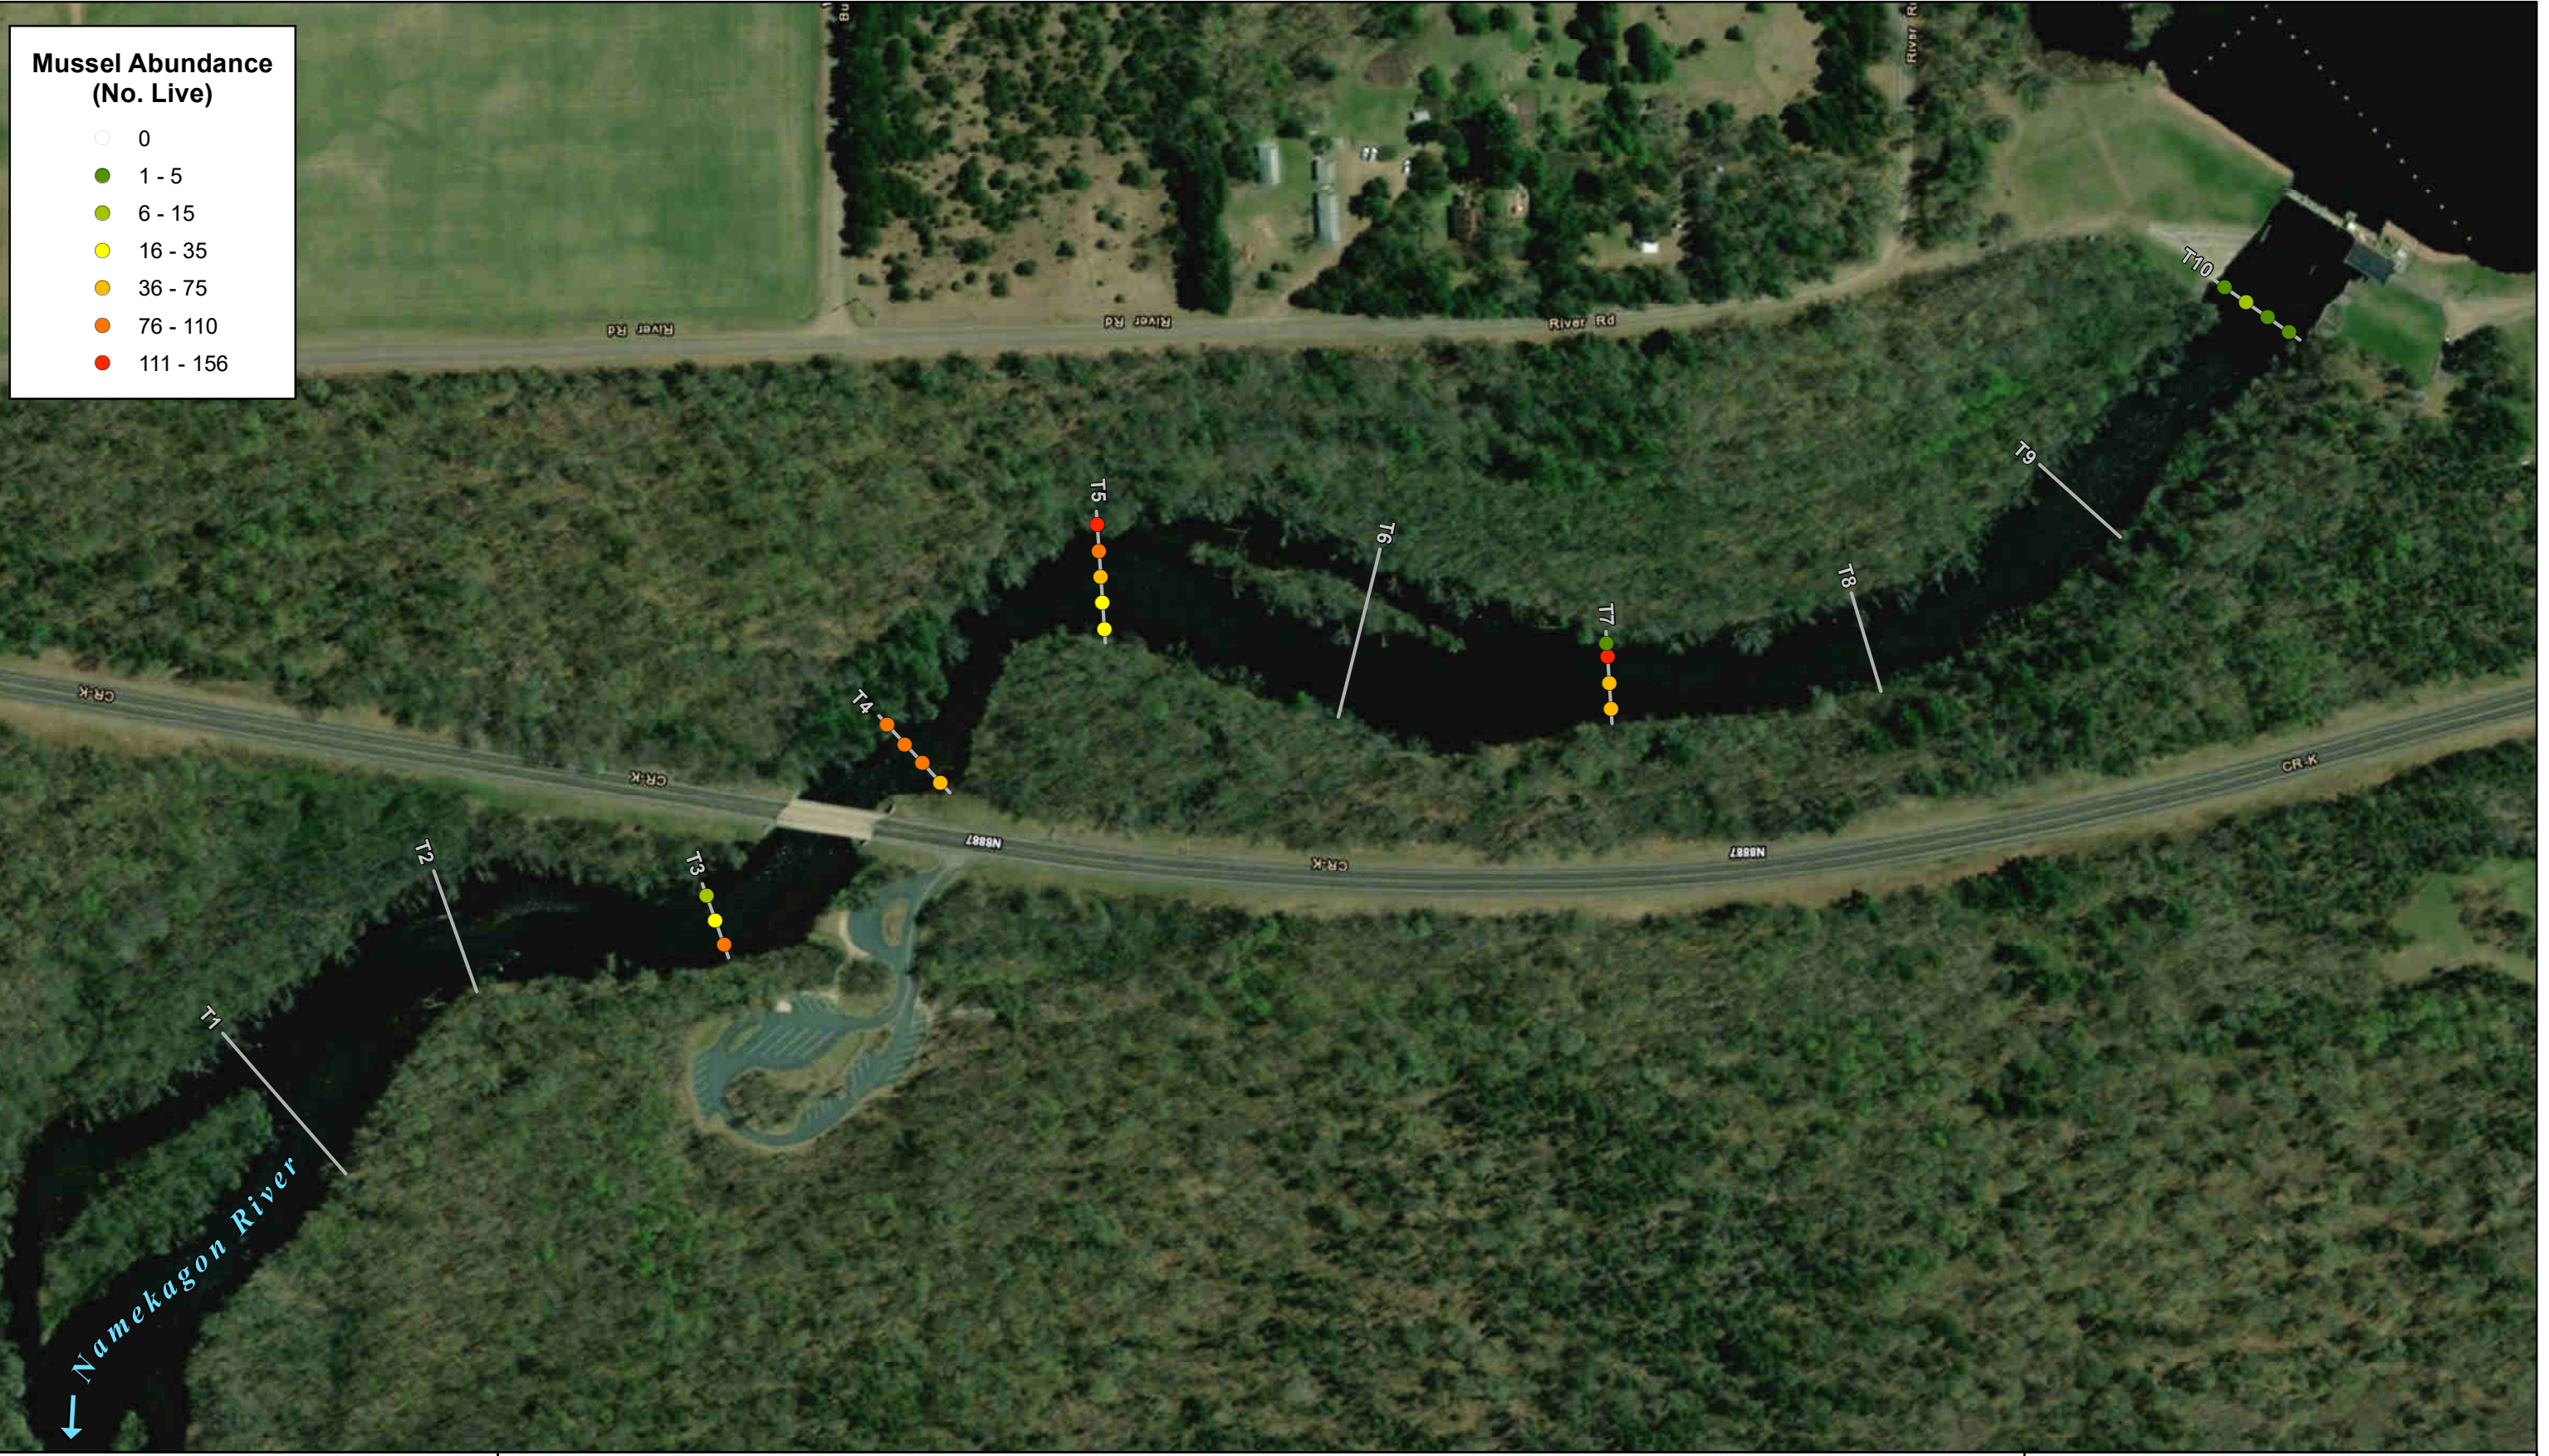
Figure 6. Mussel Abundance for the Trego Project Reach Two on the Namekagon River. Washburn County, Wisconsin.

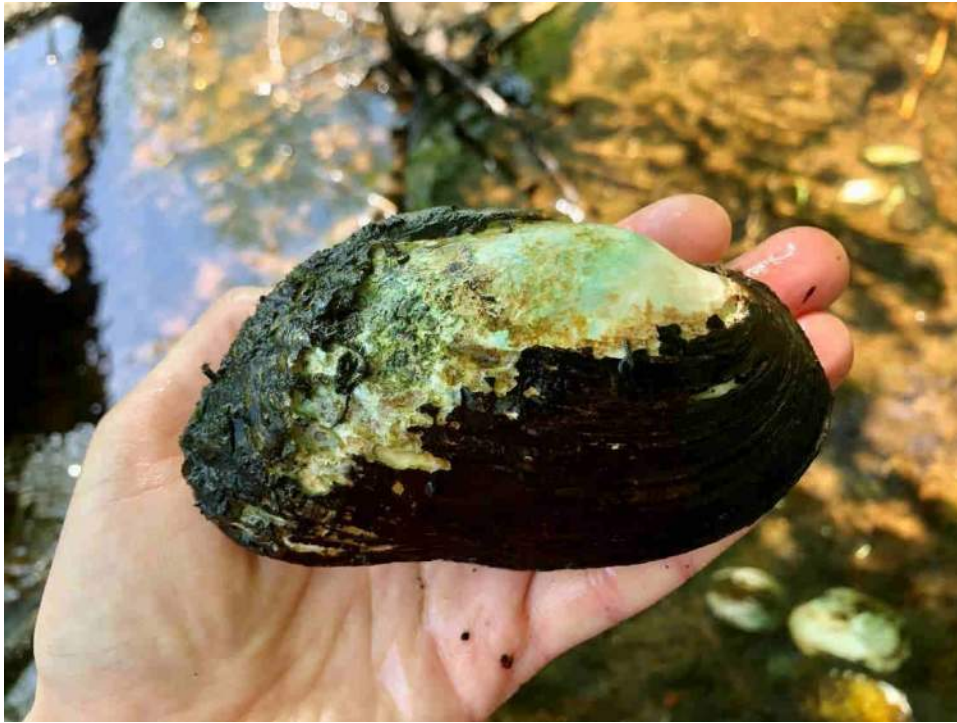
Photo 27. Representative photo of shell erosion observed on some live mussels in the project area.

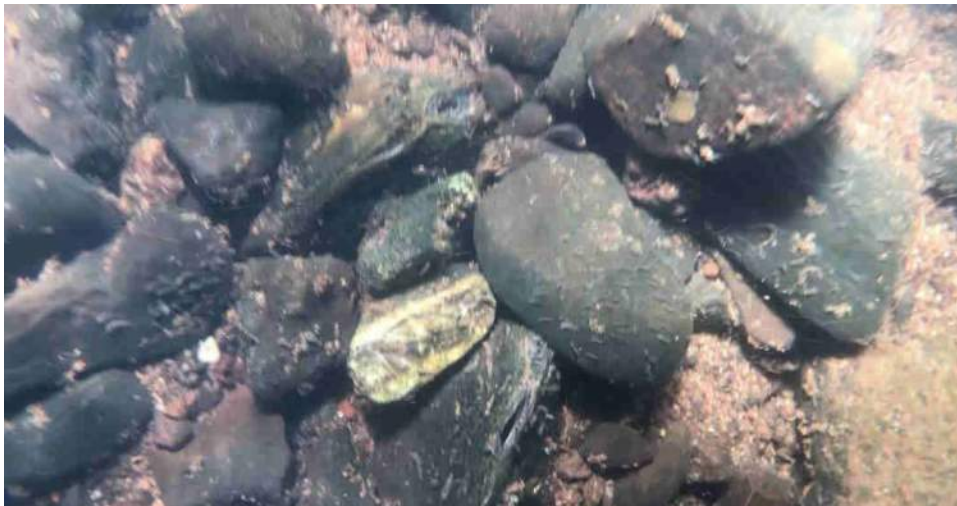
Photo 28. Representative photo of live mussels in the substrate with siphons visible.
