APPENDIX E-2 Upper Trego Reservoir Bathymetry

Trego Hydroelectric Project
Bathymetric Map Based on 2022
Substrate Survey Data Points

Hayward and Trego Aquatic and Terrestrial Invasive Species Study Report

Northern States Power Company
Hayward and Trego Hydroelectric Projects
Hayward, Wisconsin
Trego, Wisconsin

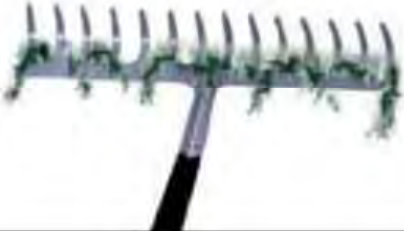
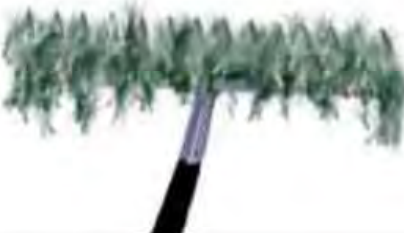
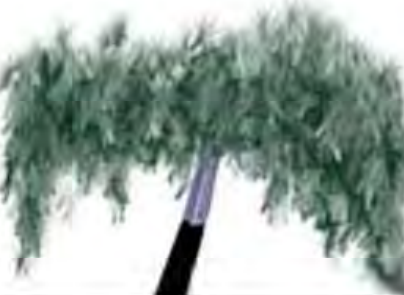
FIGURE 9
Rake Fullness per WDNR Protocol

Fullness Rating	Coverage	Description
1

<p>Only few plants. There are not enough plants to entirely cover the length of the rake head in a single layer.</p>
2

<p>There are enough plants to cover the length of the rake head in a single layer, but not enough to fully cover the tines.</p>
3

<p>The rake is completely covered and tines are not visible.</p>

Figure 9. Rake Fullness per WDNR protocol.

Points were sampled using a double-sided rake mounted on a pole. The rake was lowered until it rested gently on the lake bottom, twisted twice, then raised straight up out of the water. At each sampled point, aquatic plant species' presence and density were collected (Figures 5 - 8 and Attachments A - D). Plant density was measured by rake fullness (Figure 9). Areas not captured by the point-intercept grid were monitored for the species listed in the WDNR aquatic invasive rapid response species list (WDNR 2016). No permanent vouchers were collected. Photographs taken during the Study are included in Attachment E.

Among the points sampled, 344 were shallower than the maximum depth of rooting plants (10.5 feet) with 283 (~82% of the littoral points) exhibiting vegetation. Thirty-four native species were found during the survey (Table 2), two of which were observed visually, but not present on the rake/at a sample point (i.e., watershield (*Brasenia schreberi*) and wild calla (*Calla palustris*). Overall, predominant species were flat-stem pondweed (*Potamogeton zosteriformis*), coontail (*Ceratophyllum demersum*), common waterweed (*Elodea canadensis*), forked duckweed (*Lemna trisulca*), and fern pondweed (*Potamogeton robbinsii*). Figure 13 includes the species dominant on each rake sample in June. The average total rake fullness during the study where plants were present was 1.55 (Figure 5).

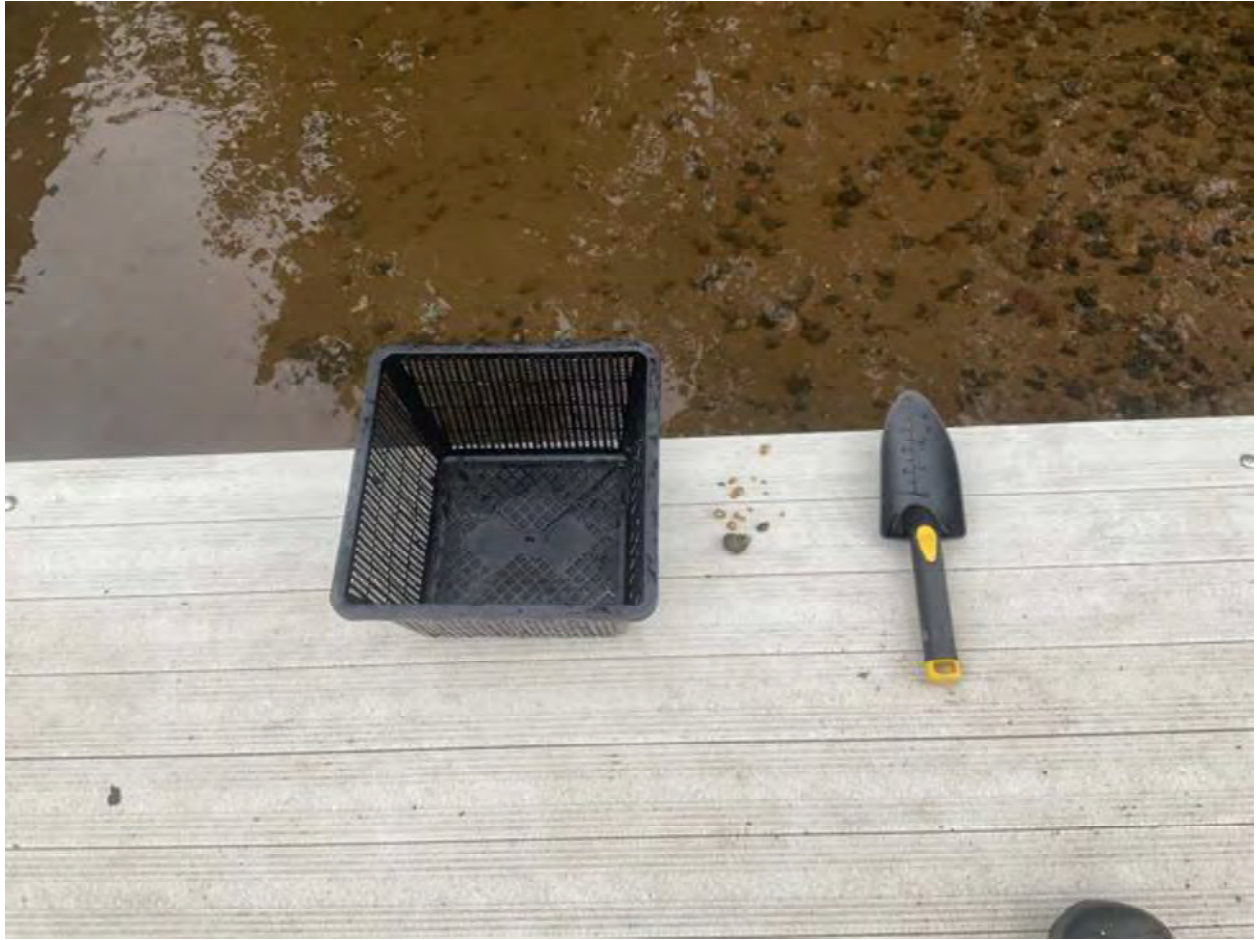
FIGURE 10
Sediment Sampling Equipment

Figure 10. Sediment sampling equipment.

10-inch Tetra Pond Planter Basket, with 1/32-inch mesh, and garden trowel

To monitor for invasive macroinvertebrates, sediment samples were collected at public boat launch sites at Hayward and Trego lakes (Figures 1 and 2). A trowel was used to scoop approximately six inches of sediment into a 10-inch Tetra Pond Planter Basket, with a 1/32nd inch mesh (Figure 10). Fine sediment was flushed out of the basket and the remaining materials were examined for Asian clam (*Corbicula fluminea*), faucet snail (*Bithynia tentaculata*), New Zealand mud snail (*Potamopyrgus antipodarum*), Malaysian trumpet snail (*Melanoides tuberculata*), rusty crayfish (*Orconectes rusticus*), and other invasive macroinvertebrates. The areas in the vicinity of these access sites were also visually examined for live snails, crayfish, and shells.

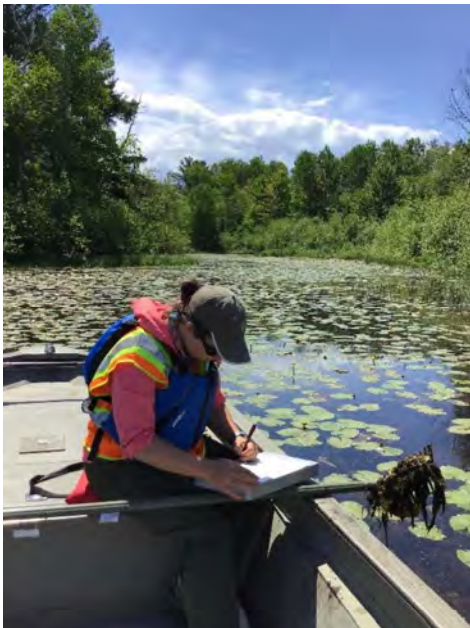
Recording aquatic plant data during the point-intercept survey in a heavily vegetated area.
46.0044666, -91.461097222, June 8, 2022

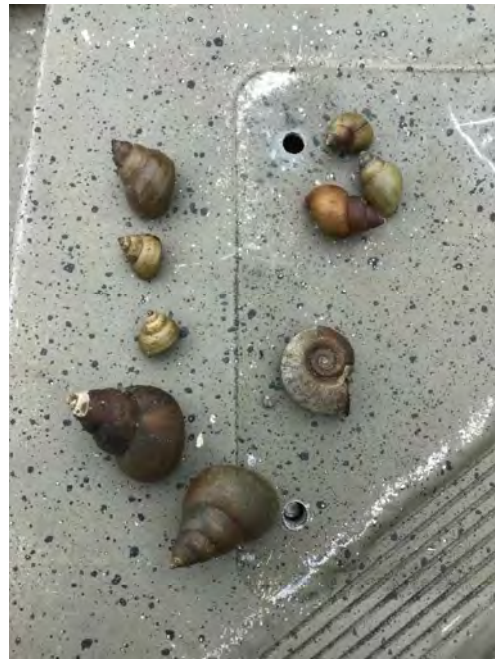
An assortment of snails found near boat launches during the sediment sampling at Trego Lake.
45.909531, -91.824674, June 10, 2022

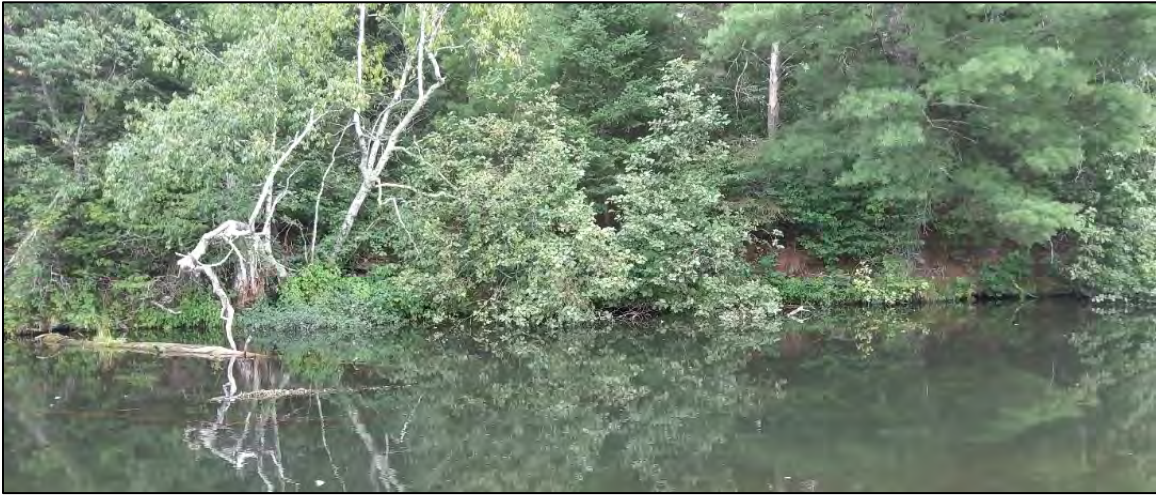
Photo 14: 47SY158/BSY-0044 - Unverified mound 50 meters inland. View to East.

The shoreline at the location where the mound was reported was inspected on foot. Surface collection along the river bank did not yield artifacts. The land is stable at the shore with a mix of pine, oak, and birch trees extending to the water (Photos 14 and 15). No additional archaeological work is recommended. Future shoreline monitoring should follow the current HRMP schedule.

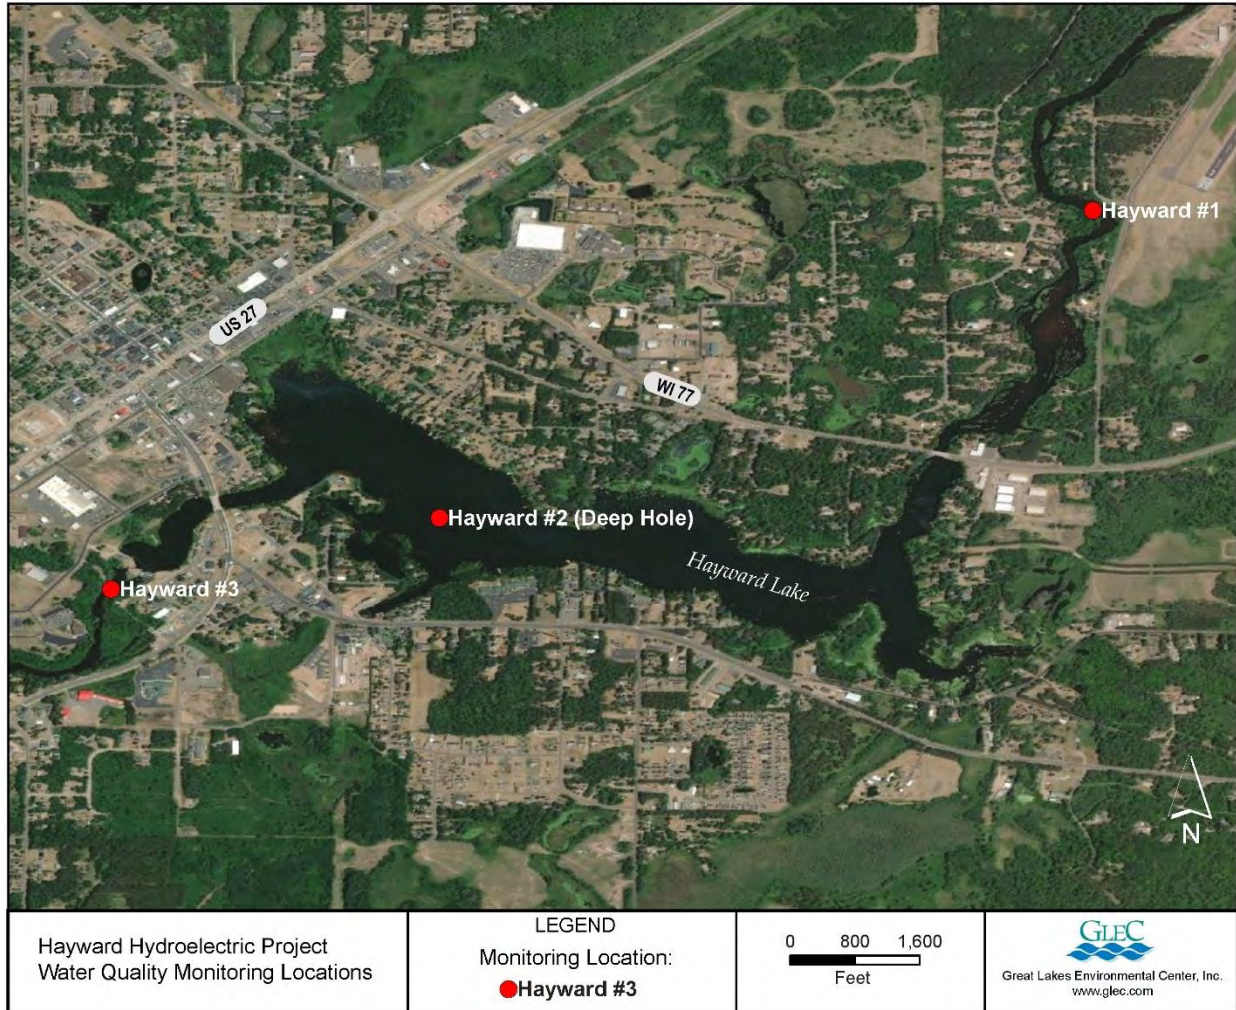
FIGURE 1. HAYWARD SAMPLING LOCATIONS FOR THE 2022 WATER QUALITY ASSESSMENT. HAYWARD #1: 46.01897, -91.45208, HAYWARD #2: 46.00855, -91.47421, HAYWARD #3: 46.00614, -91.48534

At the Trego Project, site 1 was located just upstream of the Highway 53 bridge at existing WDNR Monitoring Station 10022021, site 2 was located in the deep hole at existing WDNR Monitoring Station 663162, and site 3 was located approximately 250 feet downstream of the Trego Dam.

Figures 1, 2, and 3 illustrate the sampling locations at each Project.

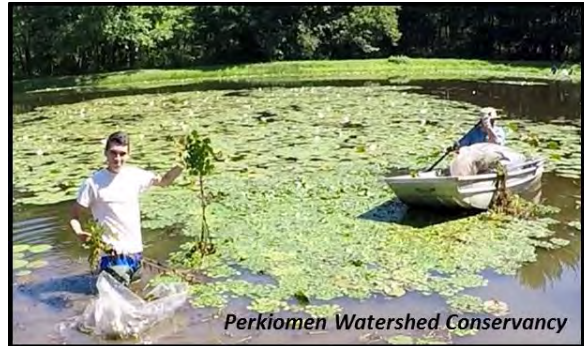
Figure 18 Manual Removal Photo

Manual removal of EWM or native plants in a 30-ft wide section parallel to shore is feasible for small-scale control as a way for lake residents to keep EWM occurrence low in front of their property and to allow watercraft travel to/from shallow docking areas.

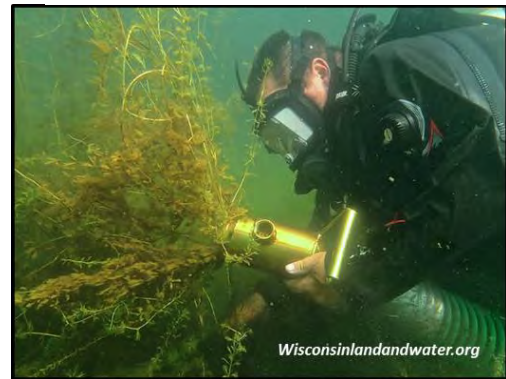
Figure 19 DASH Photo

and low frequency species and can be highly effective. DASH is labor intensive and costly at \$2,500 per day and removal rate depends on the density of EWM on-site, the height of EWM, and the number of different locations that need to be targeted for removal. Construction of a DASH unit costs range from \$9,000 if purchasing used components up to \$25,000 for new construction. Annual operating costs for two divers over 13 weeks, insurance, fuel, permits, and materials are approximately \$31,000 (Greedy, 2016). It is difficult to generalize results across different lakes and results may be lake-specific or even site-specific (Gajewski, 2016).

Using DASH for EWM control in Lake Hayward is not a realistic approach based on 2021 aquatic plant survey results. This method is best employed at small & dense infestation sites, possibly after herbicide treatment as a way to keep EWM occurrence low.

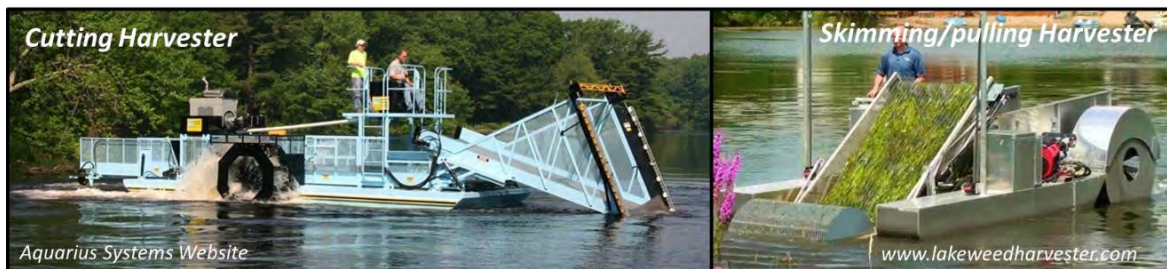
Figure 20 Mechanical Harvester Photos

It is feasible for LHPOA to hire a mechanical harvester to open navigation channels in bays where aquatic plants are causing navigation impairment and water depth is 3 feet or greater. If pursued, harvested areas should be monitored to ensure there is no increase in EWM growth in the harvested lanes.

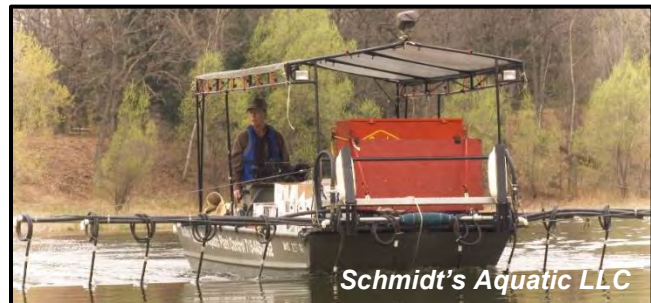
Figure 21 Chemical Treatment Photo

Impacts to native aquatic plants are an important factor when deciding whether to use chemical control. If the native plants are reduced by repeated chemical control, there is more area for EWM to grow. There were no statistically significant reductions in native plant species after treatment. Even so, if the duration of EWM or CLP control only lasts for one or two growing seasons, it is important to weigh the financial costs combined with impacts to native plants versus the relatively short-lived control. ***Although herbicide treatment may be a feasible option for EWM or CLP control in the future, it is not an appropriate control tool at this time. It is also important to consider the possibility of herbicide dilution before effective control can take place. Following up any herbicide treatment with other forms of EWM control is highly recommended.***

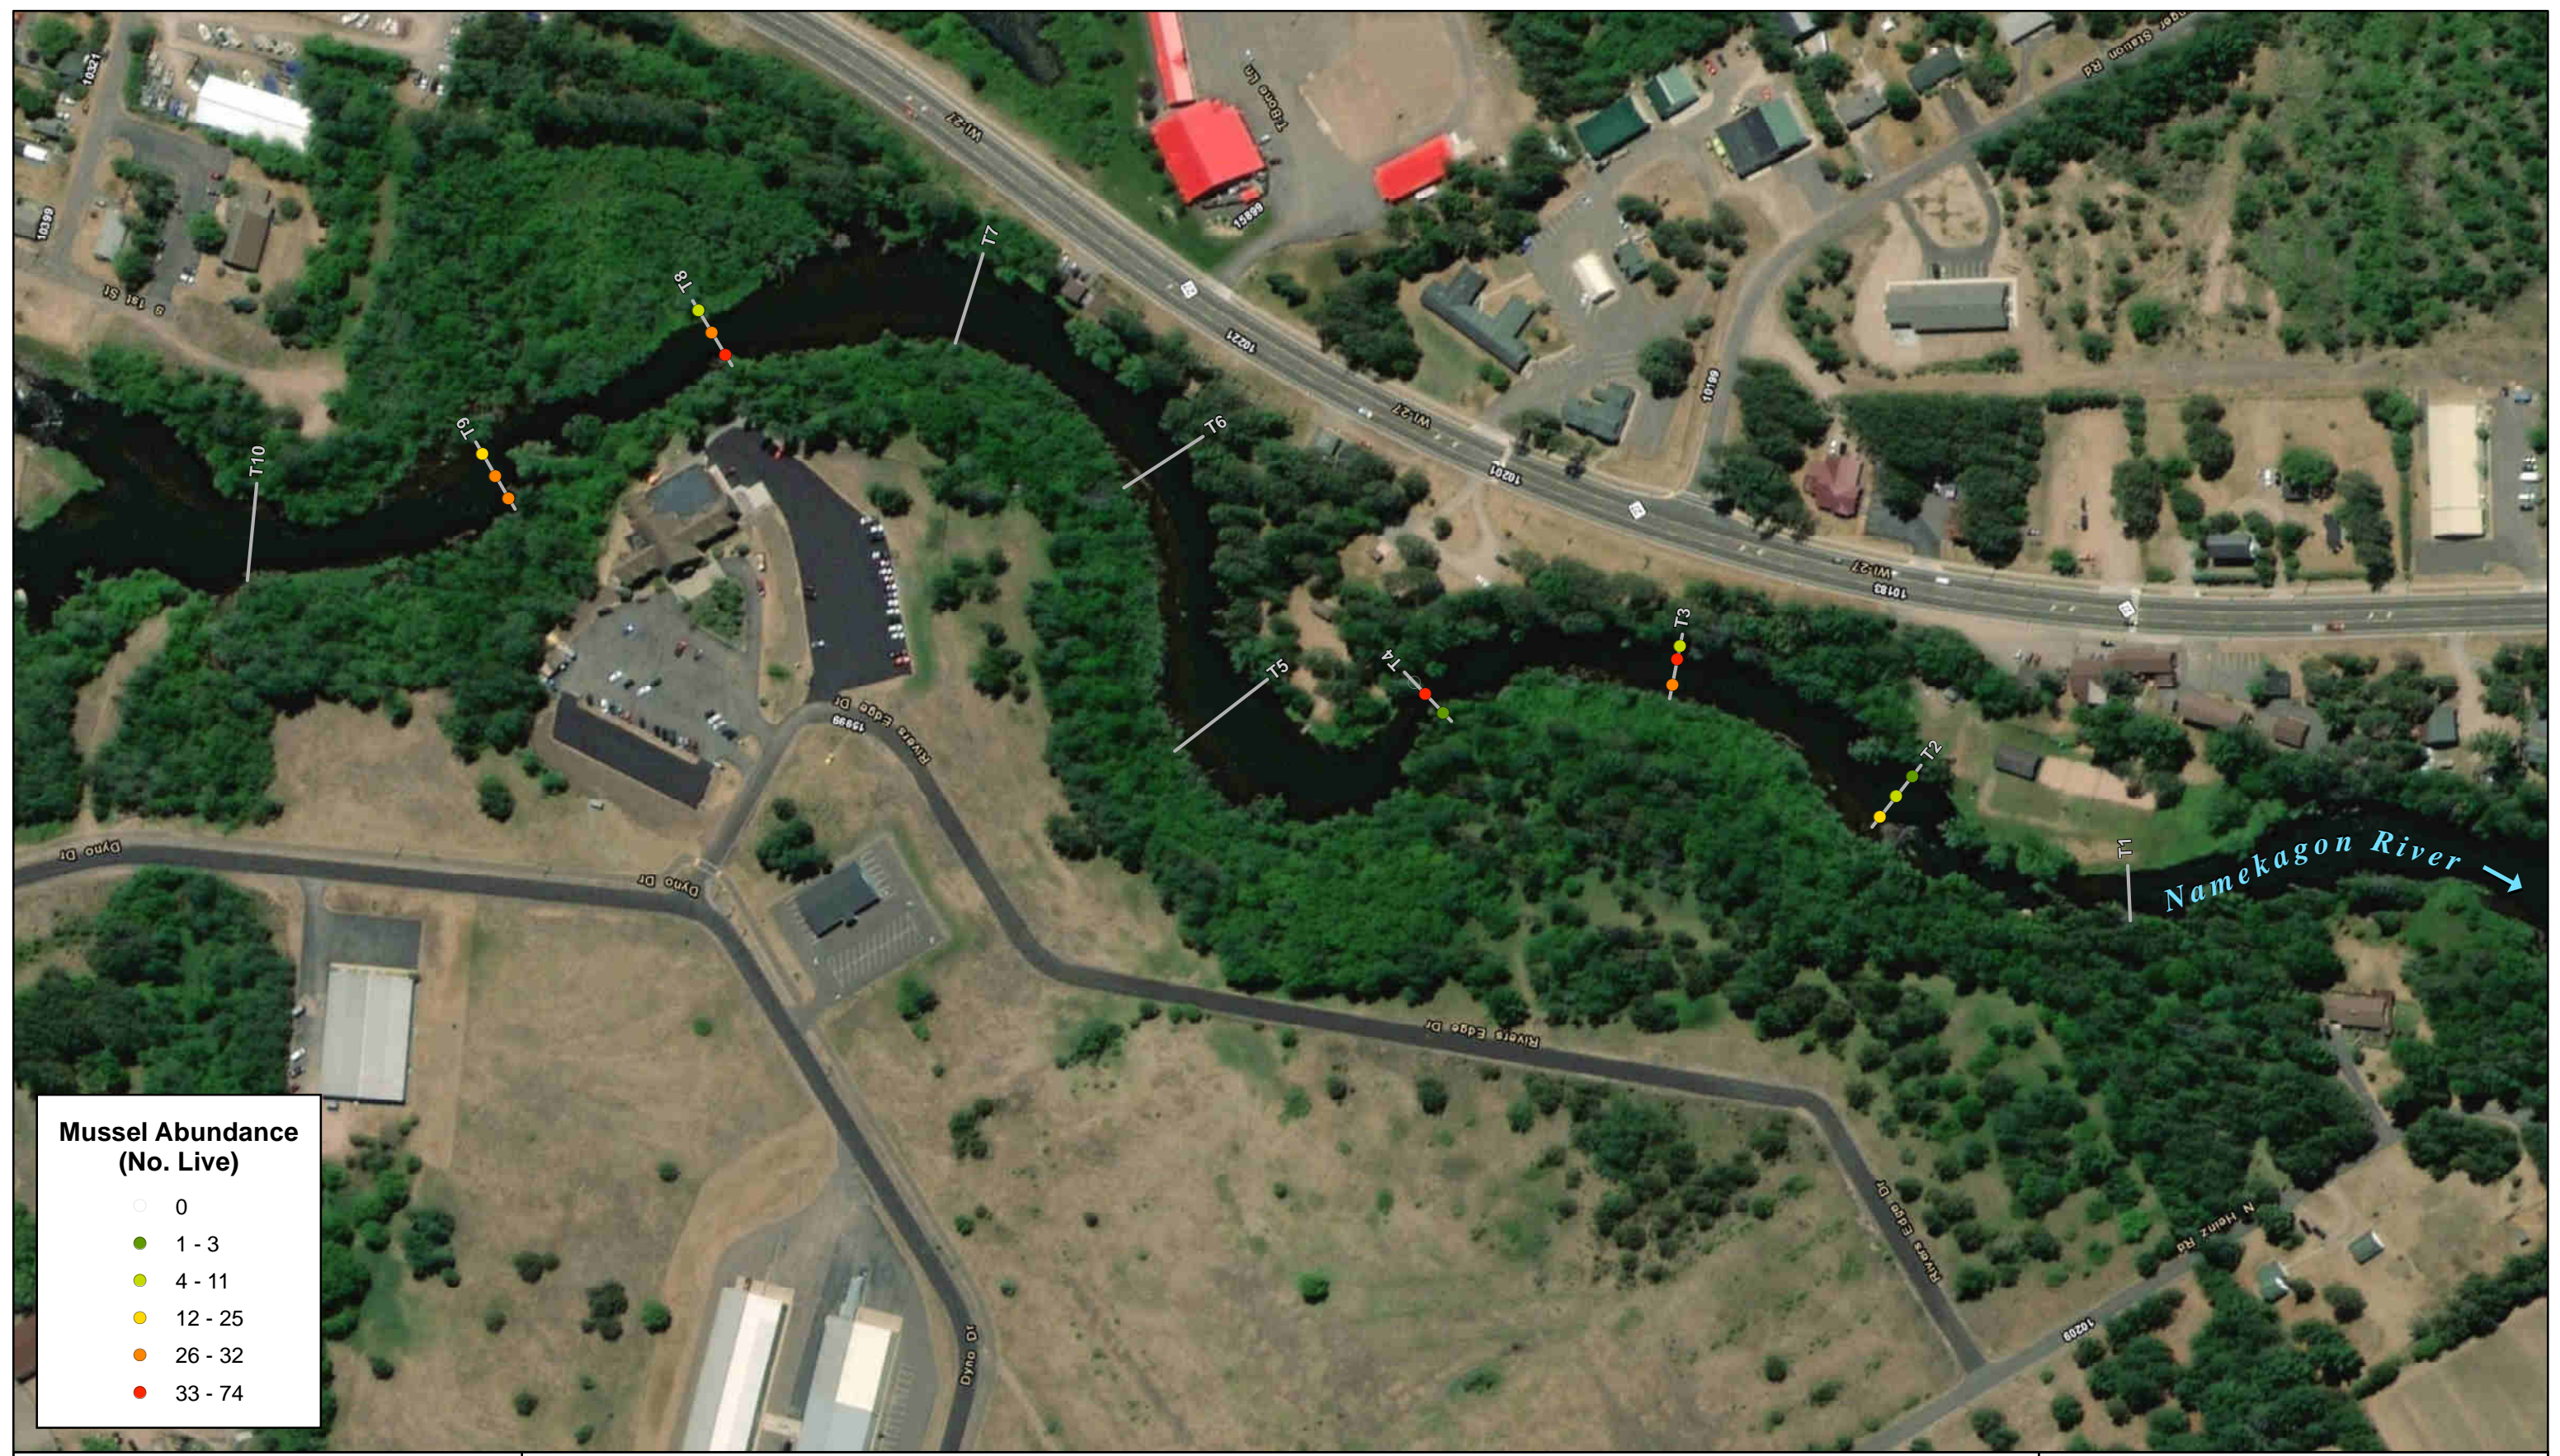
Mussel Abundance (No. Live)

- 0
- 1 - 3
- 4 - 11
- 12 - 25
- 26 - 32
- 33 - 74

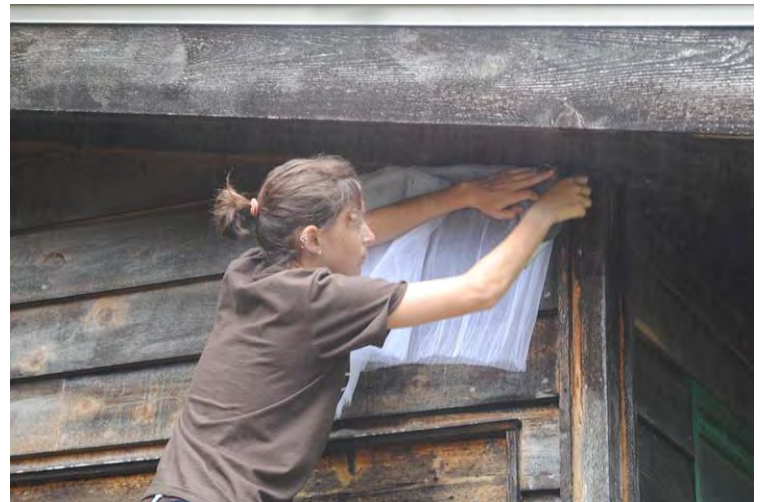
One-way exclusion devices can be created using plastic netting with one-sixth inch (0.4 centimeter) or smaller mesh. Shape the plastic netting so that it covers the opening entirely and extends at least two feet below it. Using staples or duct tape, attach the top and side edges of the

Applying screen for one-way door

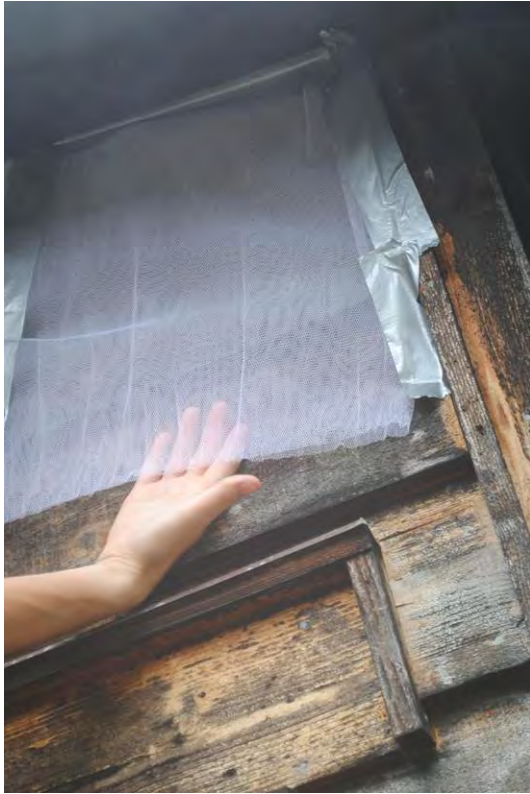
plastic netting to the building, leaving the bottom edge open. Be conscious of the netting's tautness; you should be able to slide your hand into the bottom opening though not so loose that the bats may easily crawl back up the opening. At sunset the following night, some of the bats will escape through the open, bottom portion. Leave the netting up for five to seven days; this will ensure that all bats have exited the building. After all bats have been excluded, you may then seal the openings permanently with appropriate construction materials.

Space on bottom for bats to escape

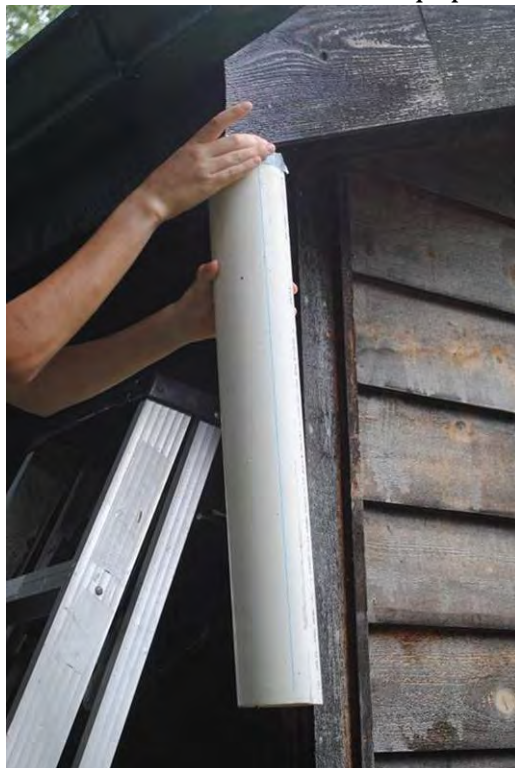
Other materials can be used to create one-way exits, such as plastic sheeting or PVC pipe. Install the plastic sheeting in the exact manner as the plastic netting. A portion of PVC pipe, which should be similar in size to a tube of caulk, can be inserted into the opening. Seal the

PVC one-way door
