**Subject: Recreation Report
 Hayward Hydro – FERC Project No. 2417**

Recreation Report for the Hayward Hydroelectric Project (FERC Project No. 2417)

February 2021
Version: DRAFT
EA Project No. 1605201

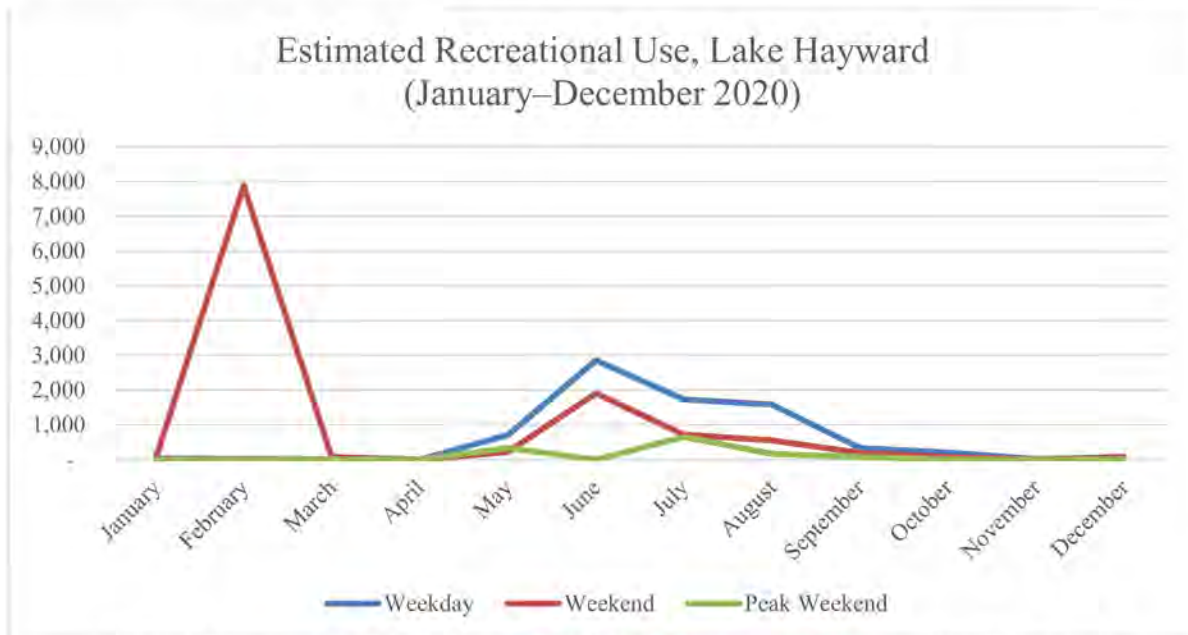
**Figure 5-1 Recreational use estimates in recreation days, Lake Hayward
(January–December 2020)**

Recreational use at Lake Hayward is most concentrated in the evening hours and on weekends. The average number of visitors per day in 2020 was estimated to be 29 on weekdays, 120 on weekends, and 135 on peak weekends (Table 5-2). Personnel associated with Lake Hayward recreational facilities indicated that Hayward Beach and Park and the Hayward Boat Landing remain popular facilities. All facilities at Lake Hayward provide opportunities for recreation that are well suited to social distancing. Personnel observed that fishing, pontoon boating, paddle boarding, canoeing, and kayaking have increased in recent years and/or in 2020. Swimming, water skiing, and jet skiing are likewise popular activities. Fishing occurs year-round; however, this activity is more popular in May and June than in the winter.

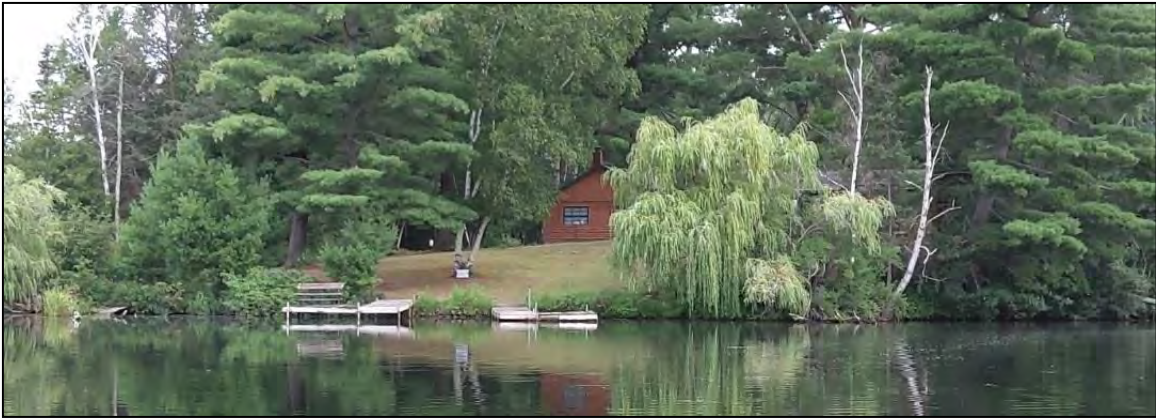
Photo 8: 47WB105 with mix of pine, oak, and birch to water's edge. View to north.

The shoreline was inspected on foot with access to the site provided by boat. Surface collection along the riverbank yielded no artifacts. The shoreline at the site is stable with trees and a managed lawn extending to the water along with two boat docks (Photo 8). The 1990 survey determined that the log structure was outside the Project impact zone. It is unknown if the structure in Photo 8 is the same one viewed during the 1990 survey 32 years ago. Whether it is or not, there is no concern that operation of the Project will affect a structure that far from the bank, just as there was no concern about it in 1990. No additional work is recommended at this site. Future shoreline monitoring should adhere to the schedule outlined in any future Historic Properties Management Plan (HPMP).

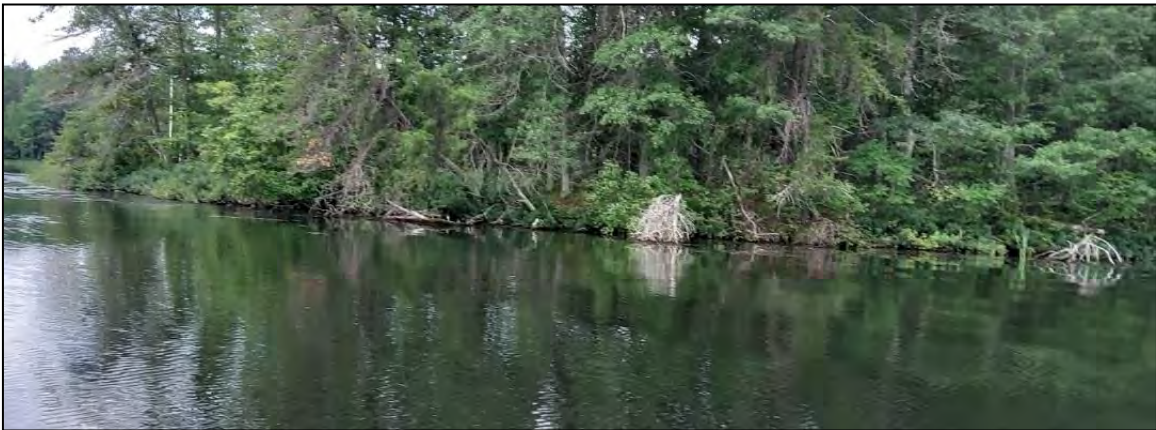
Photo 9: 47WB107 location with mix of pine, oak, and birch extending to water's edge. View to West.

Surface collection of the shoreline and bank yielded no artifacts. The shoreline at the site is stable with a mix of trees and maintained lawn extending to the water and emergent vegetation offshore (Photo 9). Future monitoring should follow the schedule outlined in any future HPMP.

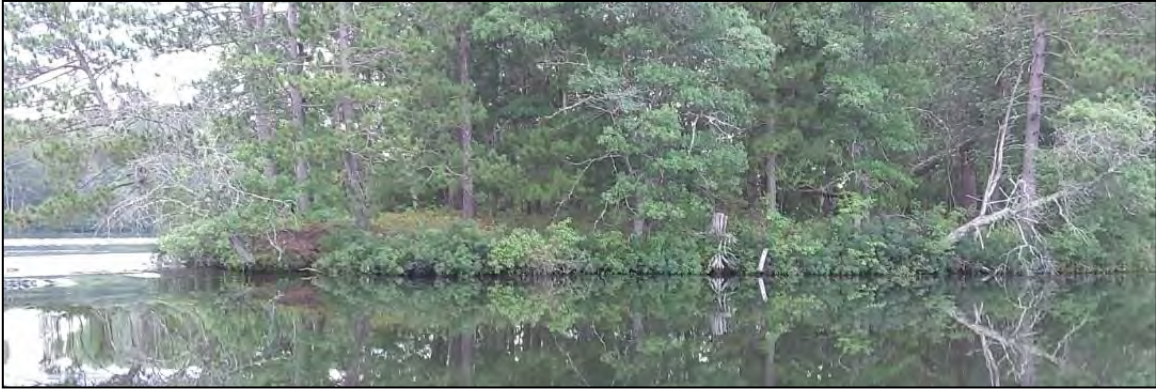
Photo 10: 47WB106 with mixed pine, oak, and birch to water's edge. View to southeast.

The shoreline at this WHPD-mapped site was surface collected on foot, with access to the site obtained by boat. No artifacts were recovered. The shoreline is stable with a mix of pine, oak, and birch trees, as well as grasses extending to the water (Photo 10). There is a small exposure at the point of land (left of photo) that did not yield artifacts. Although the 1990 survey found a “flint flake, hammerstone, and quartz shatter” (ASI #23882), the archaeologist thought that the site was “too peripheral, too disturbed to meet National Register criteria” (Harrison 1991a: 30) and that the site had been destroyed by construction. Since there were no artifacts in the small exposure, TRC does not recommend additional archaeological work at this site. Any further shoreline monitoring should follow the schedule outlined in any future HPMP.

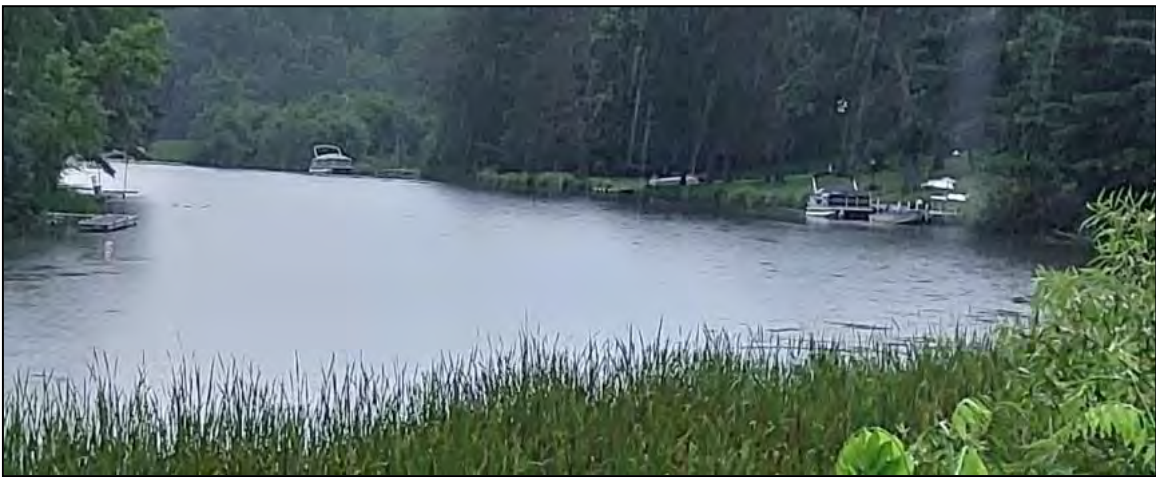
Photo 11: 47WB109 with managed lawns, mixed pine, oak, and birch to water's edge, emergent vegetation buffer. View to west.

Access to this site by boat was not possible due to shallow water and emergent vegetation. An inspection of the shoreline, conducted on foot, did not reveal any artifacts. The overview photo was taken from the US Highway 53 bridge since boat access was not possible. The shoreline at the site is stable with maintained lawns and a mix of pine, oak, and birch trees (Photo 11).

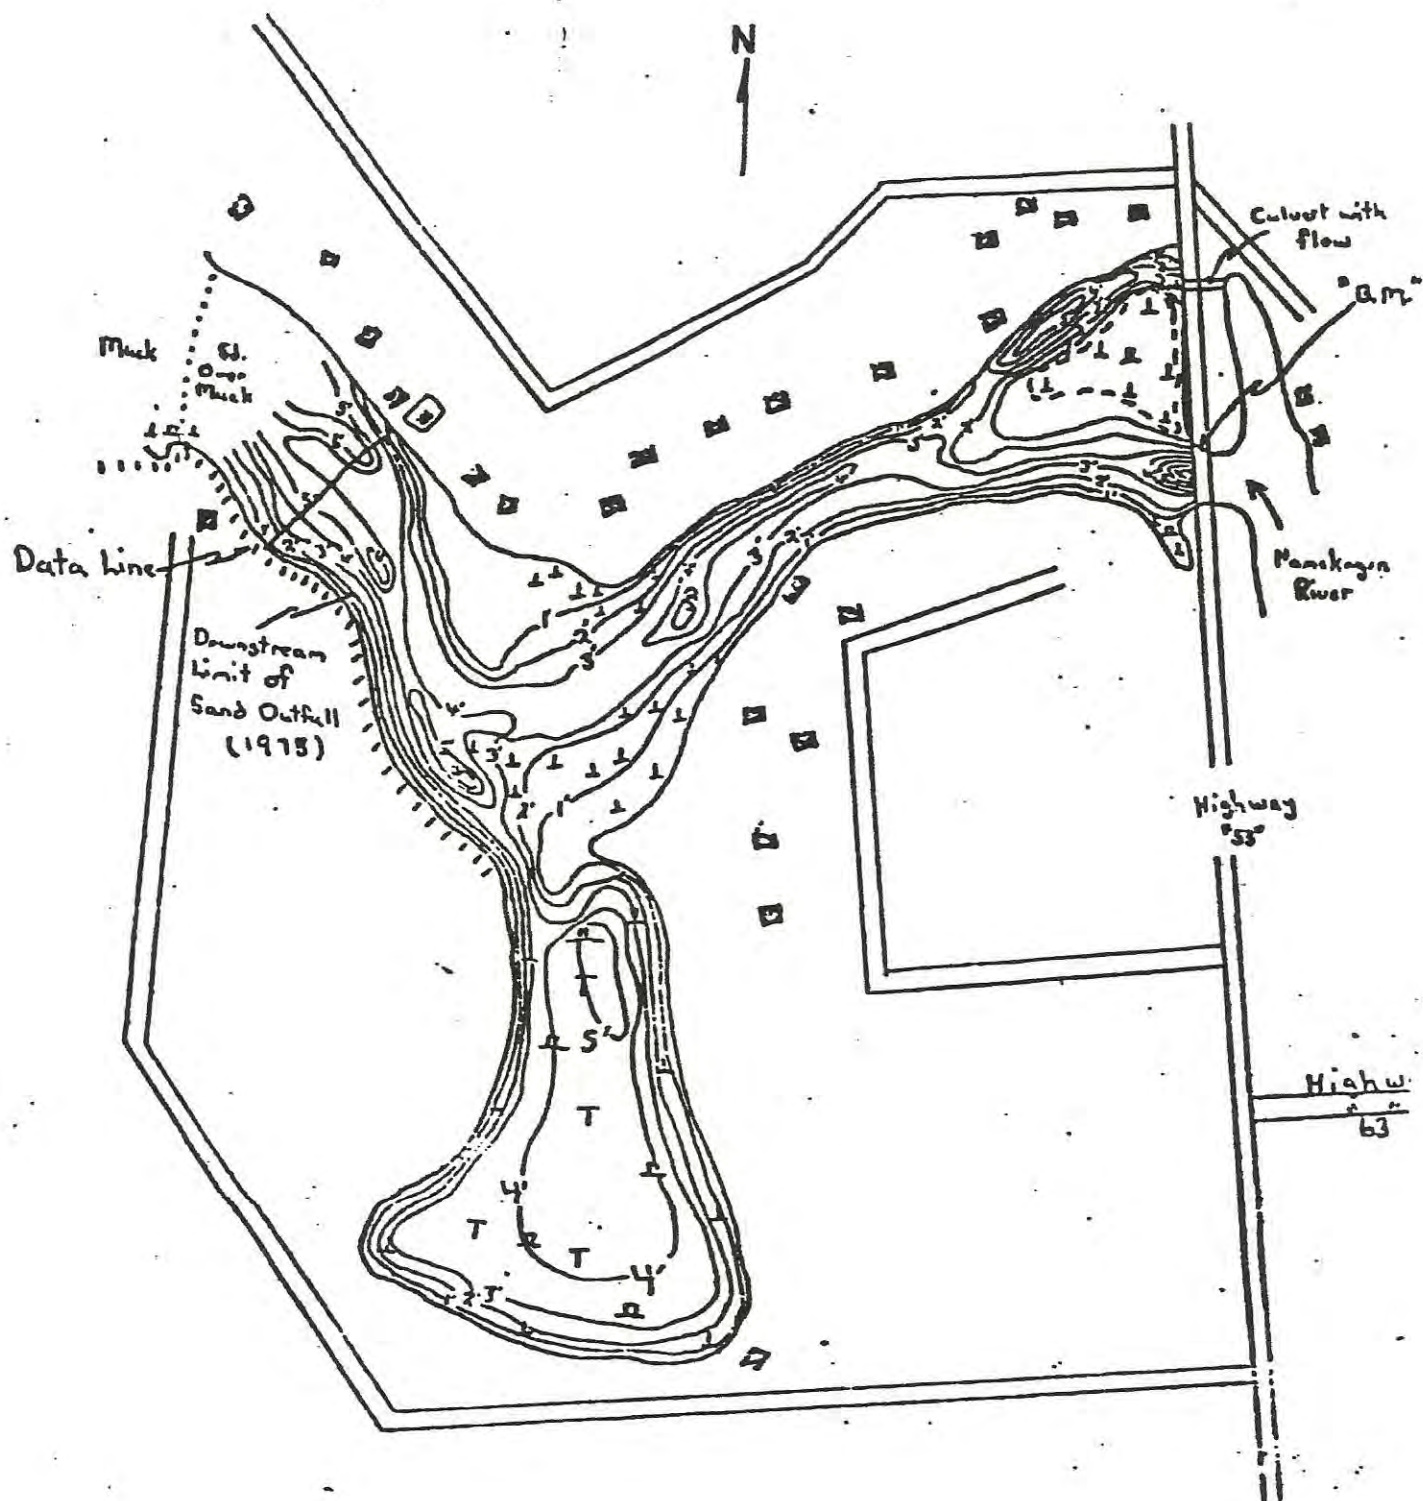
FIGURE 4. Trego Flowage Inlet Morphometry, 1979.

Transects of the inlet area were compared to post-drawdown conditions (Figures 6A thru 6D). It can be seen that in portions of cross-sections 5 and 6 up to 4 feet of sediment has accumulated

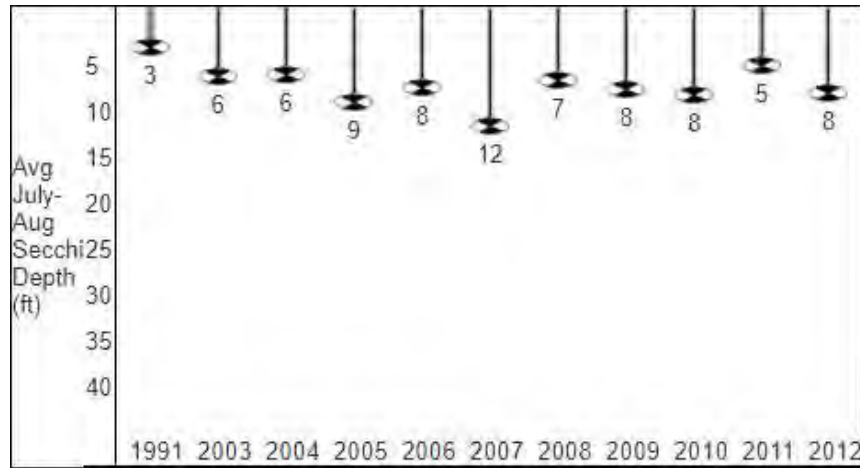
Figure 3: Average summer (July-August) Secchi disk readings at the Deep Hole Near Dam

Figure 3 shows the average total and summer (July-August) Secchi disk readings on Trego Lake between 2003 and 2012.

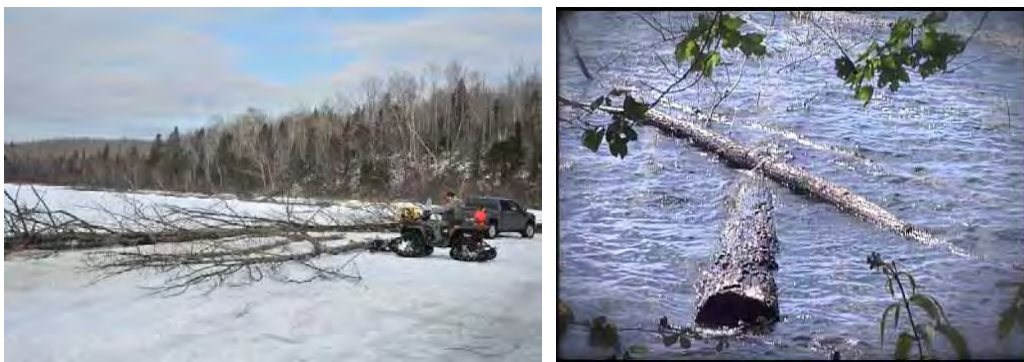
Figure 7: Coarse woody habitat-Fishsticks projects

Adding coarse woody habitat to a lake is relatively easy to do particularly when private landowners and lake associations are willing to partner with county, state, and federal agencies. Large-scale CWH projects, called “fishsticks”, are currently being completed by lake associations and local governments with assistance from the WDNR (Figure 7).

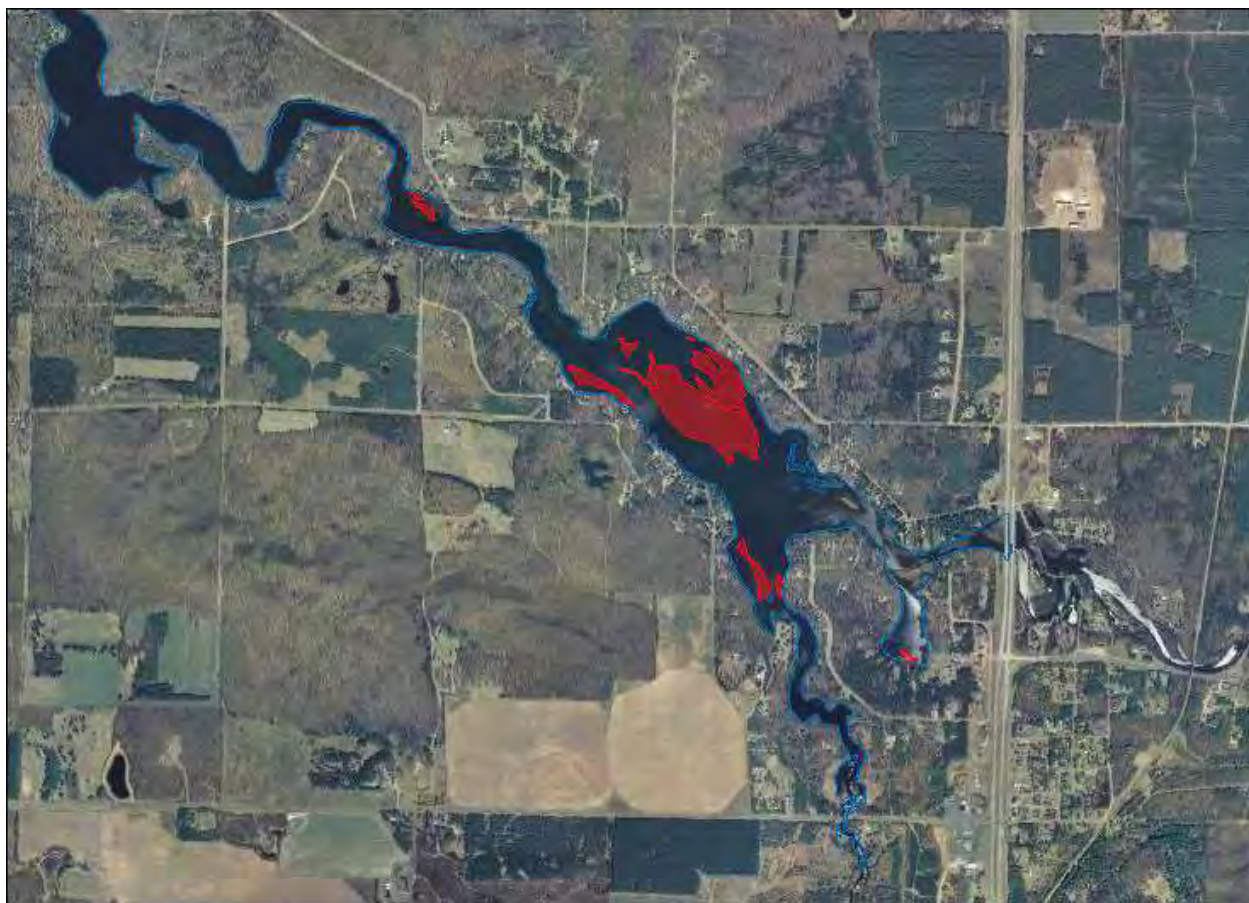
Figure 21: 2020 CLP bedmapping (ERS)

This level of CLP interferes with early season navigation, shades out more beneficial native plants later in the season, and contributes nutrients to the lake when it dies and decays in early July.

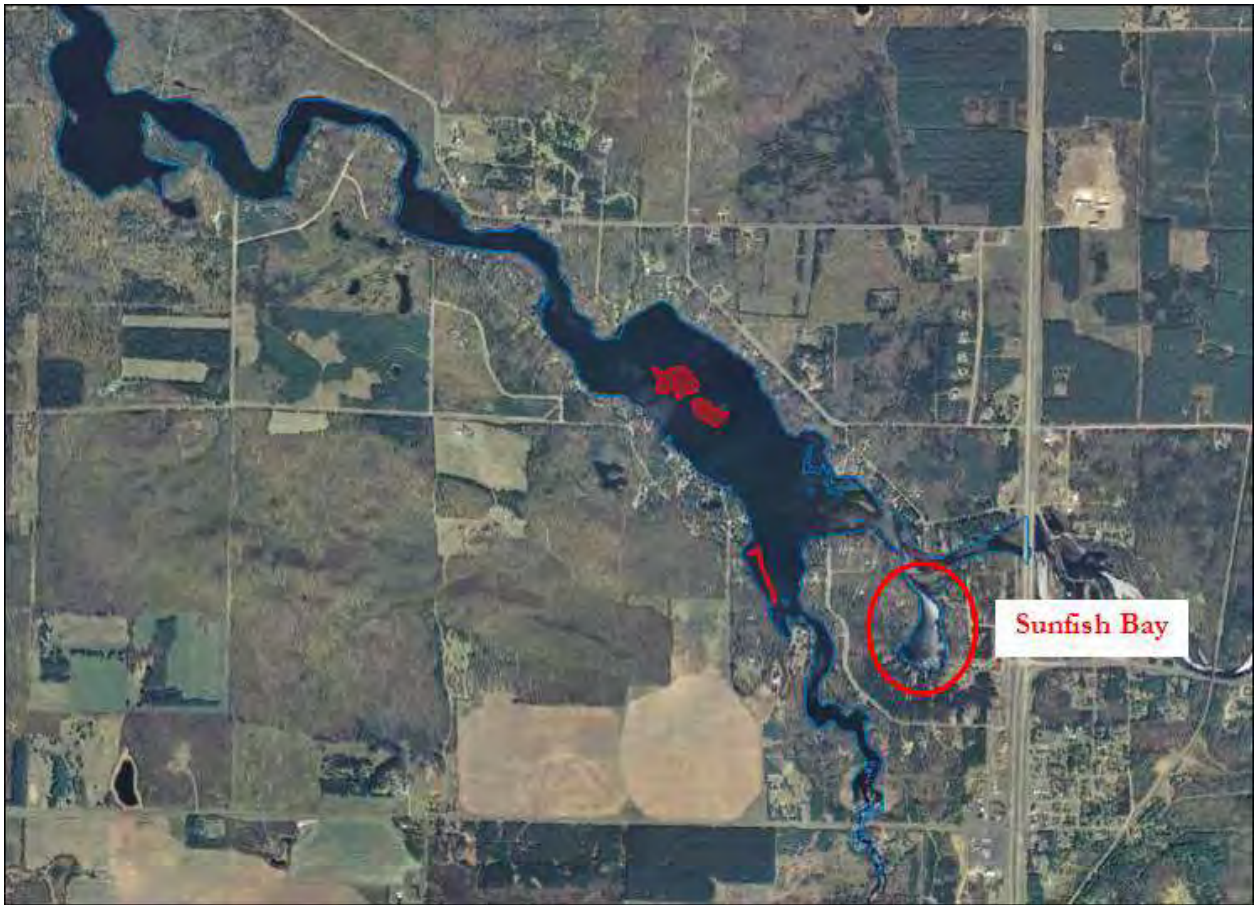
Figure 24: 2020 EWM beds in the east basin of Trego Lake

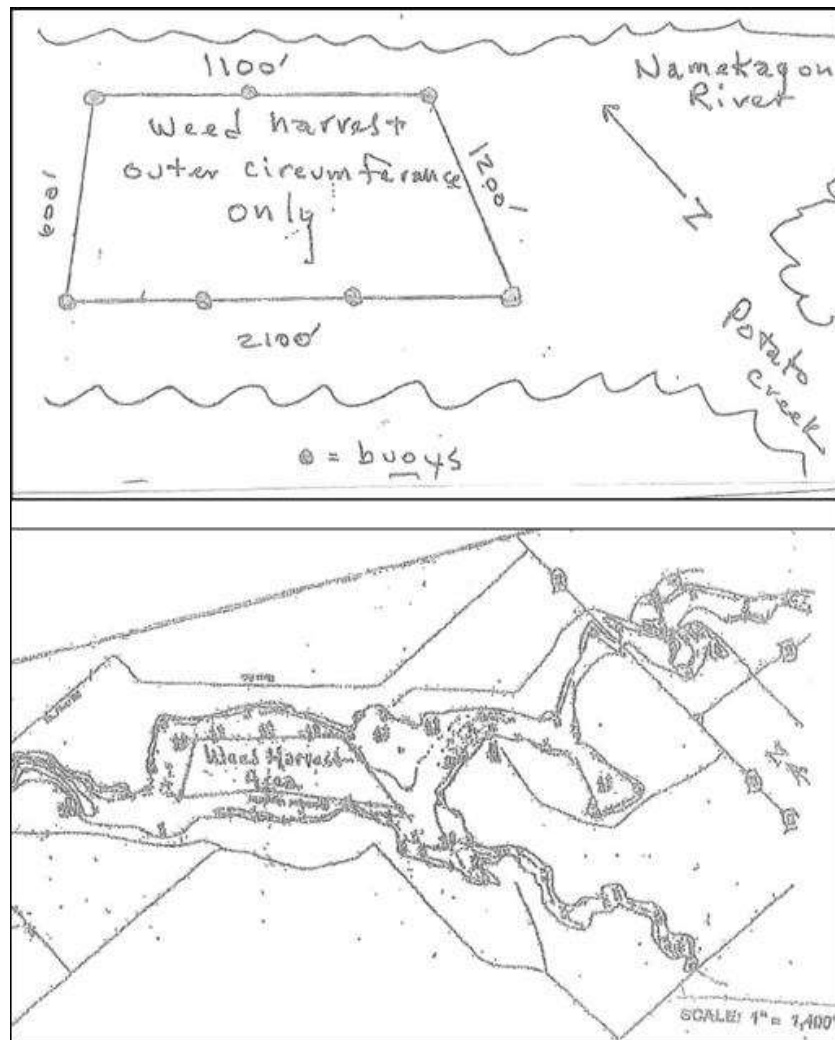
Figure 30: Navigation access lanes included with the last several WDNR mechanical harvesting permits (TLD)

The last full aquatic plant management plan, developed in 1994 recommended aquatic plant harvesting primarily in the area referred to as the east basin or upstream third of the lake. The purpose of harvesting, as listed in the WDNR mechanical harvesting permits, is to “maintain navigation channels for common use.” Access channels connecting shoreland residents to open water were predetermined and for the most part, have not changed in more than 20-years (Figure 30). These access lanes are generally 30-ft wide and all together cover approximately 1.7-acres. The TLD has an agreement with the Xcel Energy, the owner of the dam, whereby Xcel covers the cost of harvesting the predetermined navigation channels.

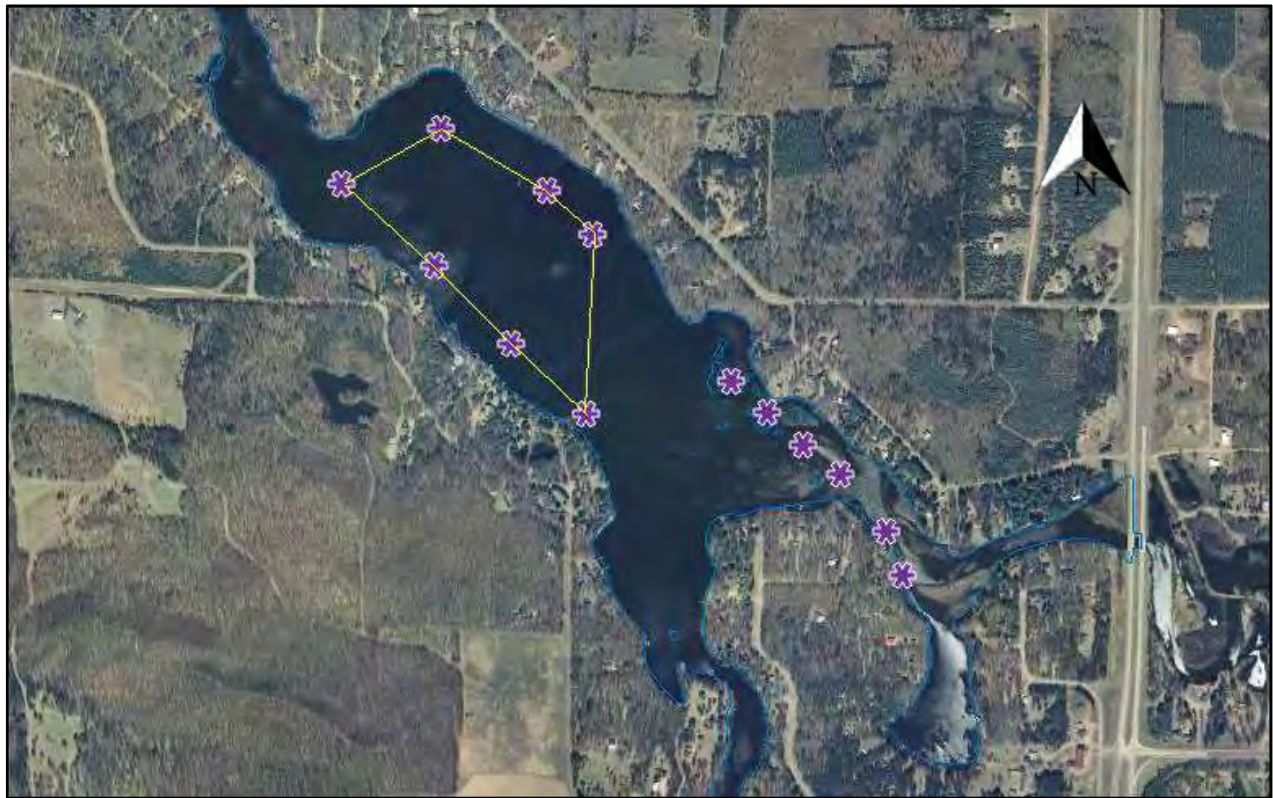
Figure 31: 2021 location of navigation buoys (purple stars), and proposed harvesting lanes (yellow lines)

Each year, the TLD provides a harvesting summary report to the WDNR. In 2019 and 2021, it was estimated that harvested vegetation totaled about 12 cubic yards of plant material each year. In 2021, due to the earlier harvest date, an estimated 66 cubic yards of plant material was removed, mostly CLP. Currently, harvested vegetation is taken to a dump site approximately a mile from the lake off County Hwy E near Trego.

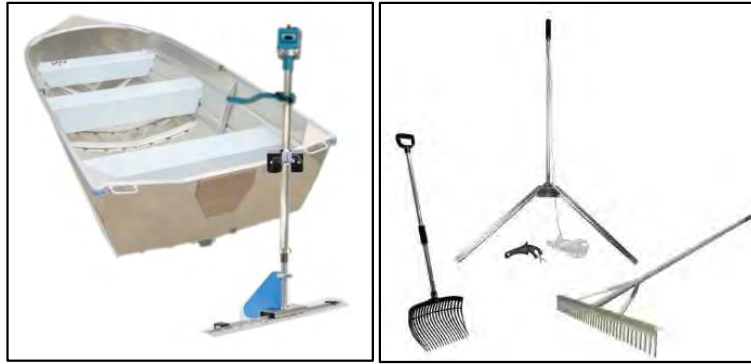
Figure 34: Aquatic Mower & Weedshear Weed Cutter (weedersdigest.com)

There are a wide range of small-scale mechanical harvesting techniques, most of which involve the use of boat mounted rakes, scythes, and electric cutters. As with all mechanical harvesting, removing the cut plants is required. Commercial rakes and cutters (Figure 34) range in prices from \$200 for rakes to around \$3000 for electric cutters with a wide range of sizes and capacities. Using a weed rake or cutter that is run by human power is allowed without a permit, but the use of any device that includes a motor, gas or electric, would require a permit. Dragging a bed spring or bar behind a boat, tractor or any other motorized vehicle to remove vegetation is also illegal without a permit. Incidental plant disruption by normal boat traffic is not considered mechanical management and is a legal method of management. Active use of an area is often one of the best ways for riparian owners to gain navigation relief near their docks. Most aquatic plants won't grow well in an area actively used for boating and swimming. It should be noted that purposefully navigating a boat to clear large areas is not only potentially illegal it can also re-suspend sediments, encourage aquatic invasive species growth, and cause ecological disruptions.

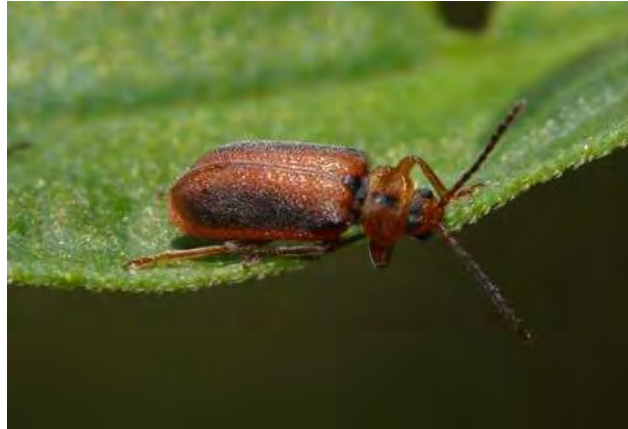
Figure 35: Galerucella Beetle

Galerucella beetles are currently approved for the control of purple loosestrife in Wisconsin (Figure 35). The entire lifecycle of Galerucella beetles is dependent on purple loosestrife. In the spring, adults emerge from the leaf litter below old loosestrife plants. The adults then begin to feed on the plant for several days until they begin to reproduce. Females lay their eggs on loosestrife leaves and stems. When the larvae emerge from these eggs they begin feeding on the leaves and developing shoots. When water levels are high these larvae will burrow into the loosestrife stems to

pupate into adult beetles. These new adults emerge and begin feeding on the loosestrife again (Sebolt, 1998). *Galerucella* beetles do not forage on any plants other than purple loosestrife. Because of this the populations, once established, are self-regulating. When the purple loosestrife population drops off, the beetle population also declines. When the loosestrife returns, the beetle numbers will usually increase. These beetles do not eradicate purple loosestrife entirely, but do help to reduce its dominance which will allow other native plants to recover.

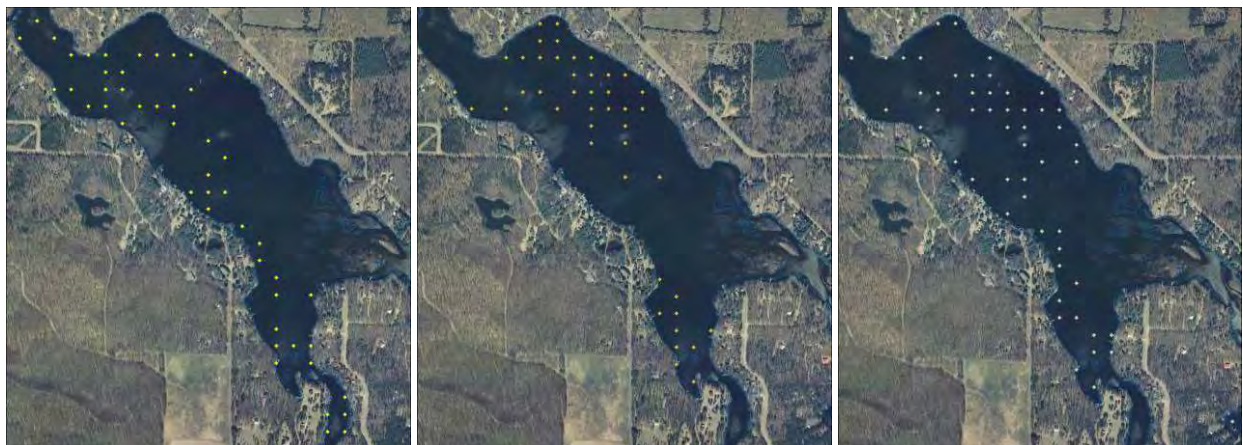
Figure 37: 2020 water celery distribution (left), coontail distribution (center), and flat-stem pondweed distribution (right)

Several other native plant species are dominant in the east basin and Potato Creek area of Trego Lake once CLP completes its life cycle. Larger, rooted plants including water celery and flat-stem pondweed, and coontail - a large suspended plant, form moderate to dense beds of vegetation in the mid to late summer throughout Trego Lake, but particularly in the east basin and Potato Creek inlet (Figure 37). The density of plants in these areas may appear worse than it is due to very abundant small floating plants including the duckweeds and watermeal that tend to get caught in the surface mats of the larger plant species (Figure 38). During mid to late summer harvesting it is these few plants that are removed most frequently and in abundance.

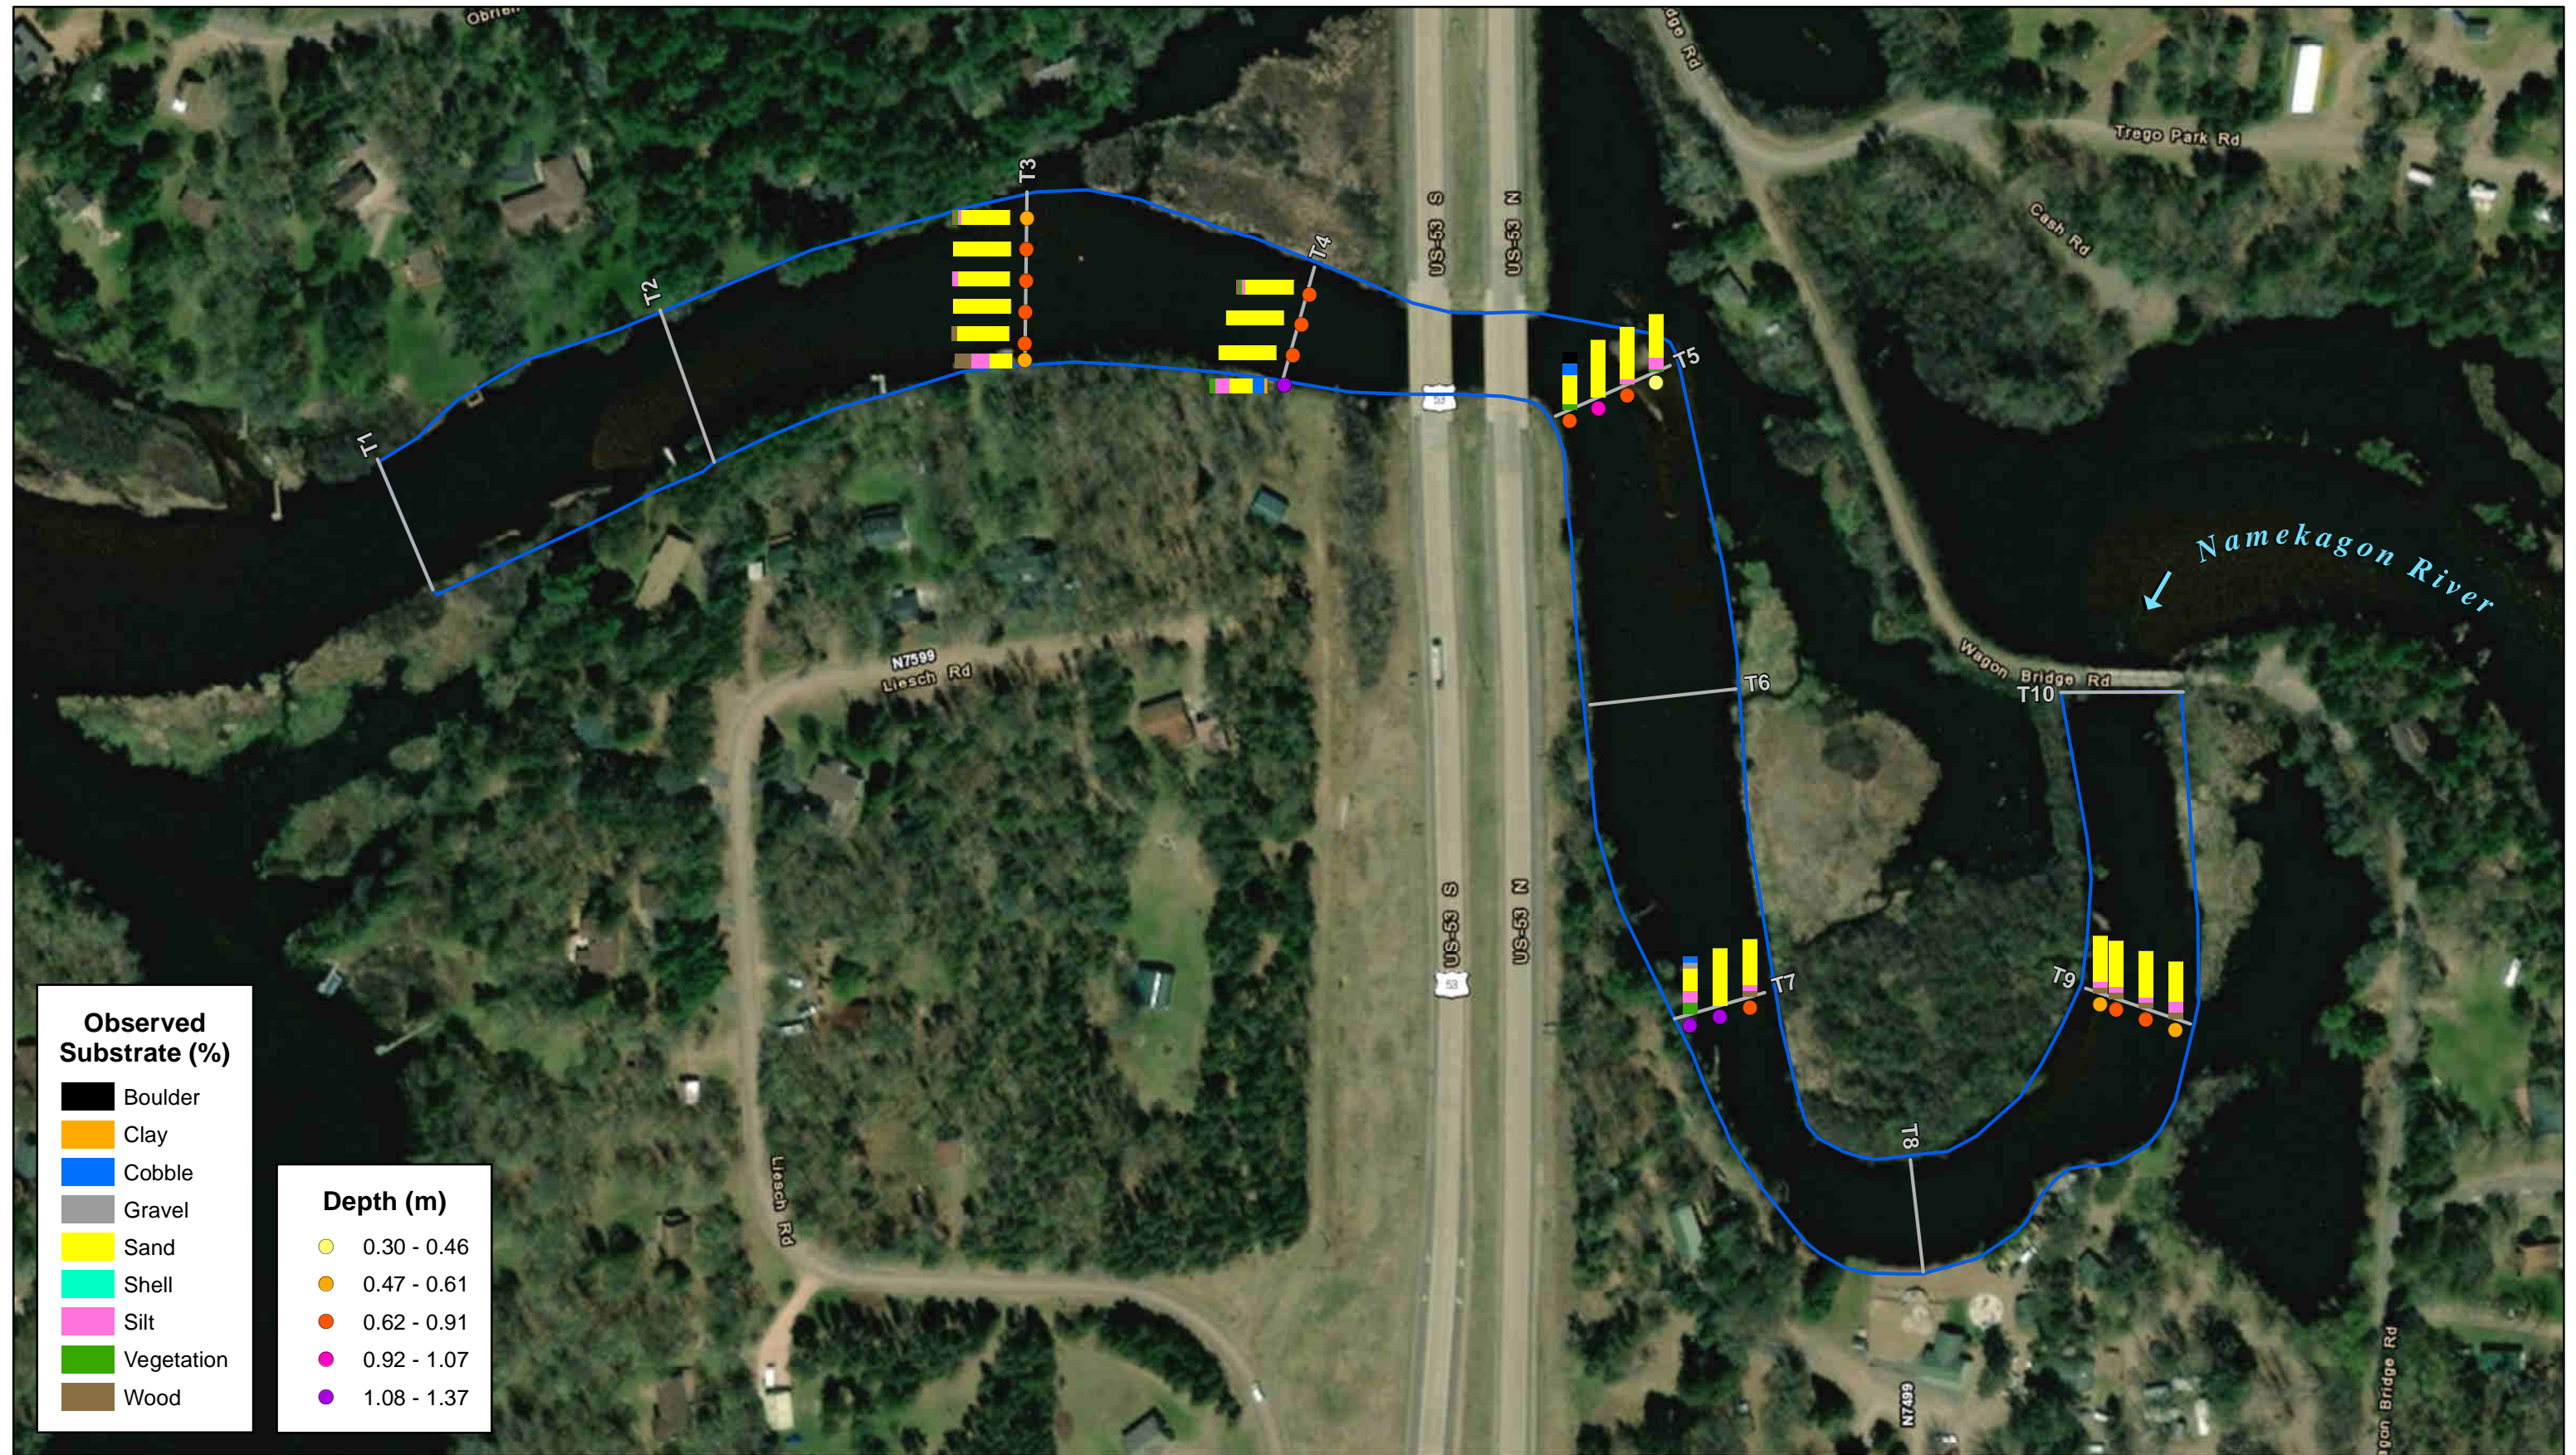
Figure 2. Substrate and Depth for the Trego Project Reach One on the Namekagon River. Washburn County, Wisconsin.

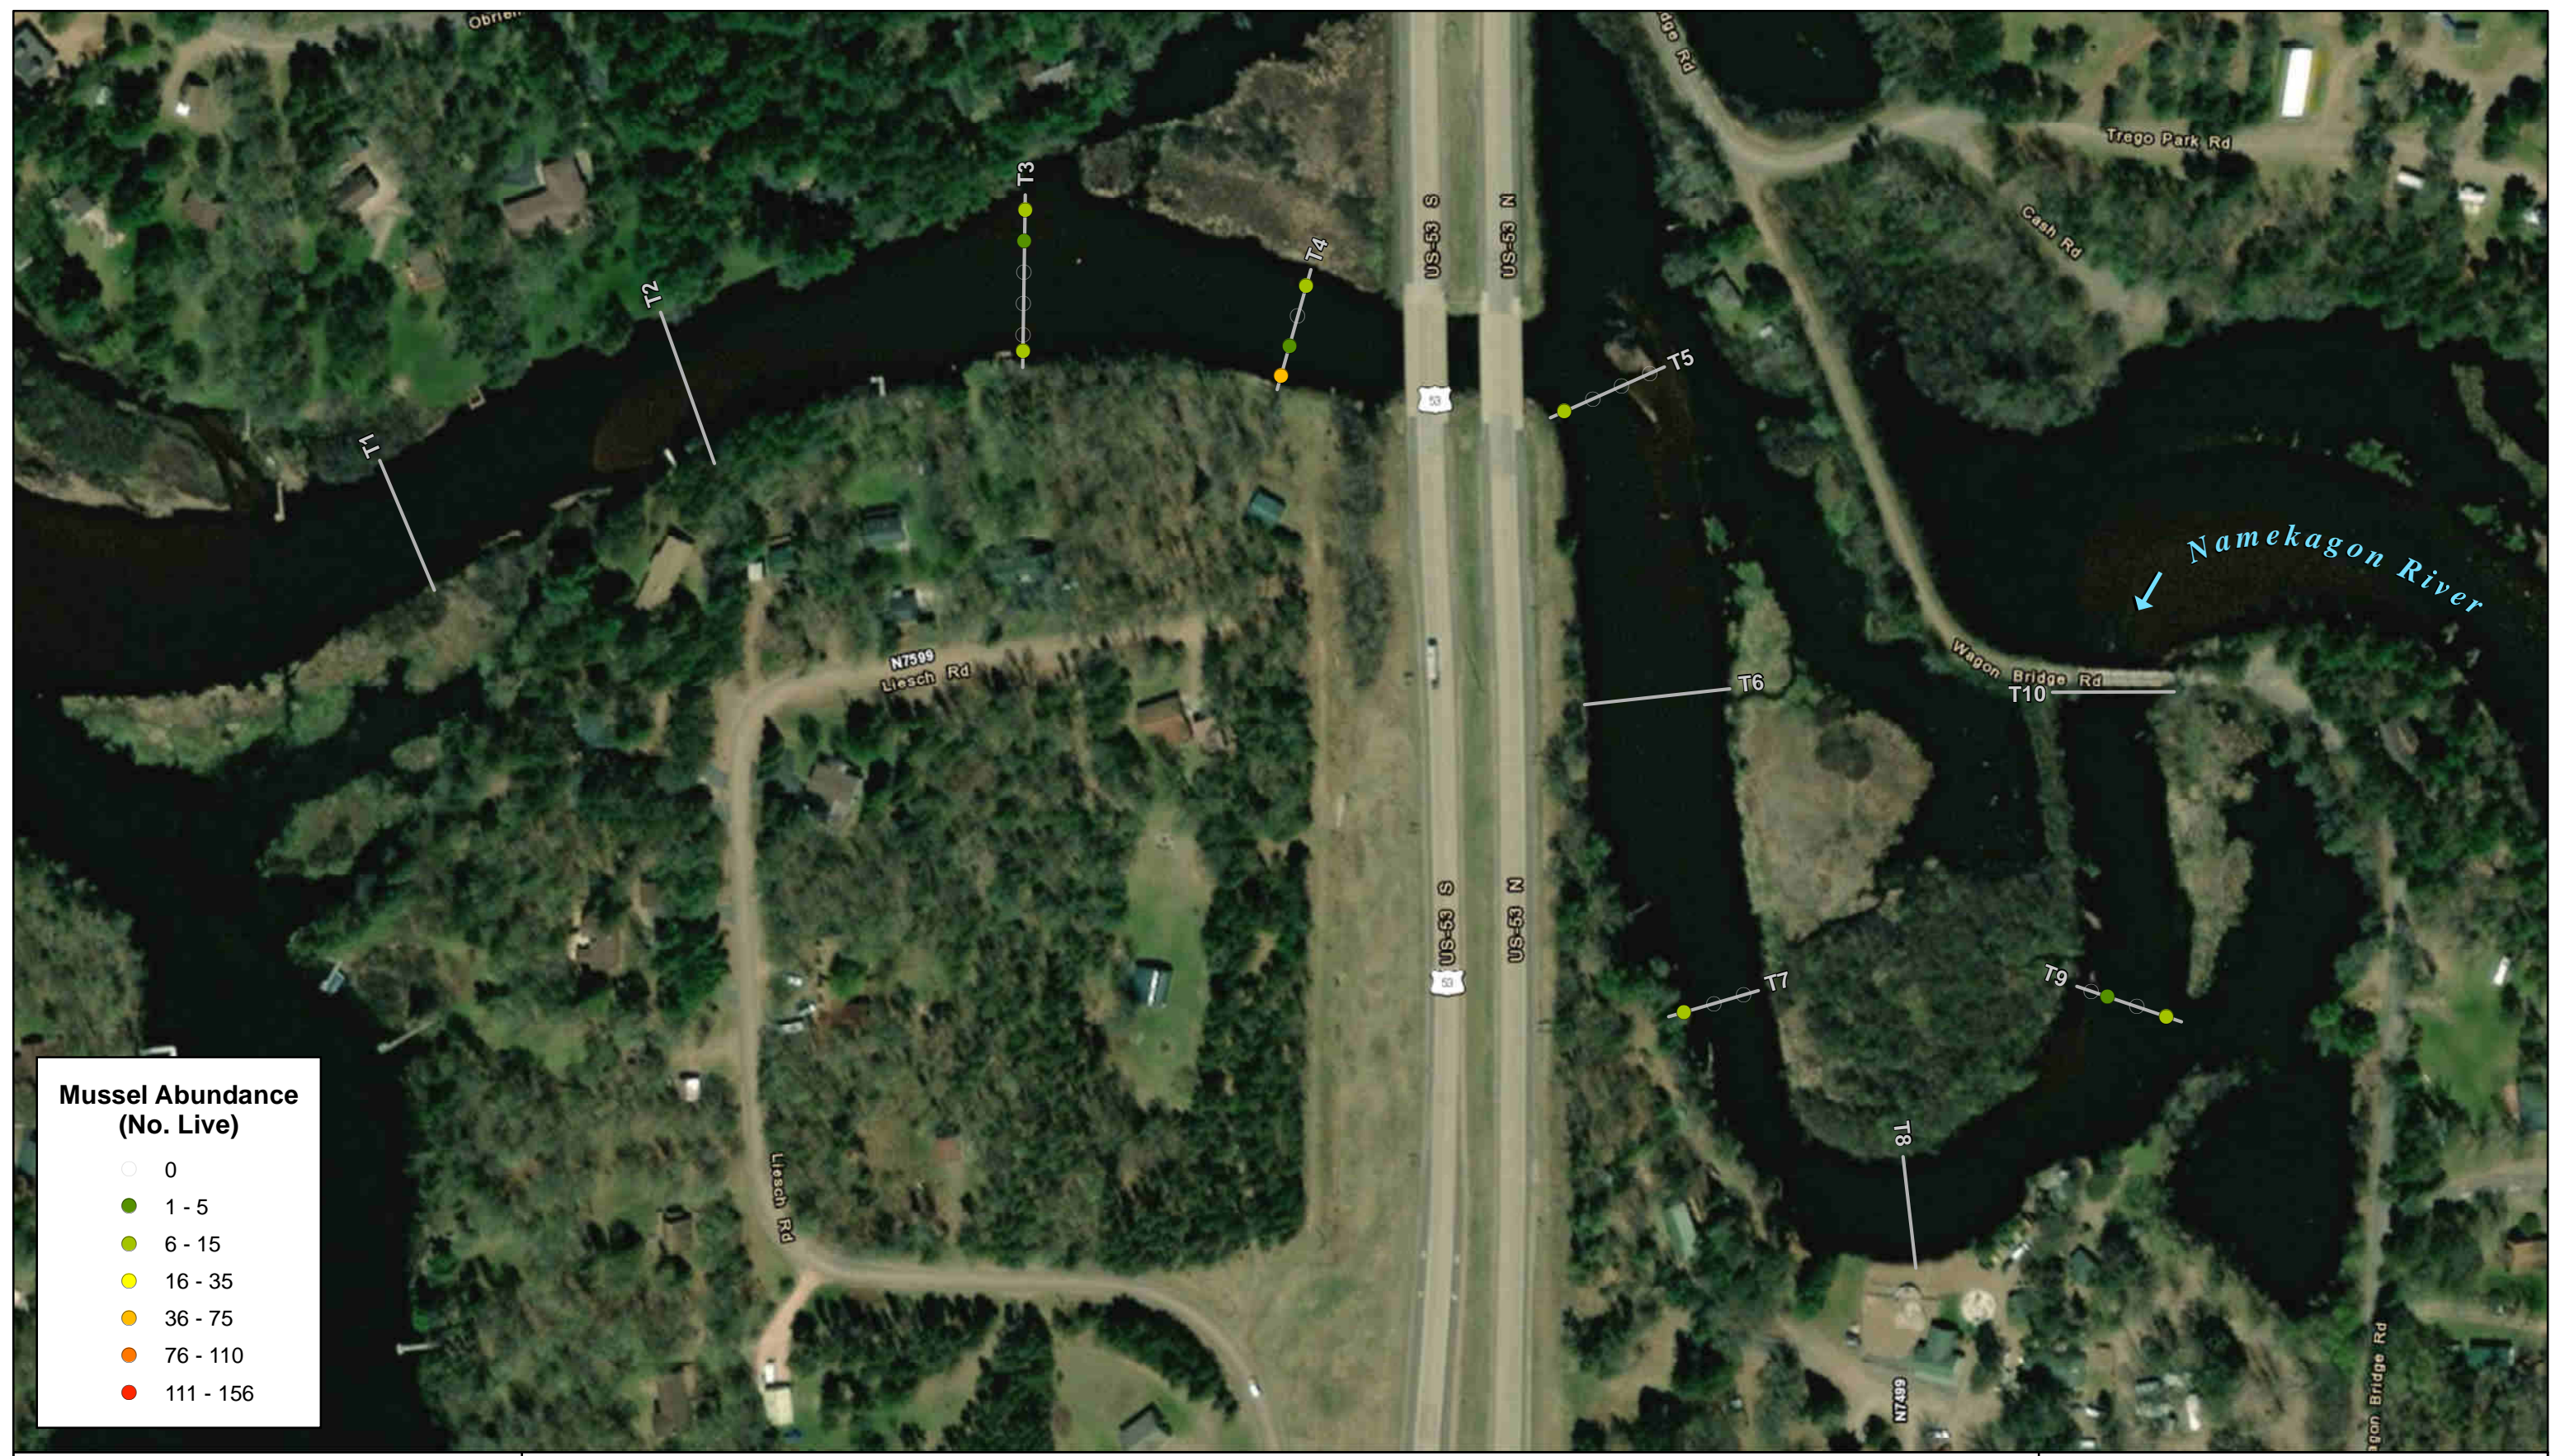
Figure 3. Mussel Abundance for the
Trego Project Reach One
on the Namekagon River.
Washburn County, Wisconsin.

Mussel abundance was highest in Transect 4 (70 individuals) and considerably lower in the remaining four transects (7 – 23 individuals per transect). Surface density ranged from 0.23 mussels/m² in Transects 5 and 7 to 1.75 mussels/m² in Transect 4 and averaged 0.60 mussels/m² over the entire reach. Mussel distribution generally corresponded with habitat type. Numerous Fatmucket individuals were collected in the vertical silty banks formed by the edges of cattail stands, and most other mussel species were collected near the banks in patches of more heterogeneous substrate. Mussels were scarce in the pure sand substrate mid-channel (Figure 3).
