**Subject: Recreation Report
 Hayward Hydro – FERC Project No. 2417**

Recreation Report for the Hayward Hydroelectric Project (FERC Project No. 2417)

February 2021
Version: DRAFT
EA Project No. 1605201

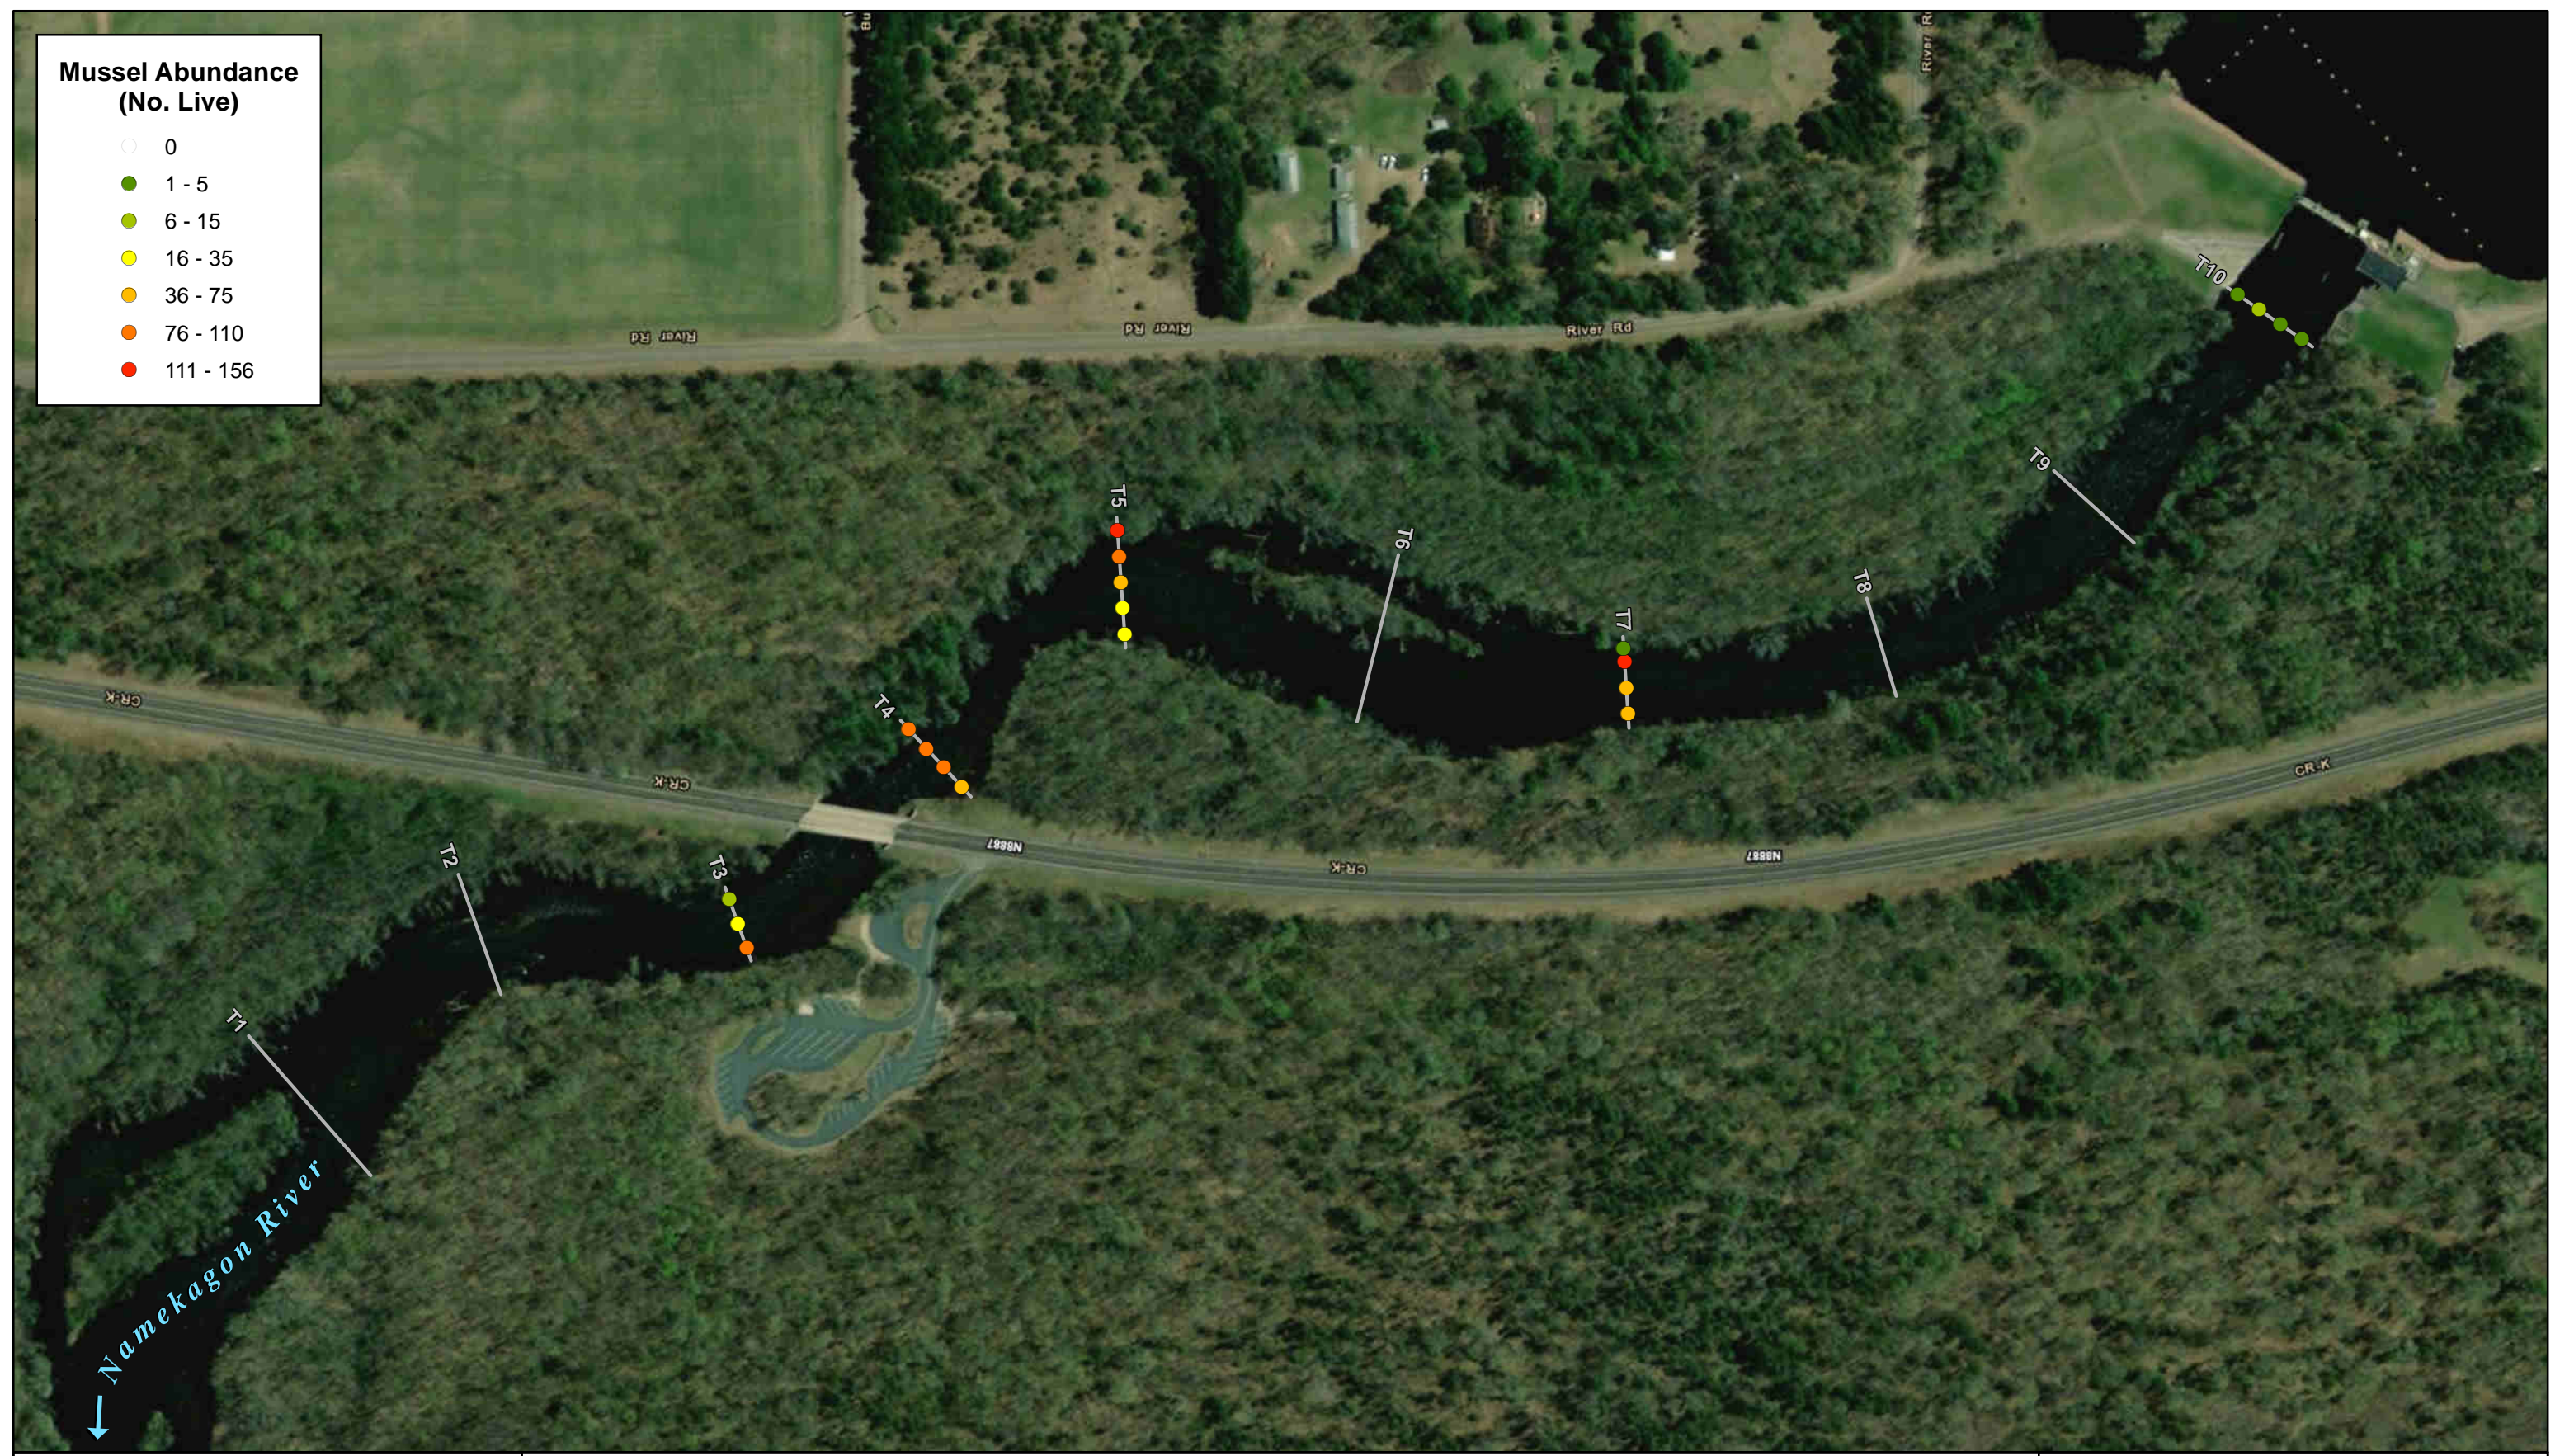
Figure 6. Mussel Abundance for the Trego Project Reach Two on the Namekagon River. Washburn County, Wisconsin.

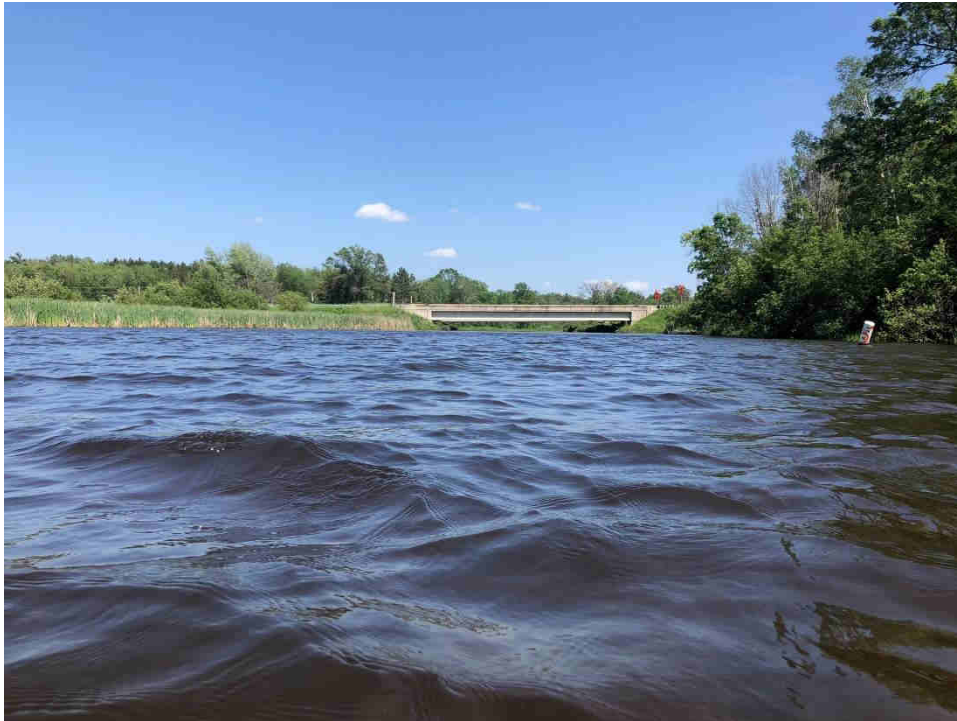
Photo 1. Reach 1, view looking upstream from Transect 3.

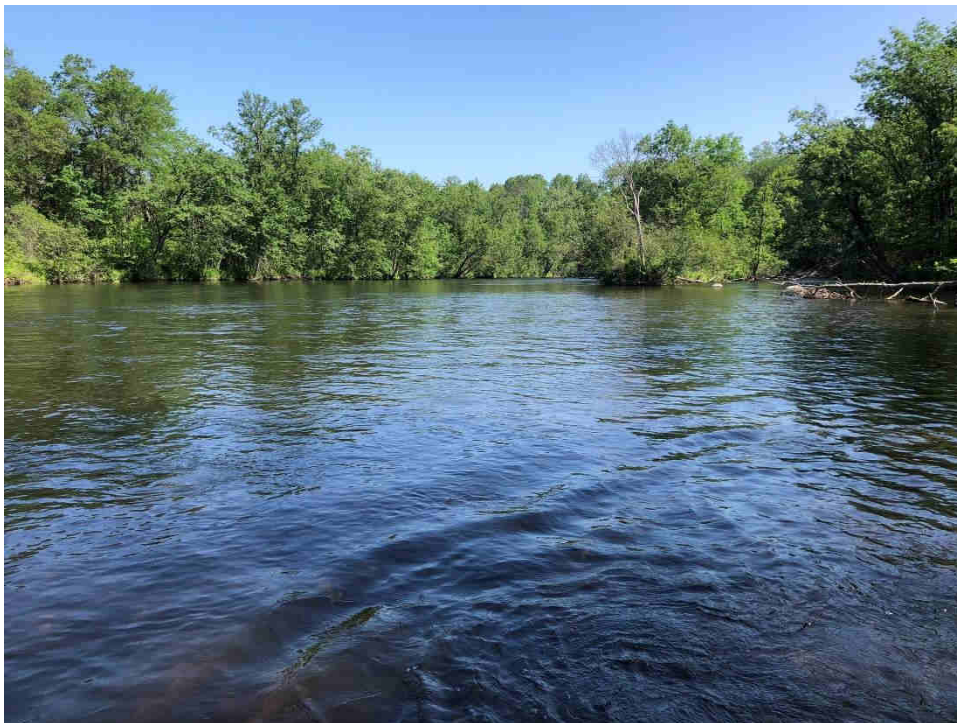
Photo 8. Reach 2, view looking downstream from Transect 7.

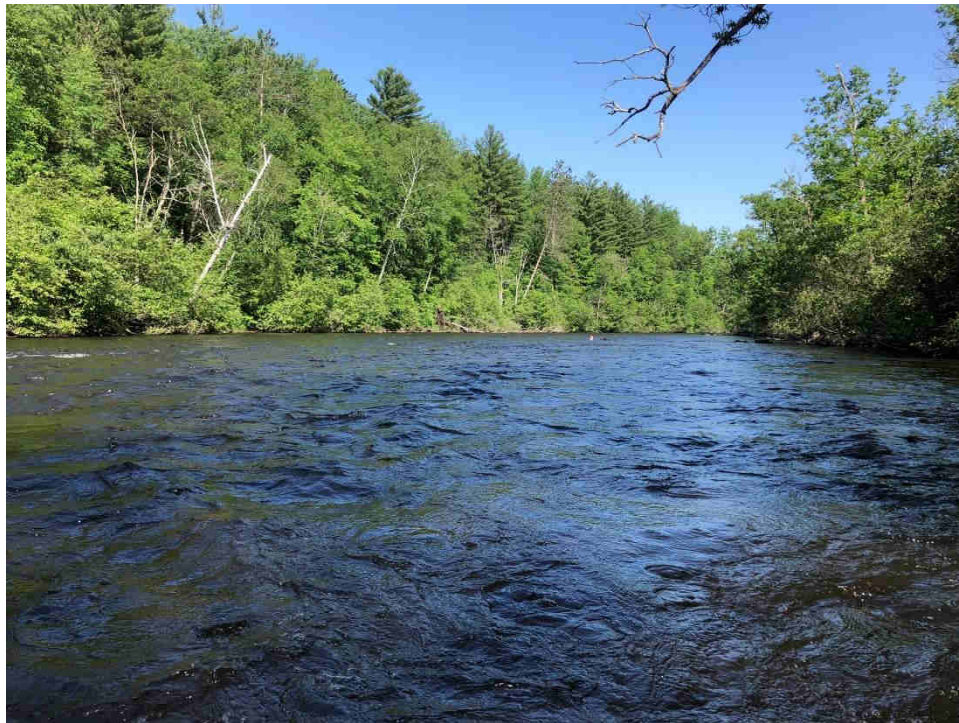
Photo 9. Reach 2, view looking downstream from Transect 10.

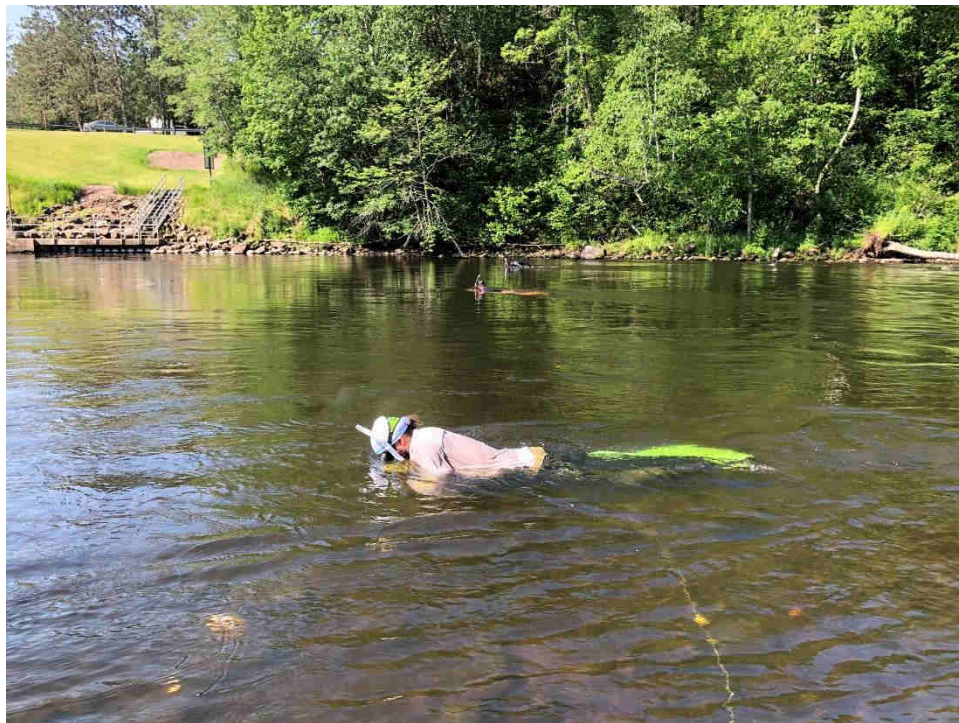
Photo 10. Reach 2, view of divers searching for mussels on Transect 10.

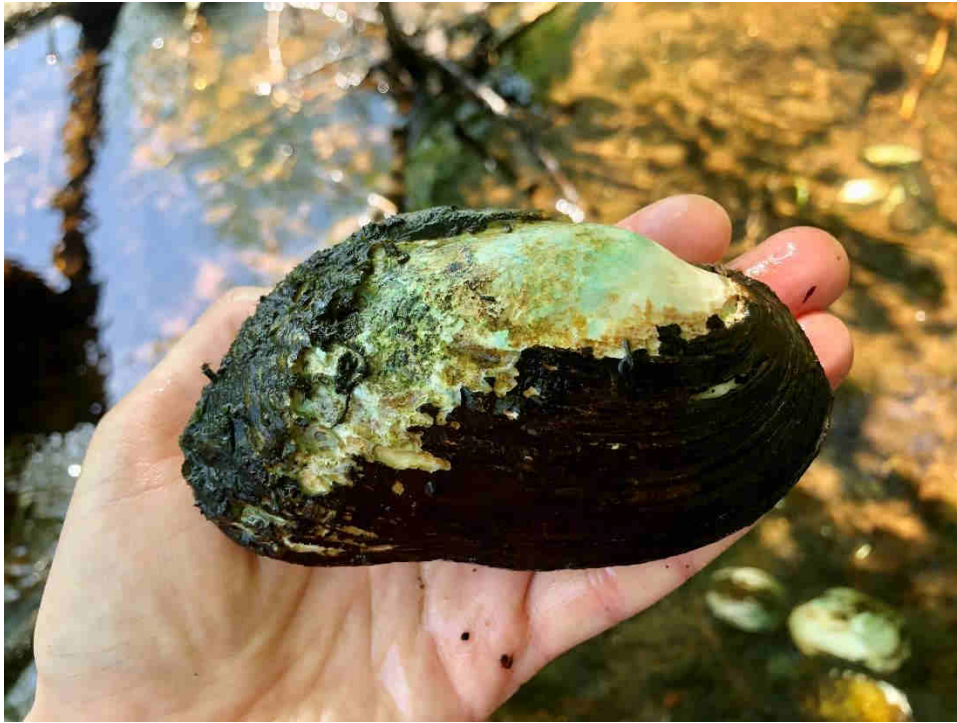
Photo 27. Representative photo of shell erosion observed on some live mussels in the project area.

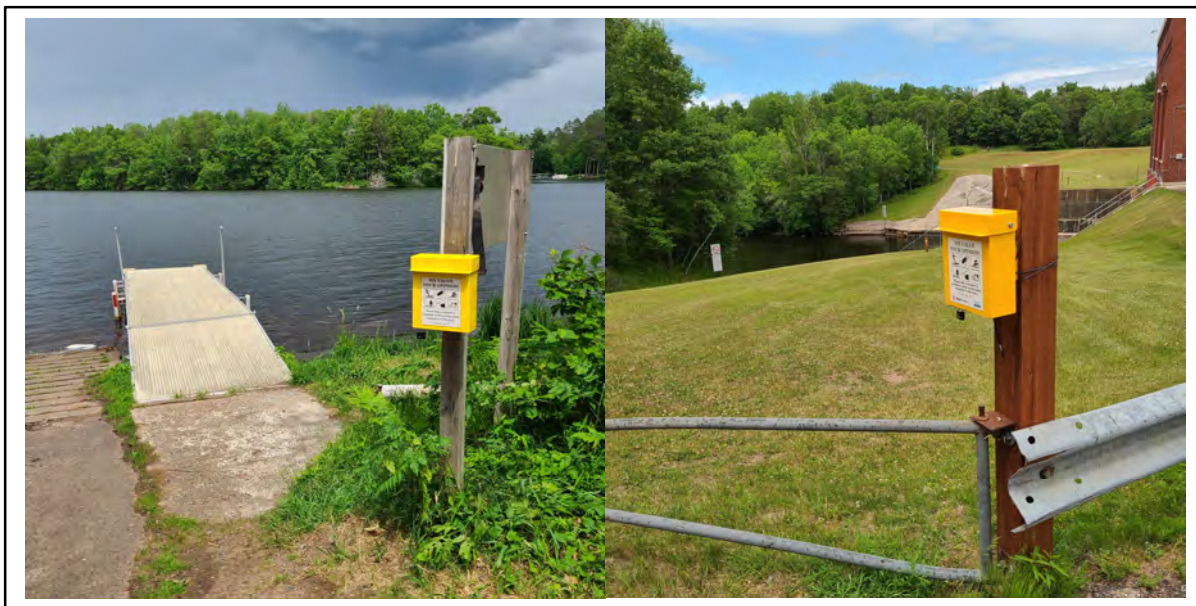
Figure 2-2 Examples of survey boxes installed at select recreational facilities

A self-reporting survey form was developed to capture detailed information on visitor use and satisfaction with the recreational facilities located on the Trego Flowage (Figure 2-1). Weatherproof survey boxes that housed the blank forms and completed survey forms were placed at various facilities around Trego Flowage (Figure 2-2). Completed forms were removed by the Trego operator on a regular basis. The goals of the self-reporting surveys were to:
