**Hayward Project  
FERC Project No. 2417**

**Trego Project  
FERC Project No. 2711**

**Exhibit E  
Environmental Report**

**Draft License Application**

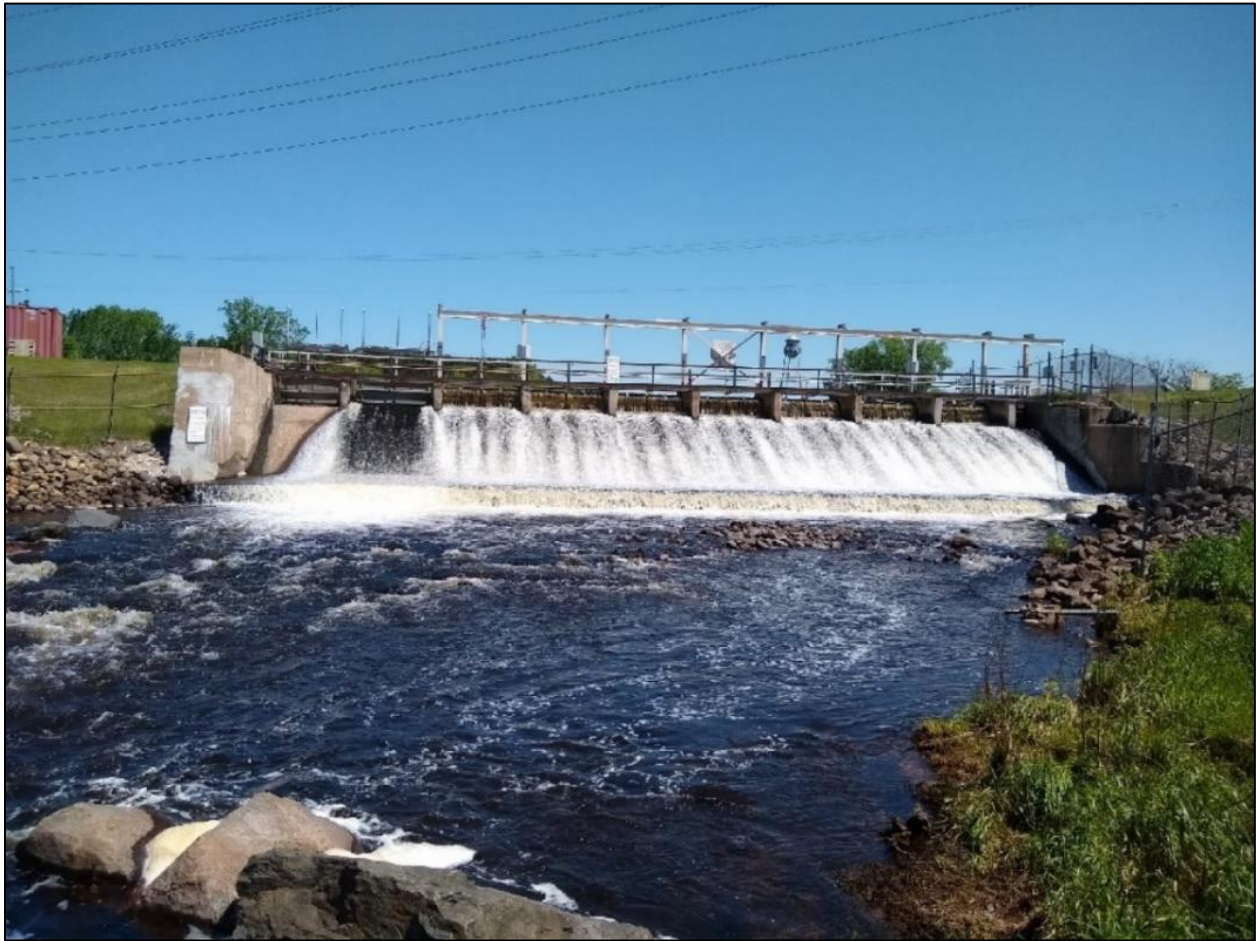
Figure 4.10.1-1 View of the Hayward Dam Spillway looking upstream from bypass reach.

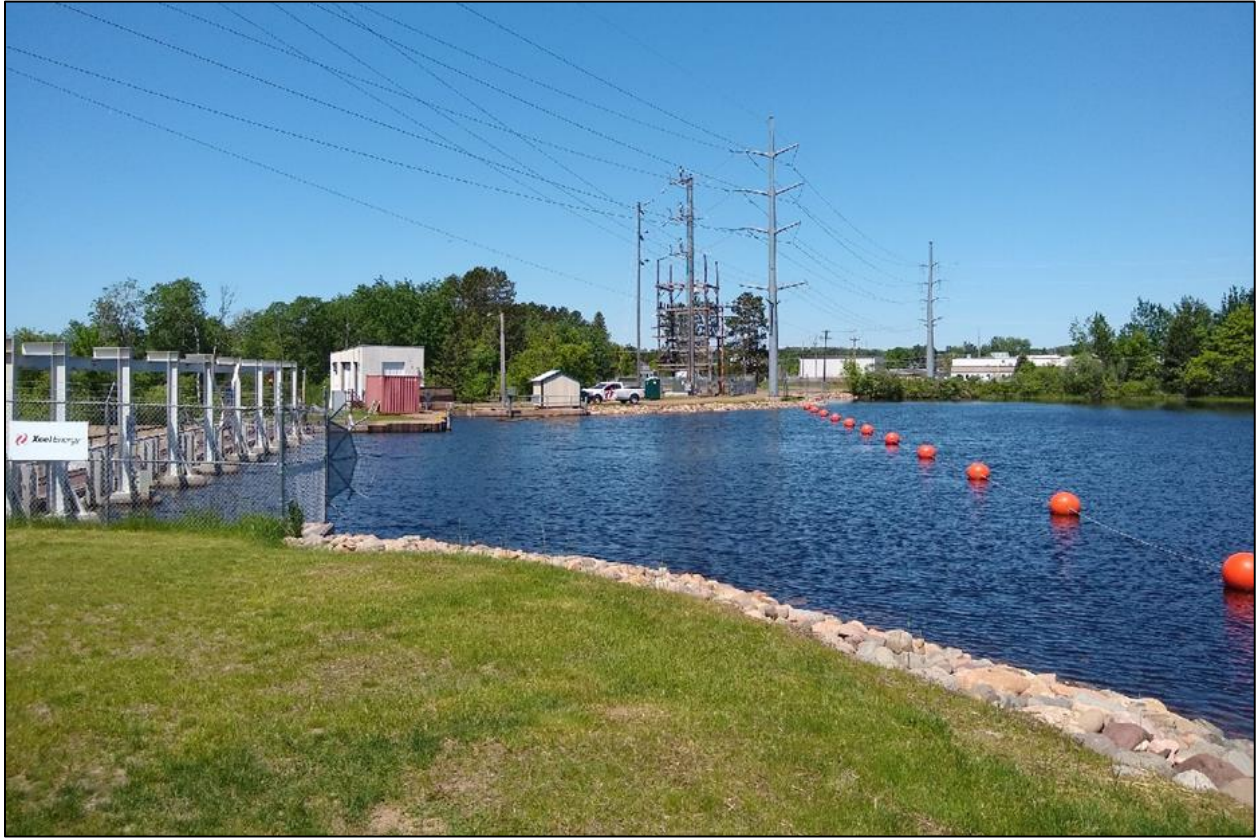
Figure 4.10.1-2 Hayward Dam and powerhouse from the East Bank (looking west)

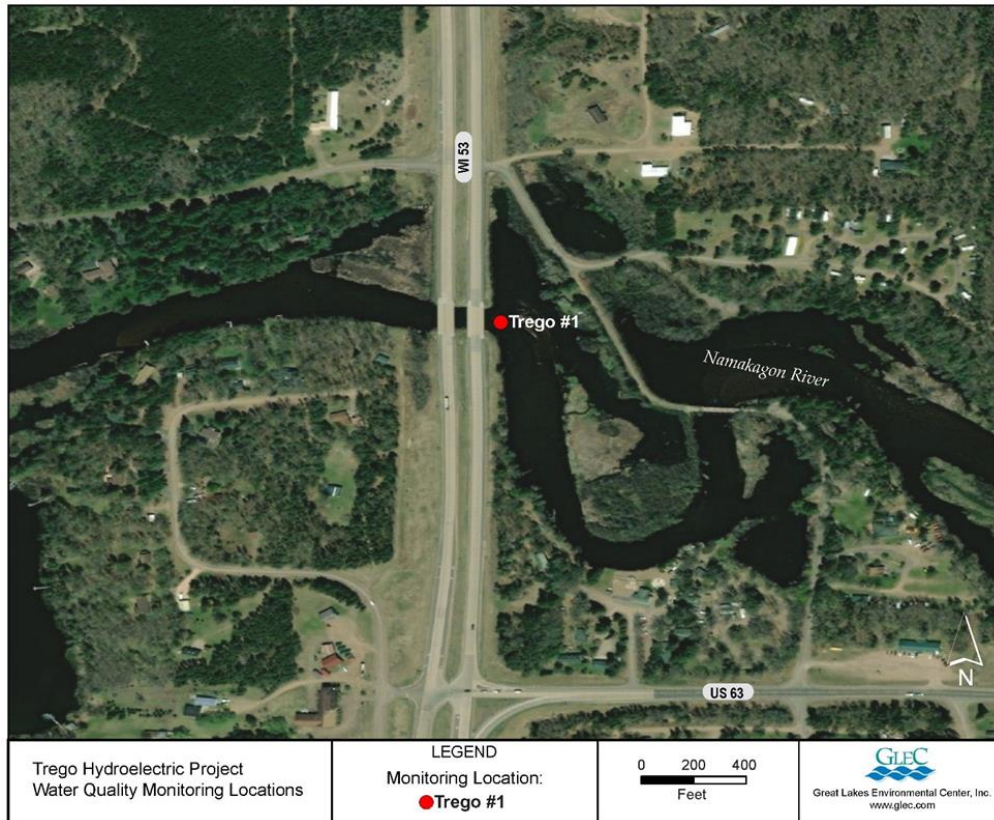
Figure 5.4.1.2.3-1 2022 Trego Project 2022 Water Quality Monitoring Study Monitoring Locations (Site 1)

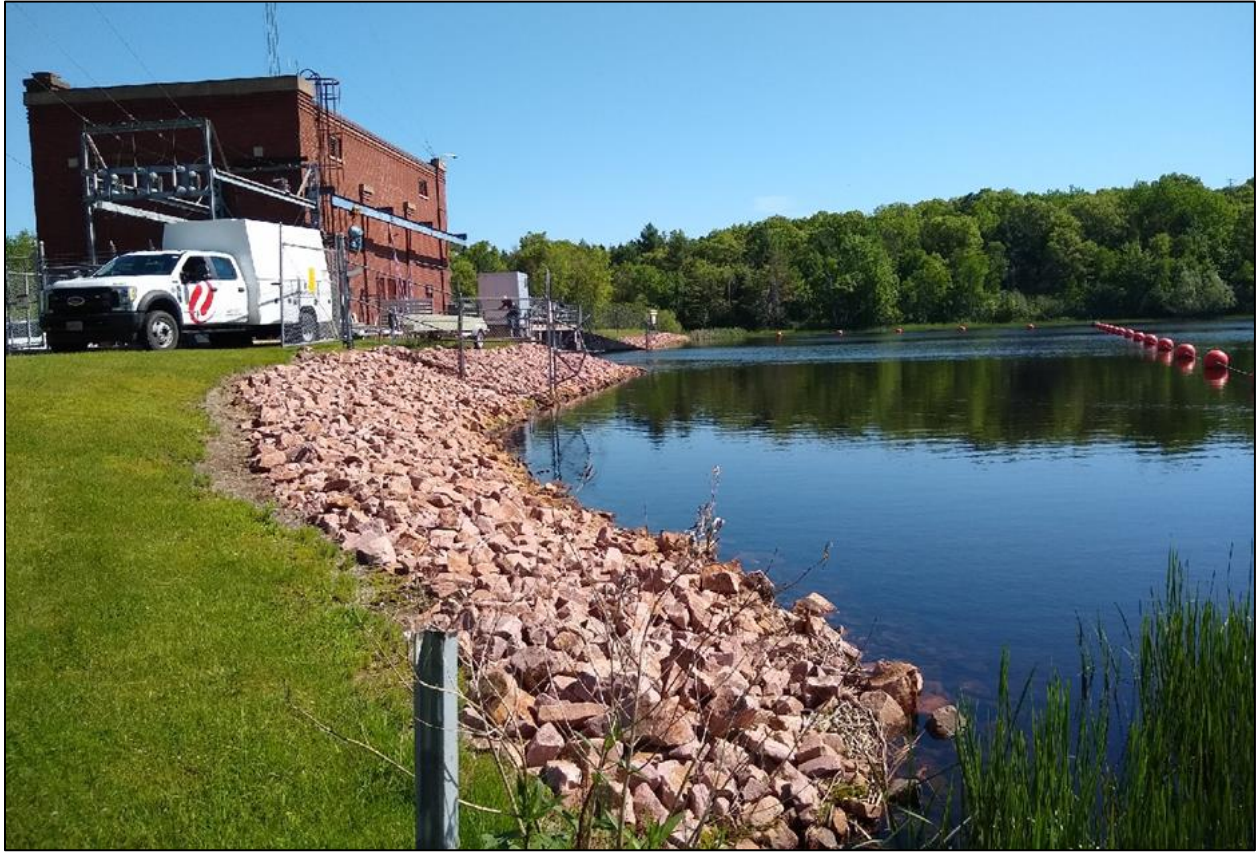
Figure 5.10.1-1 View of Trego Dam and Powerhouse (looking northeast).

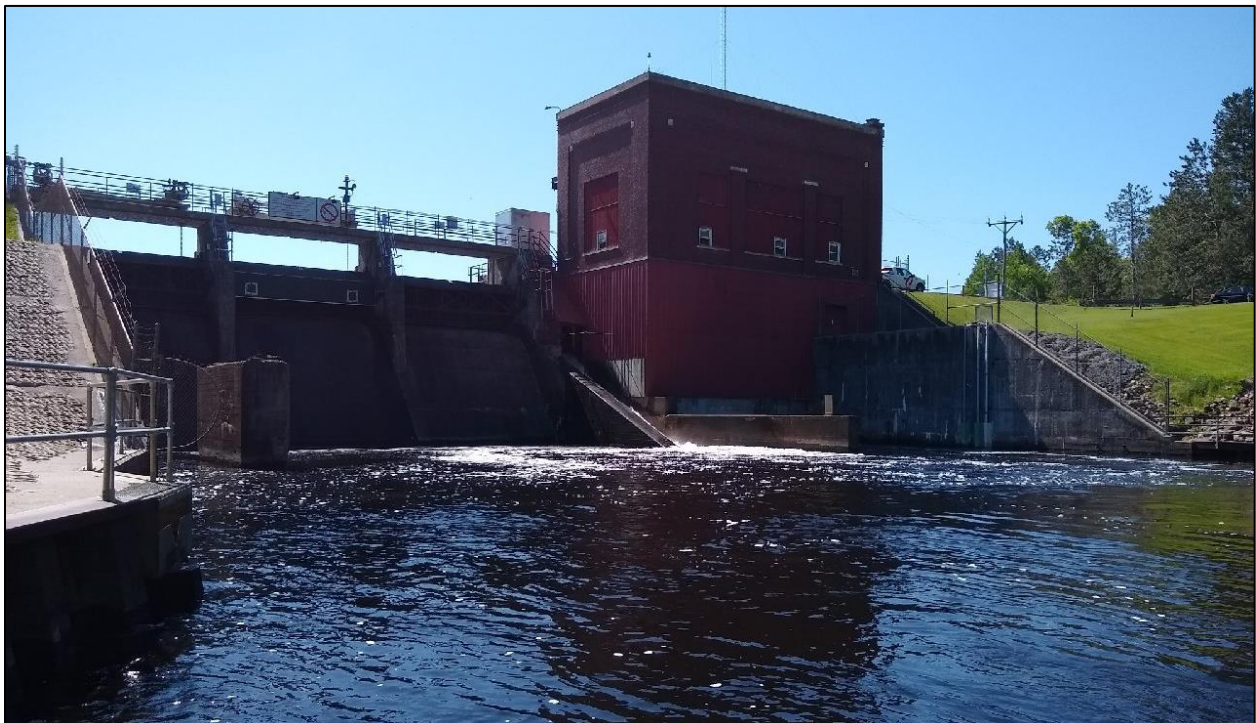
Figure 5.10.1-2 View of Trego Dam and Powerhouse from Canoe Portage Put-In (looking upstream)
