**White River Hydroelectric Project
FERC Project No. 2444**

**Application for a Subsequent License for a Minor Water Power Project
Less than 1.5 Megawatts**

**Volume 3 of 4
Appendices**

July 2023

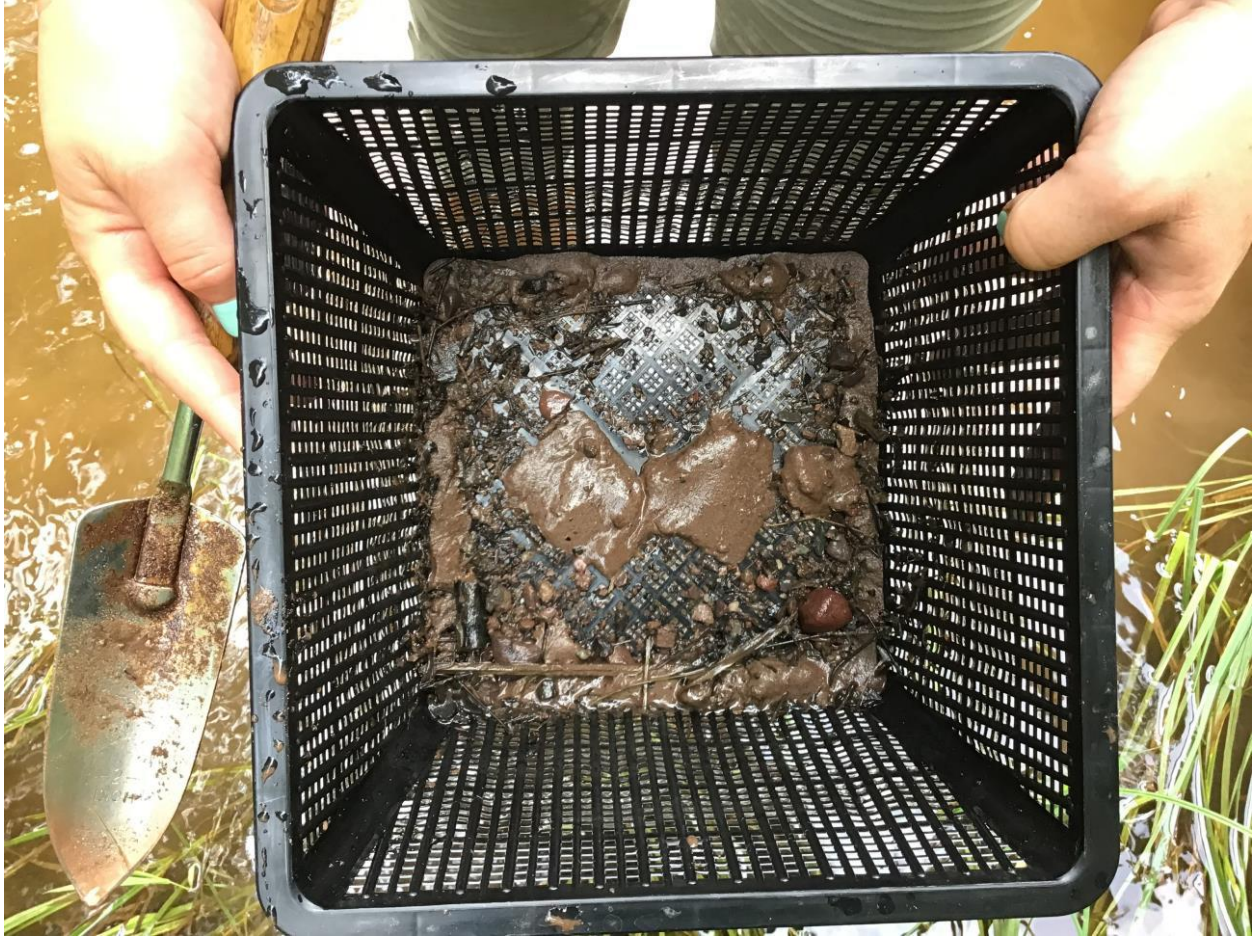
FIGURE 6 Sediment Basket

Figure 6. Sediment basket.

Using a 10-inch Tetra Pond Planter Basket, with a $1/32^{\text{nd}}$ inch mesh, a sample is being rinsed for examination.

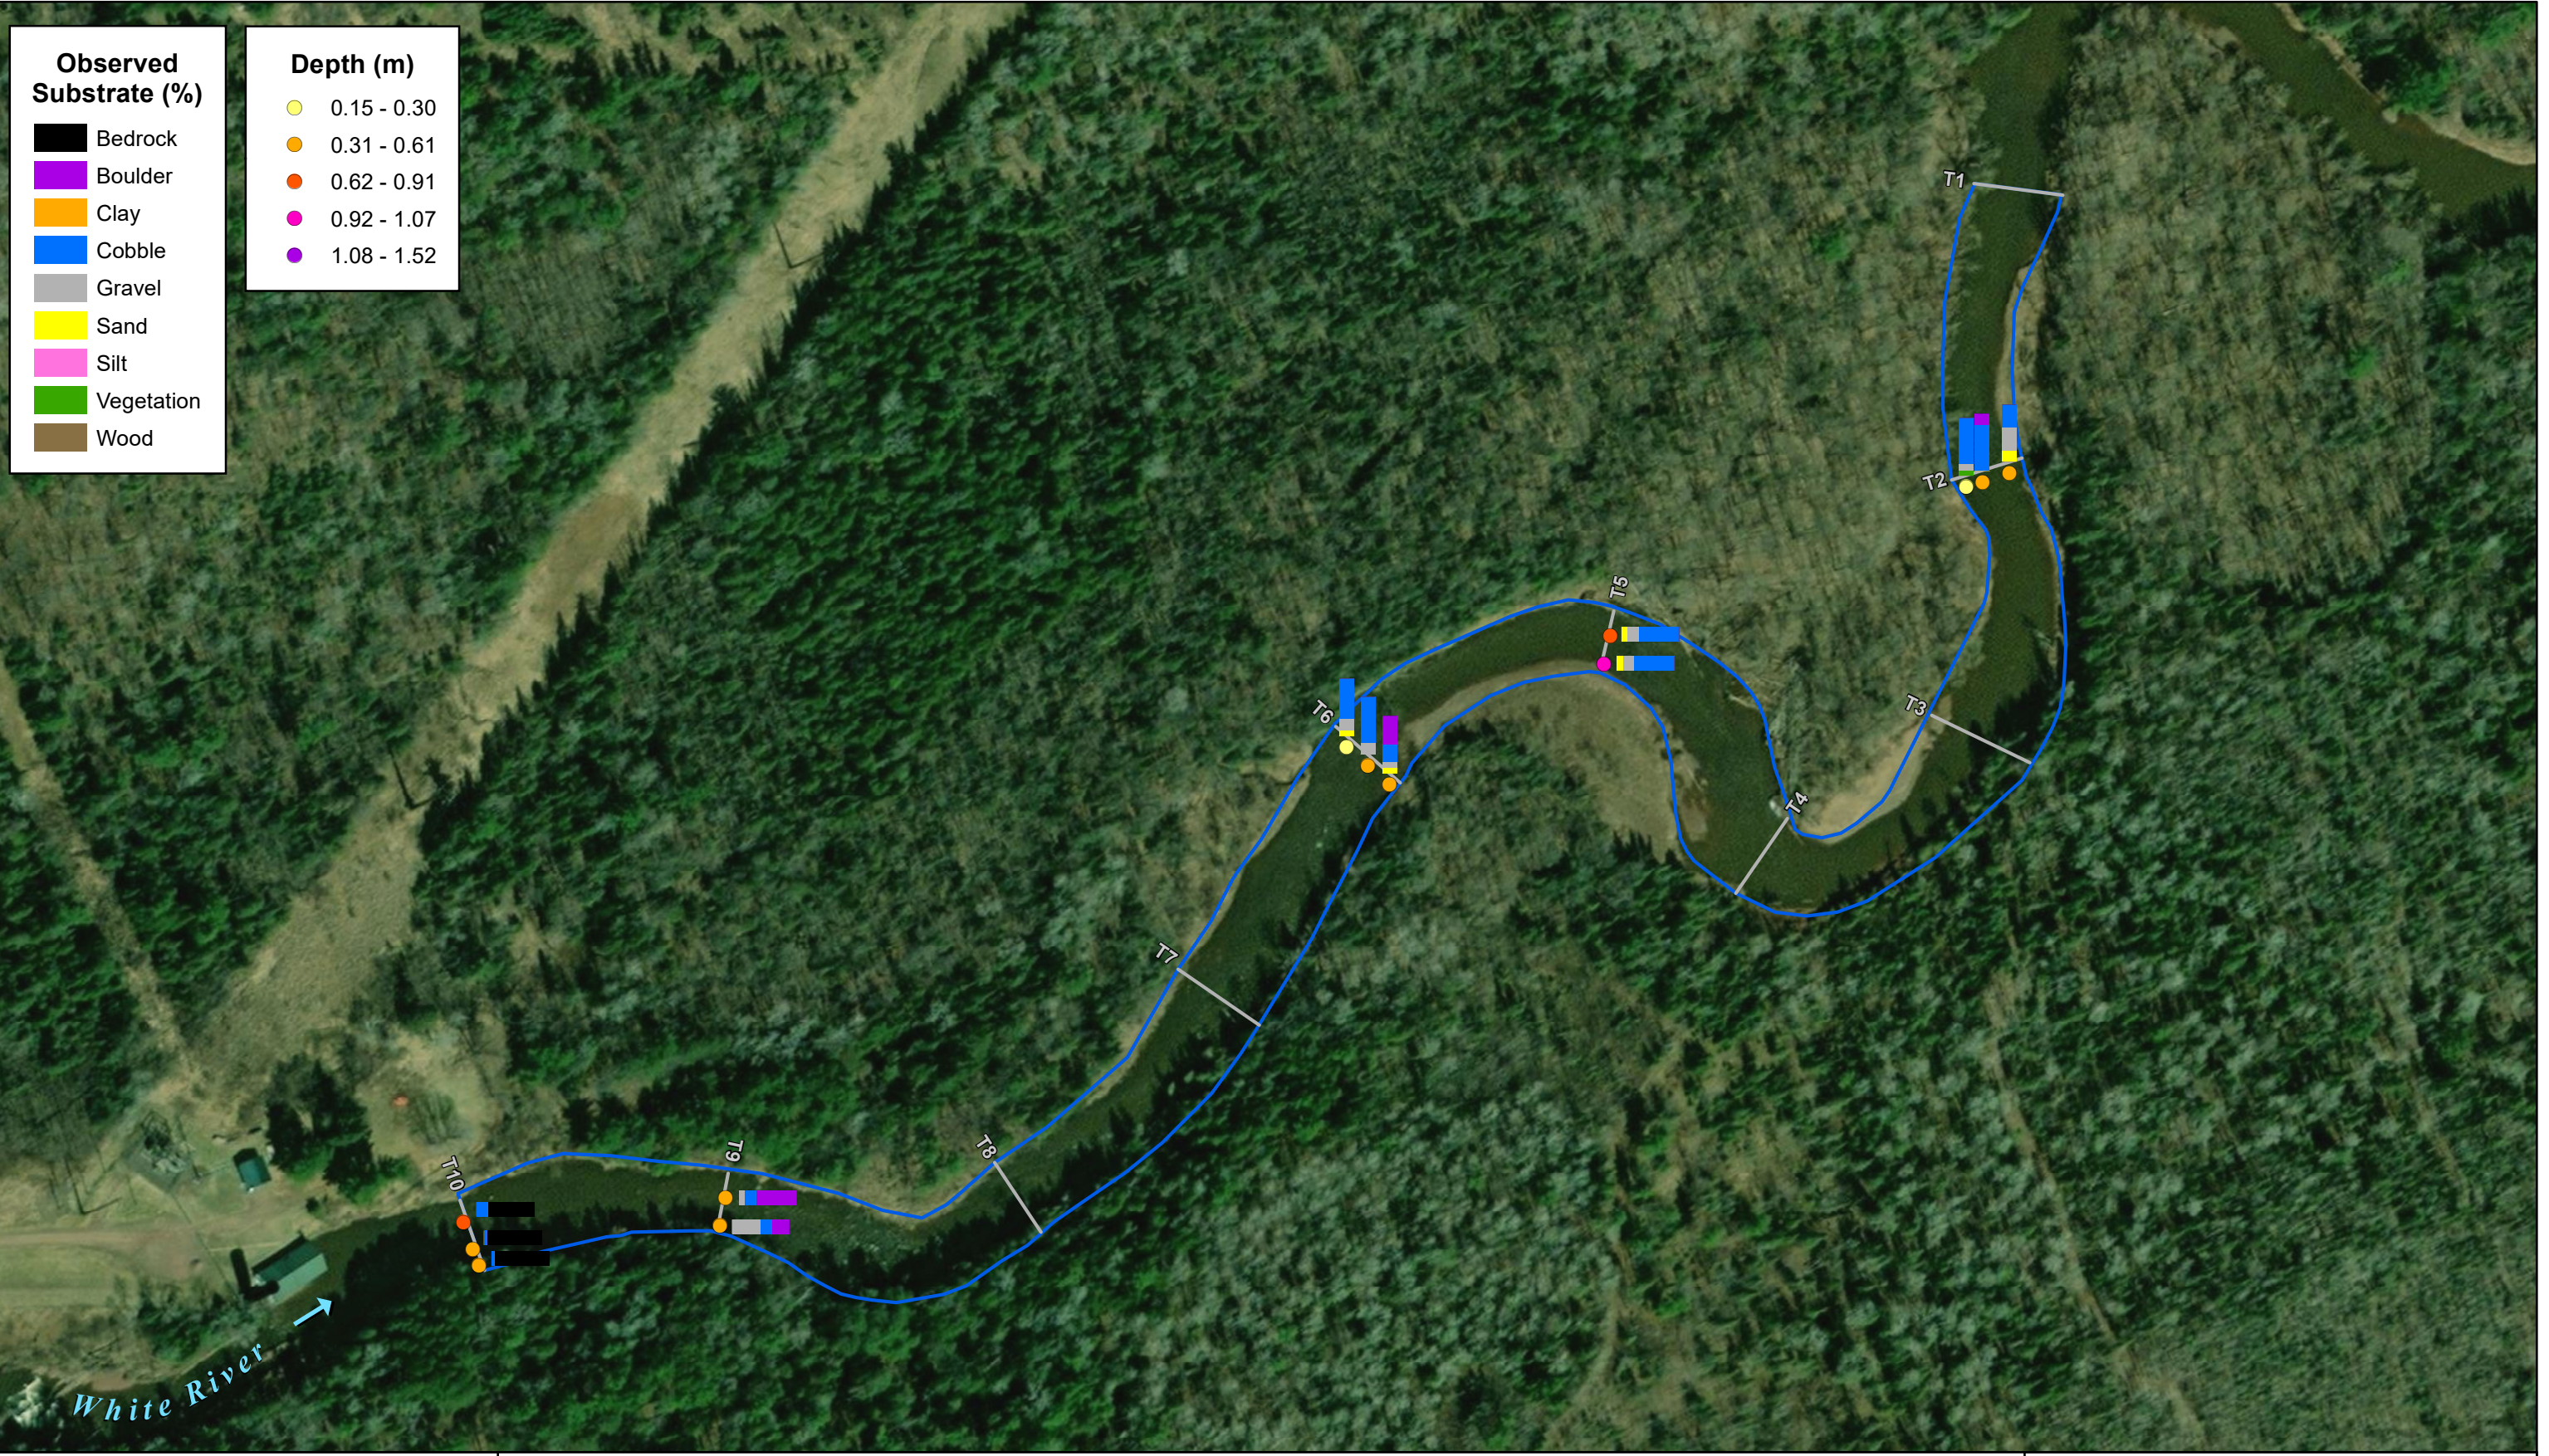
Figure 3. Substrate and Depth for the White River Project Reach Two on the White River. Ashland and Bayfield Counties, Wisconsin.

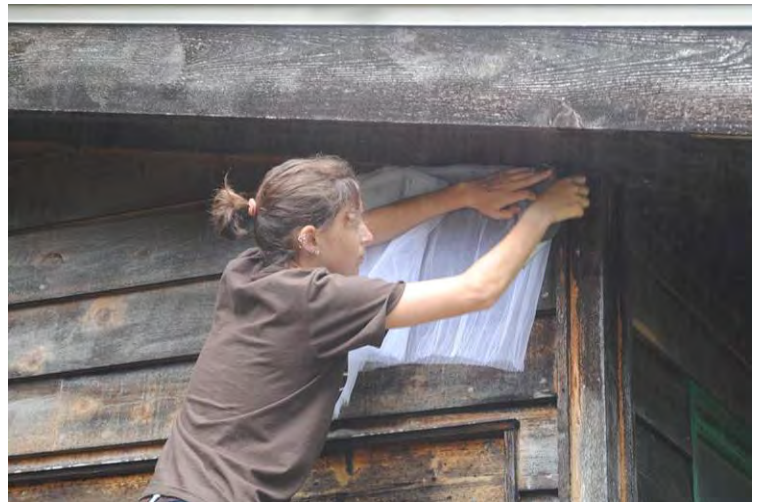
One-way exclusion devices can be created using plastic netting with one-sixth inch (0.4 centimeter) or smaller mesh. Shape the plastic netting so that it covers the opening entirely and extends at least two feet below it. Using staples or duct tape, attach the top and side edges of the

Applying screen for one-way door

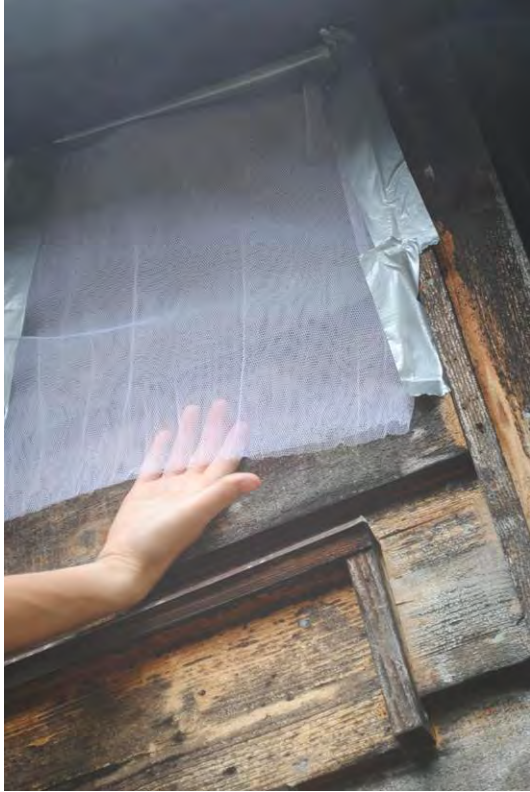
plastic netting to the building, leaving the bottom edge open. Be conscious of the netting's tautness; you should be able to slide your hand into the bottom opening though not so loose that the bats may easily crawl back up the opening. At sunset the following night, some of the bats will escape through the open, bottom portion. Leave the netting up for five to seven days; this will ensure that all bats have exited the building. After all bats have been excluded, you may then seal the openings permanently with appropriate construction materials.

Space on bottom for bats to escape

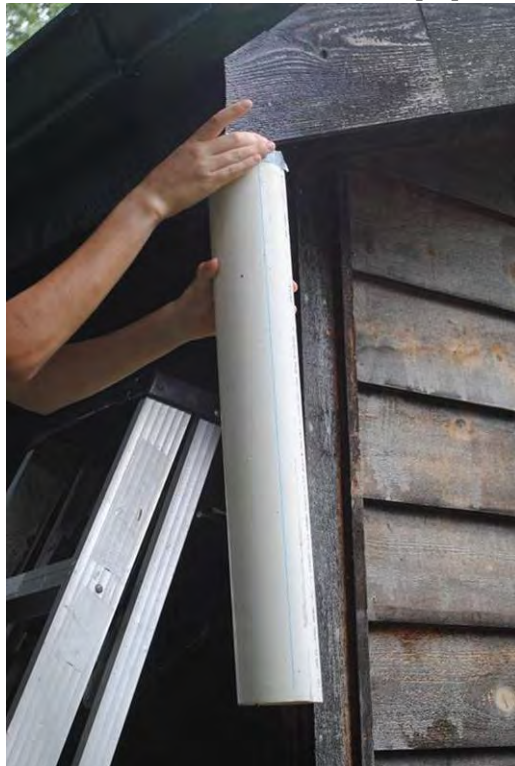
Other materials can be used to create one-way exits, such as plastic sheeting or PVC pipe. Install the plastic sheeting in the exact manner as the plastic netting. A portion of PVC pipe, which should be similar in size to a tube of caulk, can be inserted into the opening. Seal the

PVC one-way door

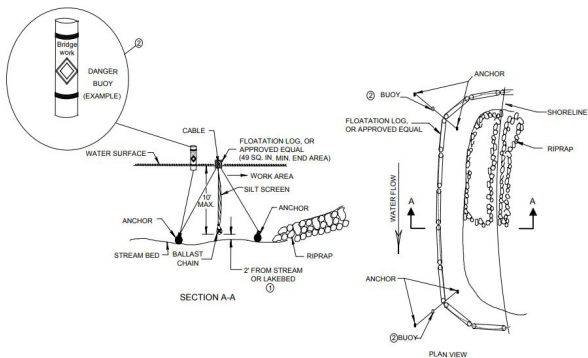
- Refer to WDNR T.S. Silt Curtain (1070) for specific criteria.
- Install in or adjacent to the waterway or waterbody before construction activities begin. Install as close to the construction as practical.
- Maintain a 2-foot gap between the weighted lower end of the curtain and the bottom of the waterway or waterbody.
- Follow guidelines outlined in WDNR T.S. Silt Curtain (1070) regarding anchorage and danger buoys.
- Must remain in place and be maintained until the construction activity is completed and the disturbed area is stabilized.
- This detail is an example of typical installation guidance.
