September 22, 2022

Subject: Shoreline Monitoring of Archaeological Sites and Erosion Check on the Gile Flowage Storage Reservoir (FERC# 15055) in Iron County, Wisconsin.  
TRC Project No. 450488.0000  
WIARC No. 285

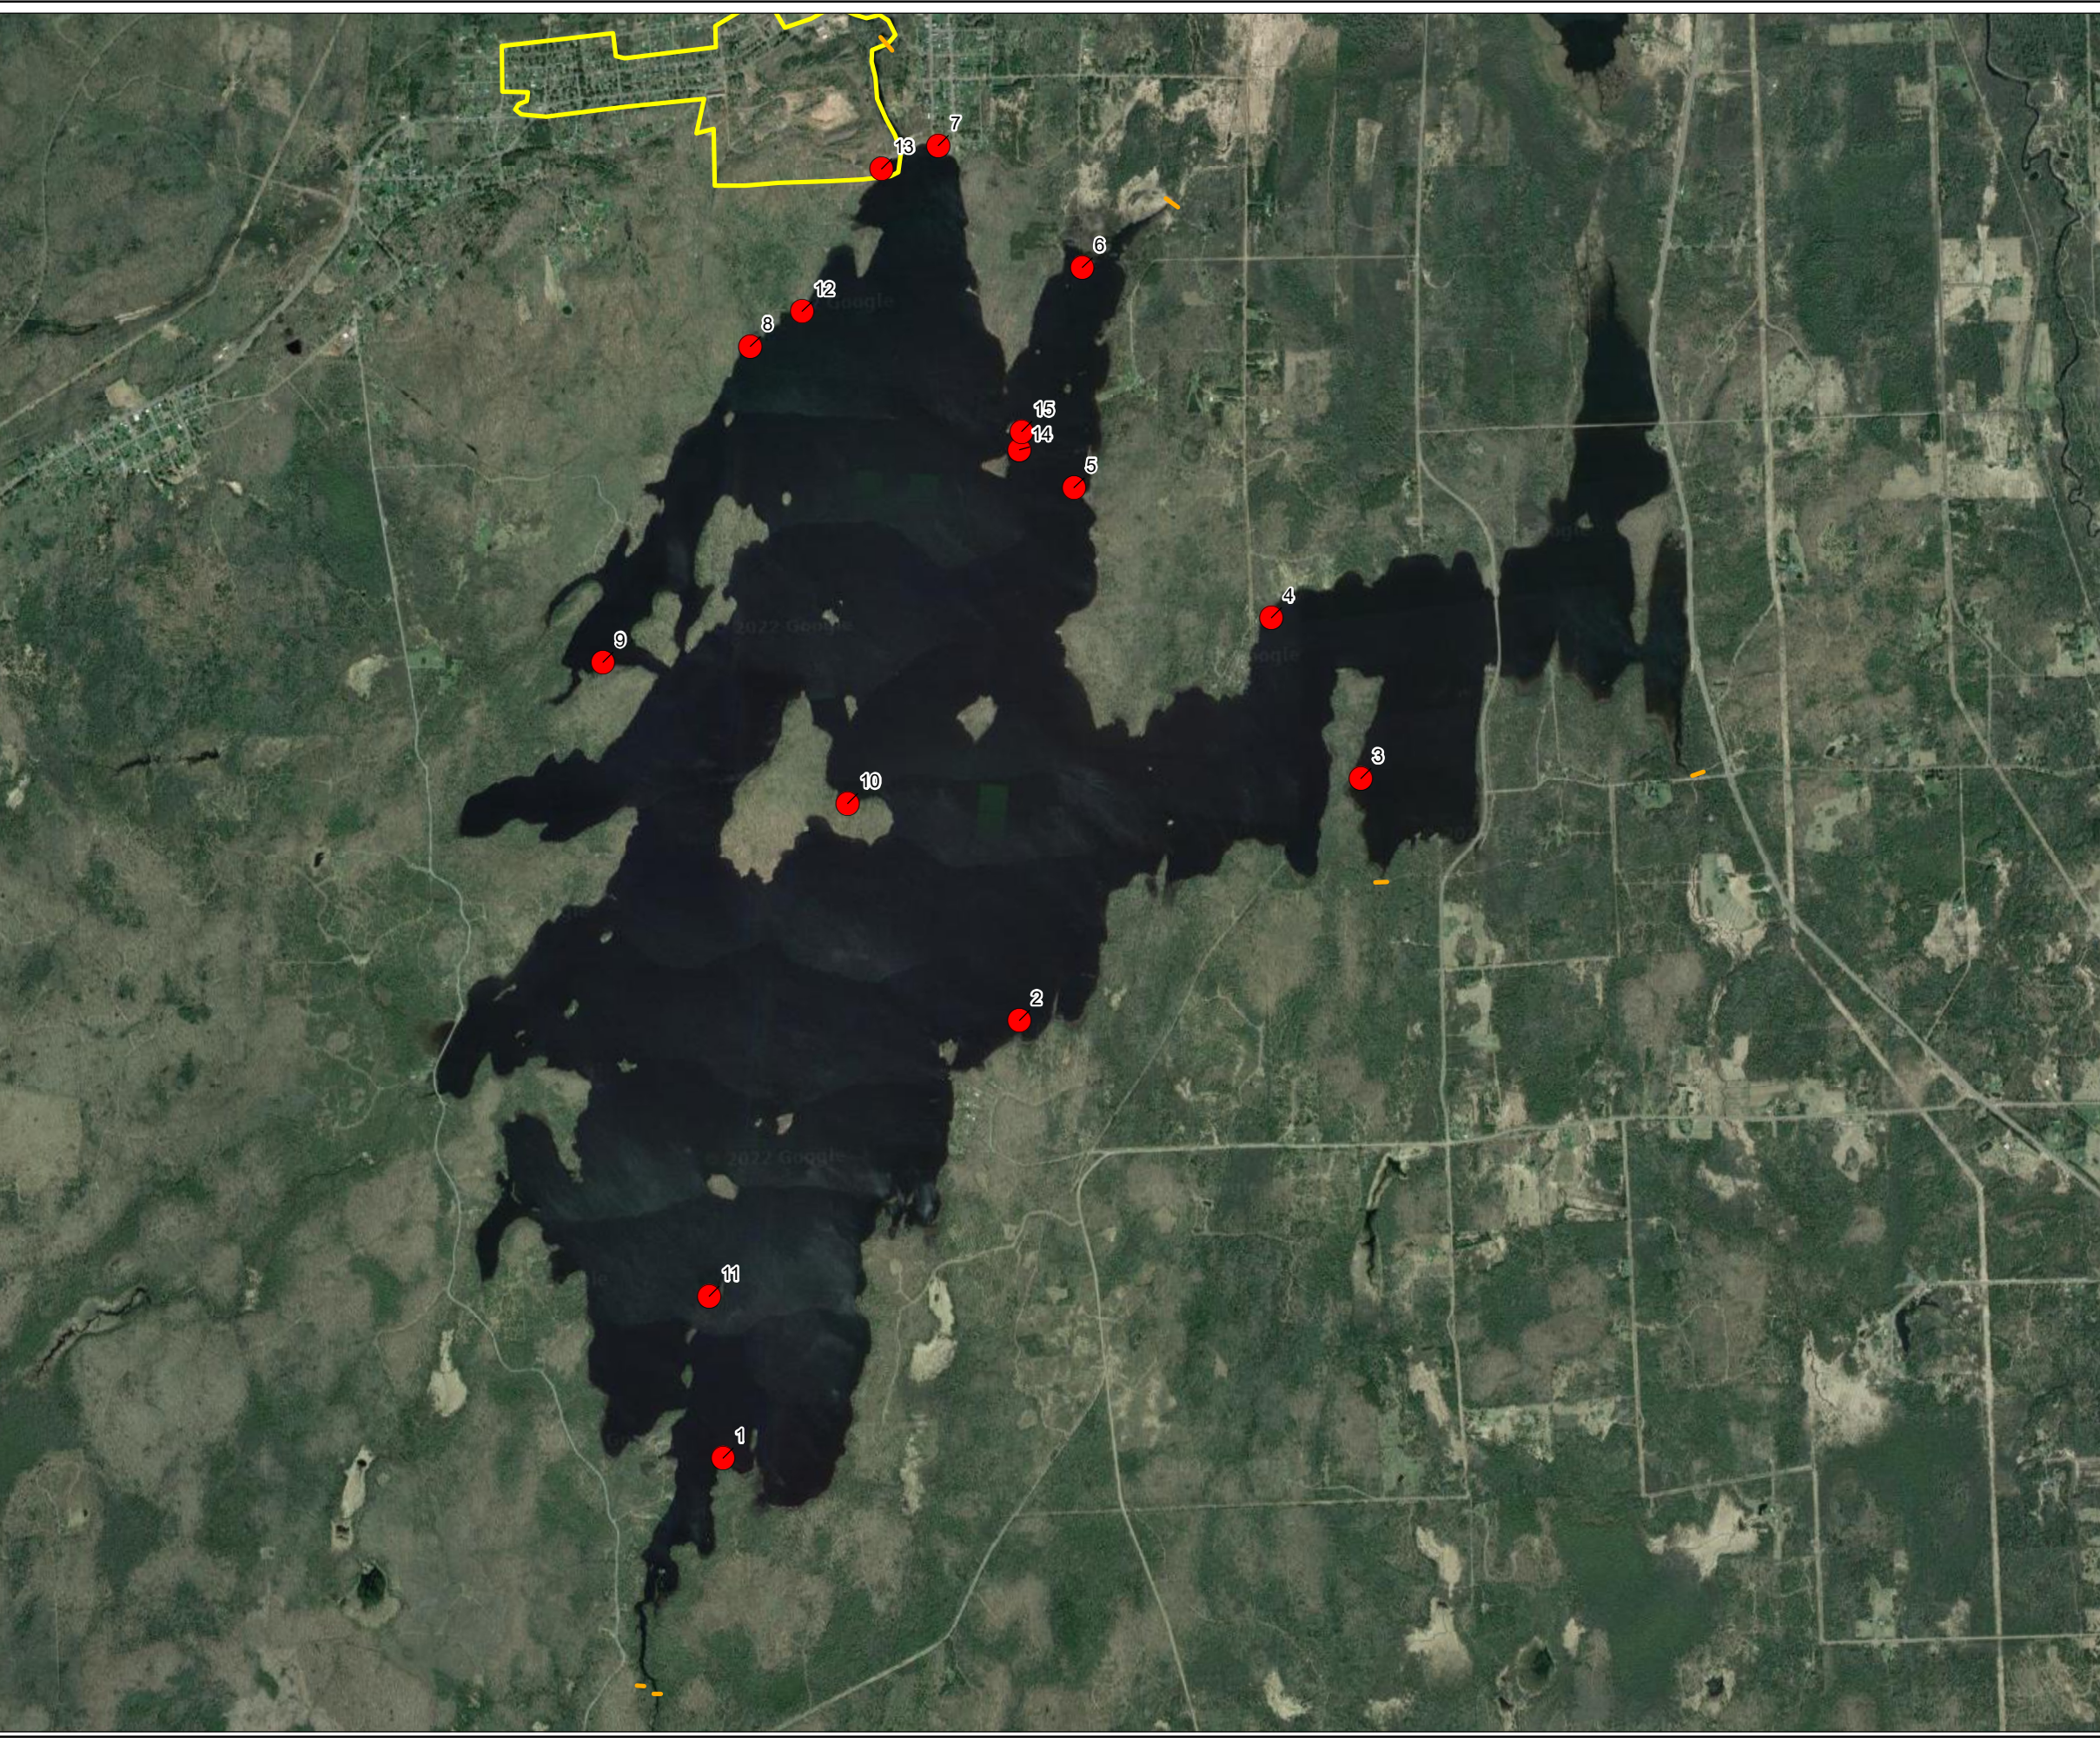
<b>PROJECT:</b>		<b>Xcel Energy Gile Flowage Archaeological Survey Iron County, WI</b>	
<b>TITLE:</b>		<b>Erosion Locations Map</b>	
DRAWN BY:	A.MCMAHON	PROJ NO.:	486101.0000.0000
CHECKED BY:	R.KLABACKA-WILLIAMS	<b>FIGURE 2</b>	
APPROVED BY:	A.VAN DYKE		
DATE:	SEPTEMBER 2022

The literature and archives research revealed that one cultural resource and one GLO-mapped trail were overlapped by the water. Five areas of erosion (E-1 through E-5) were also noted.

The single cultural resource site is designated as the Montreal Company Location Historic District. Most of the MCLHD shoreline is stable except for a small area designated as E-3. TRC recommends that NSPW monitor the erosion at site E-3 for any changes within 5 years of license issuance.

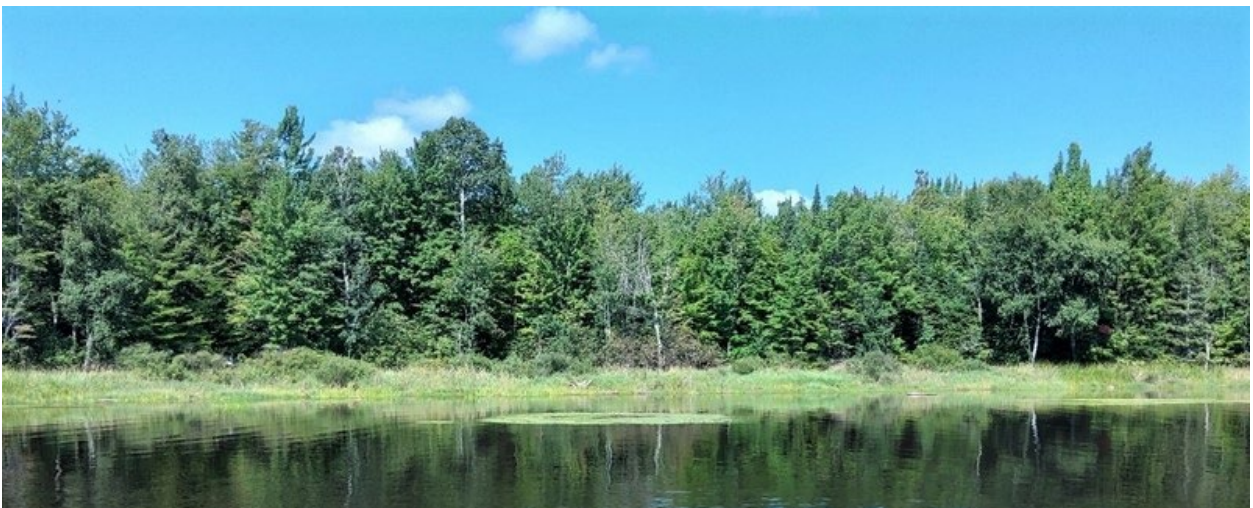
**Photo 3: Emergent wetland vegetation; background – coniferous forest. View to west.**

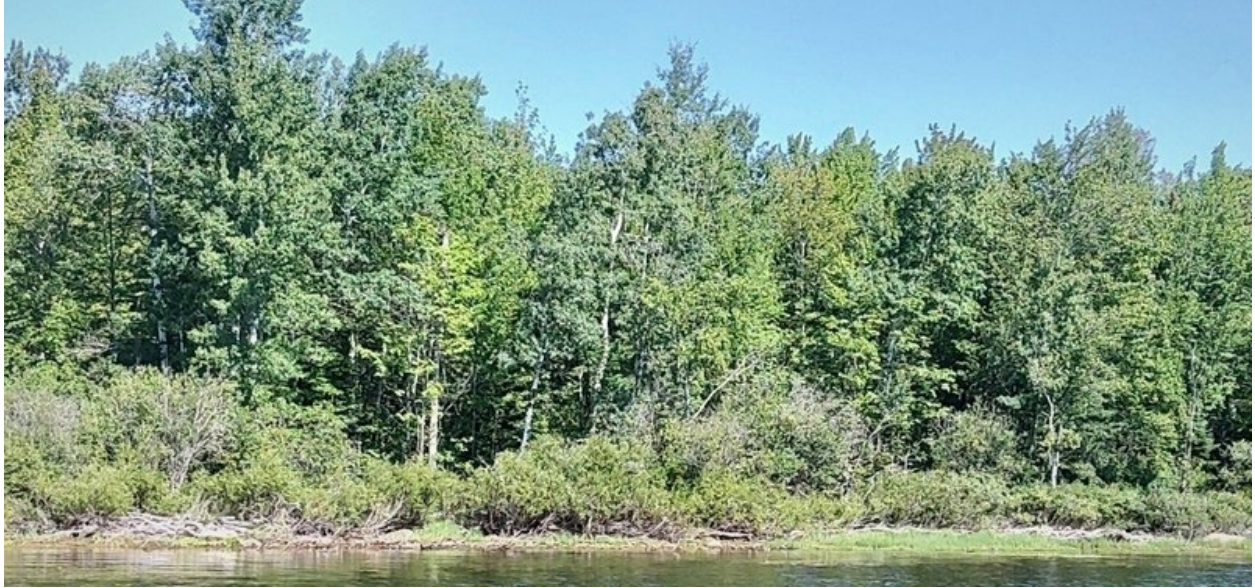
**Photo 4: Shrub-carr; background – coniferous forest. View to north.**

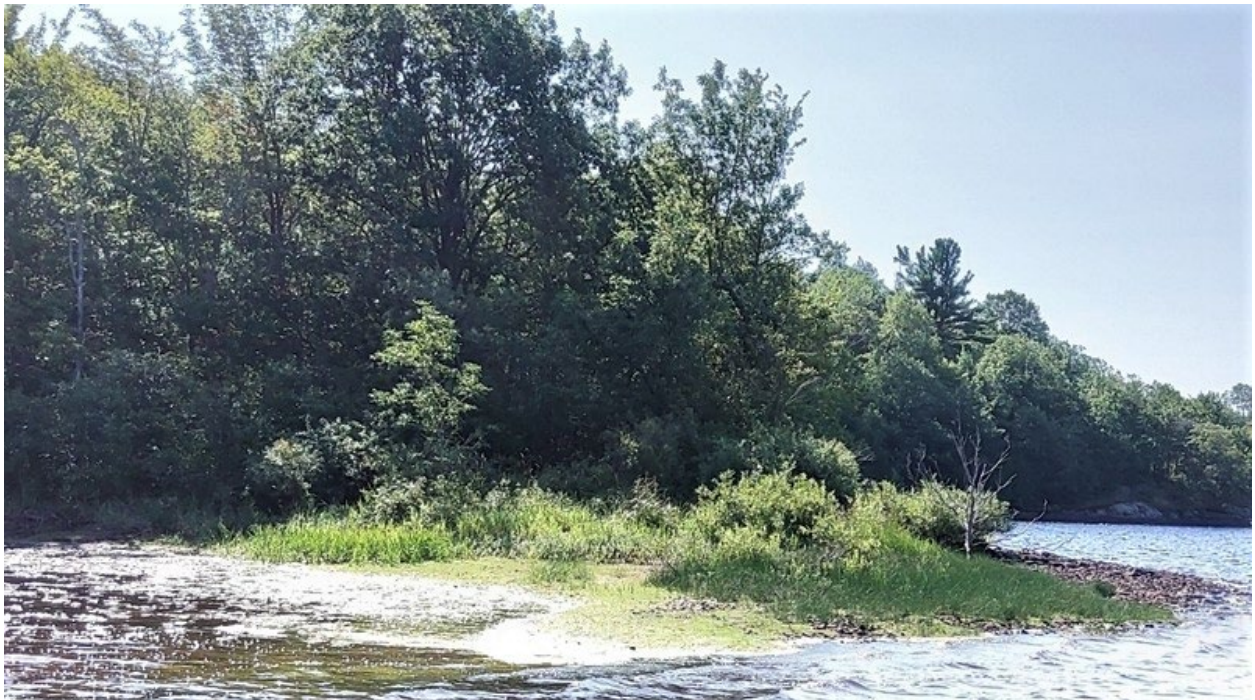
**Photo 5: Foreground – mud/gravel bar; middle ground – emergent wetland vegetation; background – coniferous forest.  
View to east.**

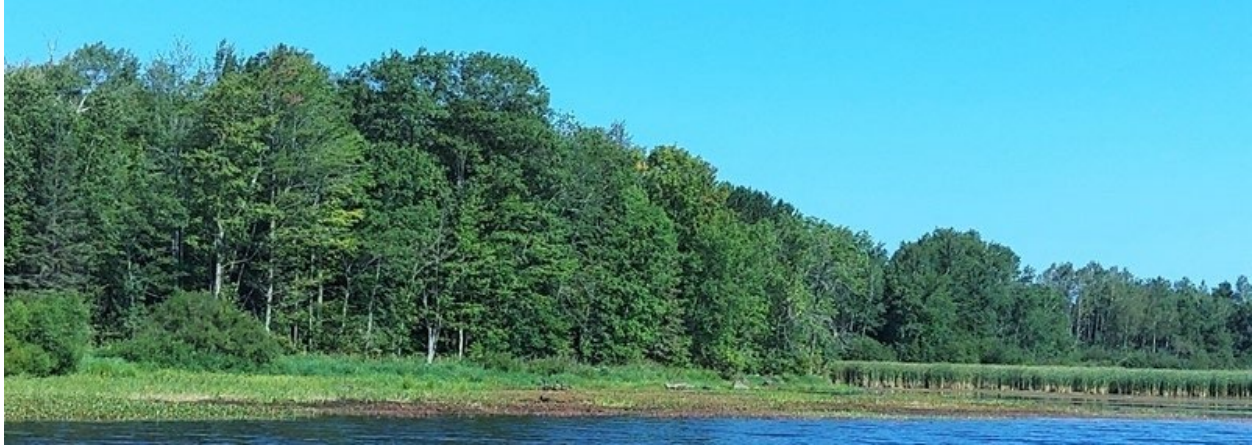
**Photo 6: Left side – deep marsh; right side – shallow marsh; middle – mud flat; background – mixed deciduous/coniferous forest. View to northeast.**

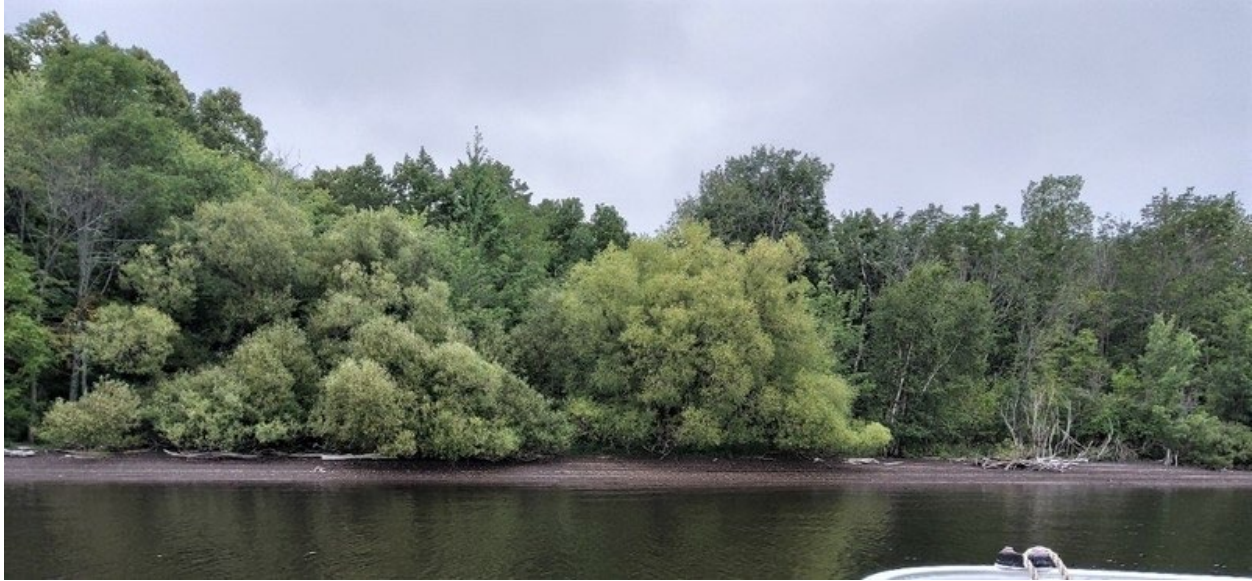
**Photo 8: Mud flat along the shoreline under the canopy of mixed deciduous/coniferous forest. View to north.**

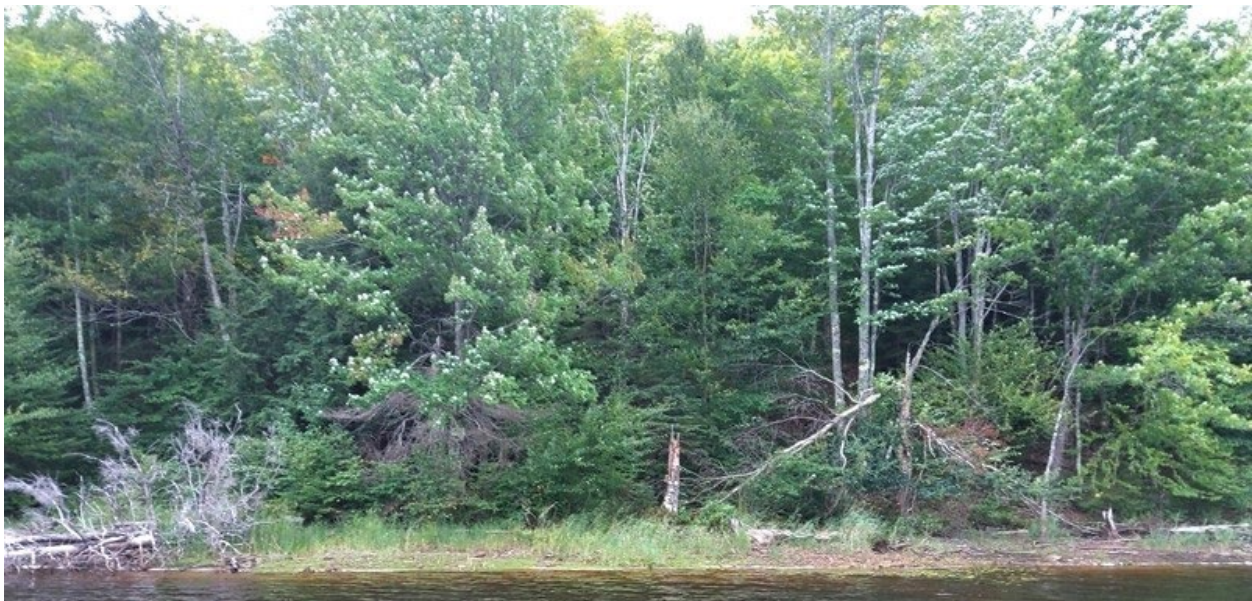
**Photo 9: Mud flat or sand bar with sparse emergent vegetation; background - mixed deciduous/coniferous forest. View to south.**
