**Gile Flowage Storage Reservoir Project
FERC Project No. 15055**

**Exhibit E
Environmental Report**

Draft License Application

**Mead
& Hunt**

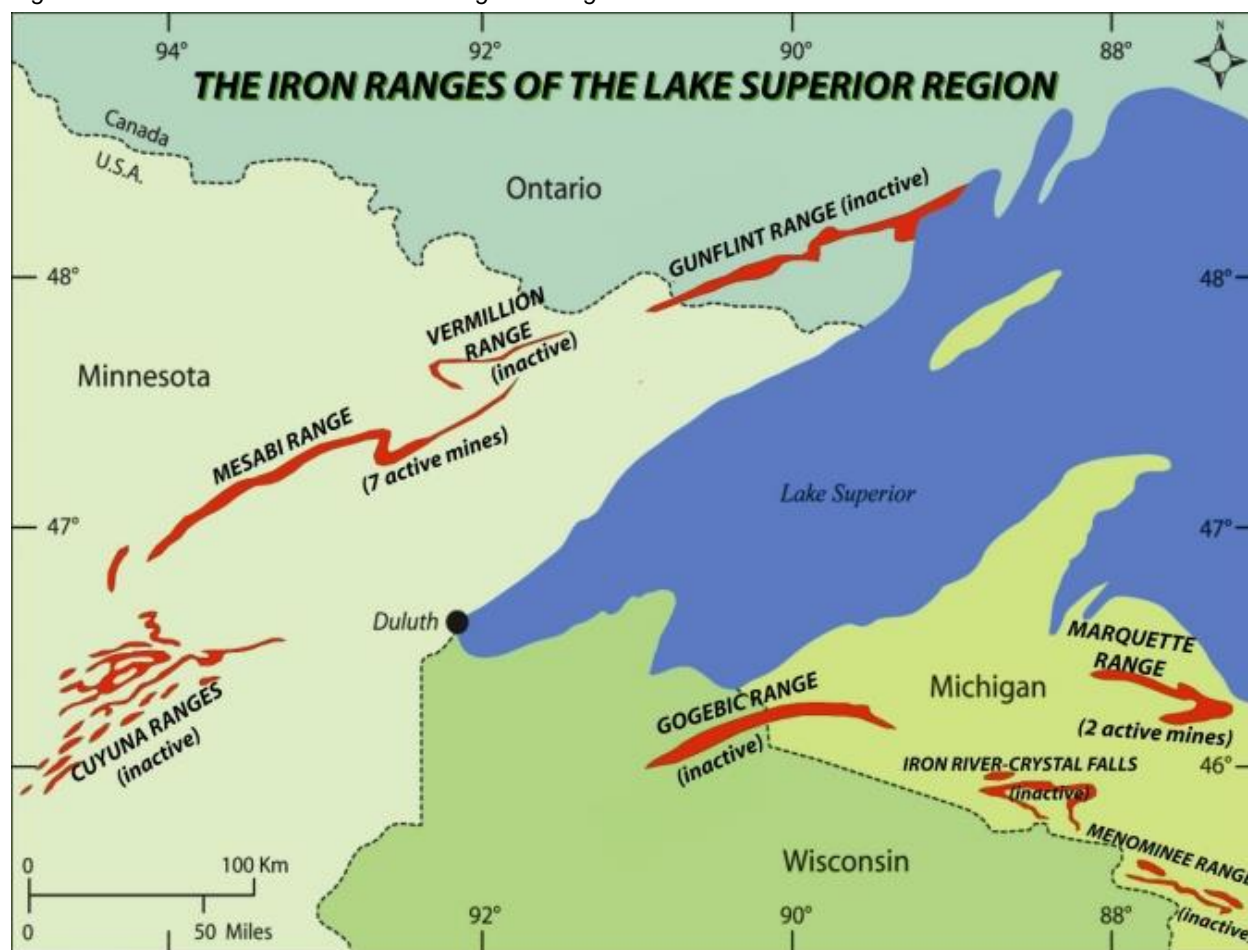
Figure 3.3.1.1-1 General Location of the Gogebic Range

The current topography of the area was created when glacial activity eroded the remnant mountain range known as the Gogebic Range, as shown in **Figure 3.3.1.1-1**.¹⁰ North of the range, glacial activity left behind a sloping lake plain with numerous river valleys, creating a fissured pattern. Elevations within the lake plain generally increase from north to south, from a low of 601 feet NGVD at Lake Superior to 1,863 feet NGVD in the Gogebic Range. This range runs in a general west to east direction that approximates the path of State Highway 77, which is located just to the north of the Gile Project (Town of Pence, 2005a).

The Gogebic Range is underlain conformably by the older Palms Formation, which is composed of quartzite, slate, and conglomerate. The Palms Formation is found on the southeast side of the Gogebic Range where it overlies the Bad River dolomite, where present, or lower Precambrian granite, metamorphosed basalt, and other igneous rock where the dolomite is absent. The younger Tyler Formation is located northwest of the Gogebic Range and includes slate with greywacke and siltstone that was deposited as a thick layer of sediment, up to 10,000 feet thick, which accumulated when the Gogebic Range was located at the Superior Craton edge along the Niagara Escarpment (Ayres Associates, 2016).

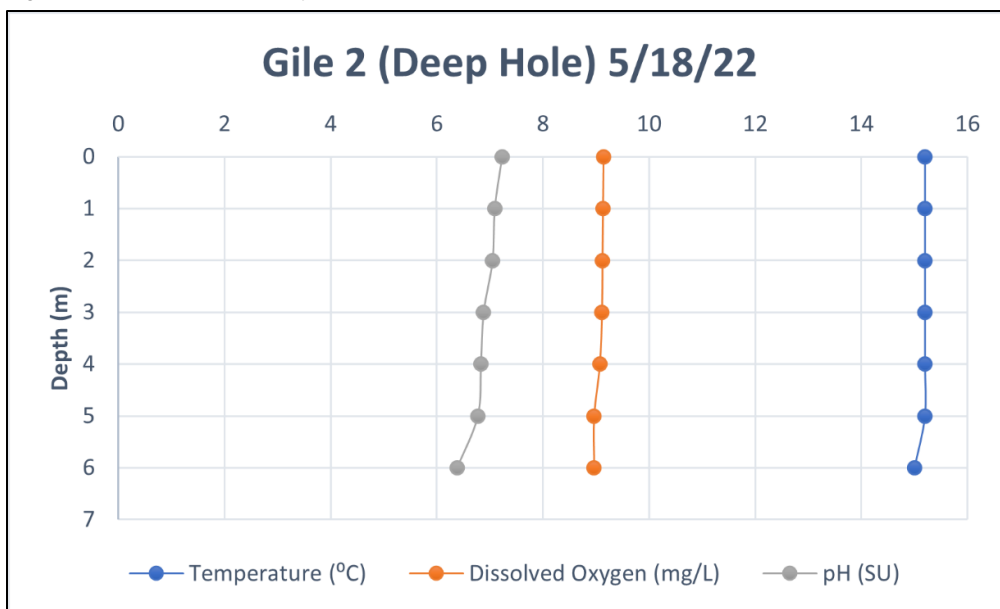
Figure 3.4.1.2.3-2 Site 2 May Profiles

All parameters measured during the depth profile monitoring met Wisconsin’s water quality standards. Analysis of the study data indicates the Gile Flowage was not stratified at any location.
