**Gile Flowage Storage Reservoir Project
FERC Project No. 15055**

**Exhibit E
Environmental Report**

Final License Application

Northern States Power Company
A Wisconsin Corporation

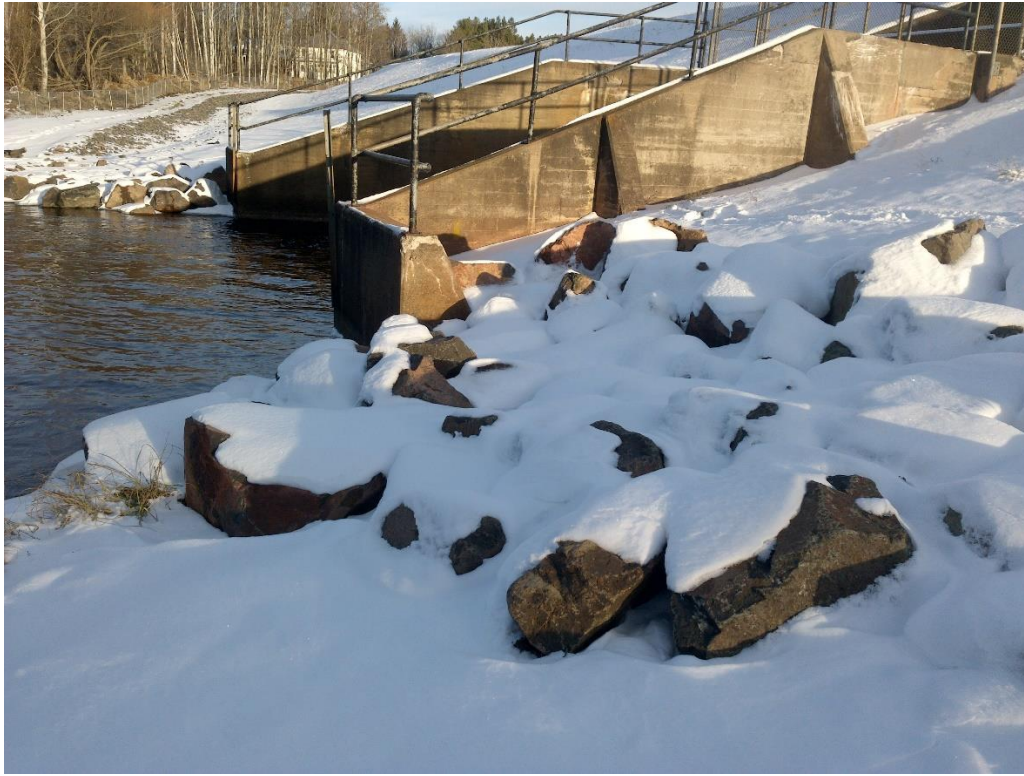
Figure 3.3.1.4-1 Completed Erosion Mitigation

In addition to the erosion sites documented along the reservoir shoreline, one additional erosion site was noted downstream of the dam in the tailwater area.¹⁵ The area is located on the west bank at the toe of

the water control structure, adjacent to the west wingwall downstream of the dam. It appears human traffic and possibly high flows have scoured the bank and exposed soil adjacent to the wingwall. This site was identified in the FERC's October 3, 2022 follow-up comments regarding their 2022 Annual Dam Safety Inspection, which required NSPW to address the erosion by August of 2023 (Federal Energy Regulatory Commission, 2022). The site was re-visited in July of 2023 and updated photographs prior to the repair will be included in the USR. NSPW completed the erosion mitigation in August 2023 through the placement of filter fabric and rock riprap. The results of the erosion mitigation are displayed in **Figures 3.3.1.4-1, 3.3.1.4-2, and 3.3.1.4-3.**
