**Subject: Response to Additional Information Request
Hayward Hydroelectric Project (FERC Project No. 2417-067)
Trego Hydroelectric Project (FERC Project No. 2711-025)**

Hayward and Trego Projects
FERC Project Nos. 2417 and 2711Final License Application – Revised Exhibit E
Hayward Project Environmental Analysis

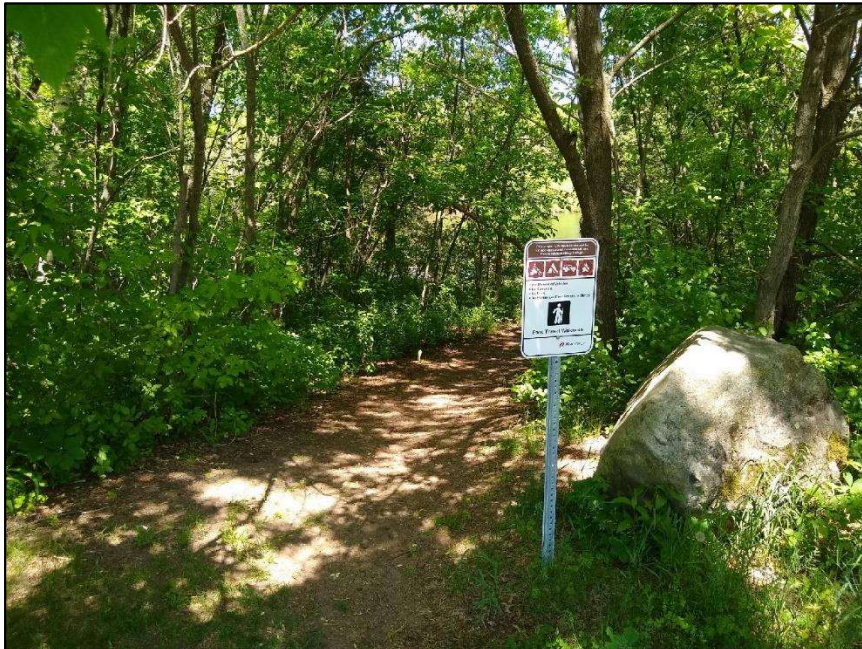
Figure 4.8.1.4.1-2 Canoe Portage Signage and Path to Put-In at the Hayward Project

This FERC-Approved recreation site is owned and operated by NSPW. The canoe portage trail runs approximately 600 feet southwest from the Take-Out along the side of 1st Street and a gravel road to a path leading to the Namekagon River. There is parking along the gravel road to accommodate six vehicles in addition to the parking available at the Take-Out. The portage trail is clearly marked. (EA Engineering, Science, and Technology, Inc., 2023) The site is shown in **Figure 4.8.1.4.1-2**. Additional photographs taken during the study are included in Appendix 3 of the Recreation Study Report included in **Appendix E-29**.

| Recreation Site | Recommended Improvements |
|--|---|
| Canoe Portage Trail and Put-In | Need to replace invasive species sign |

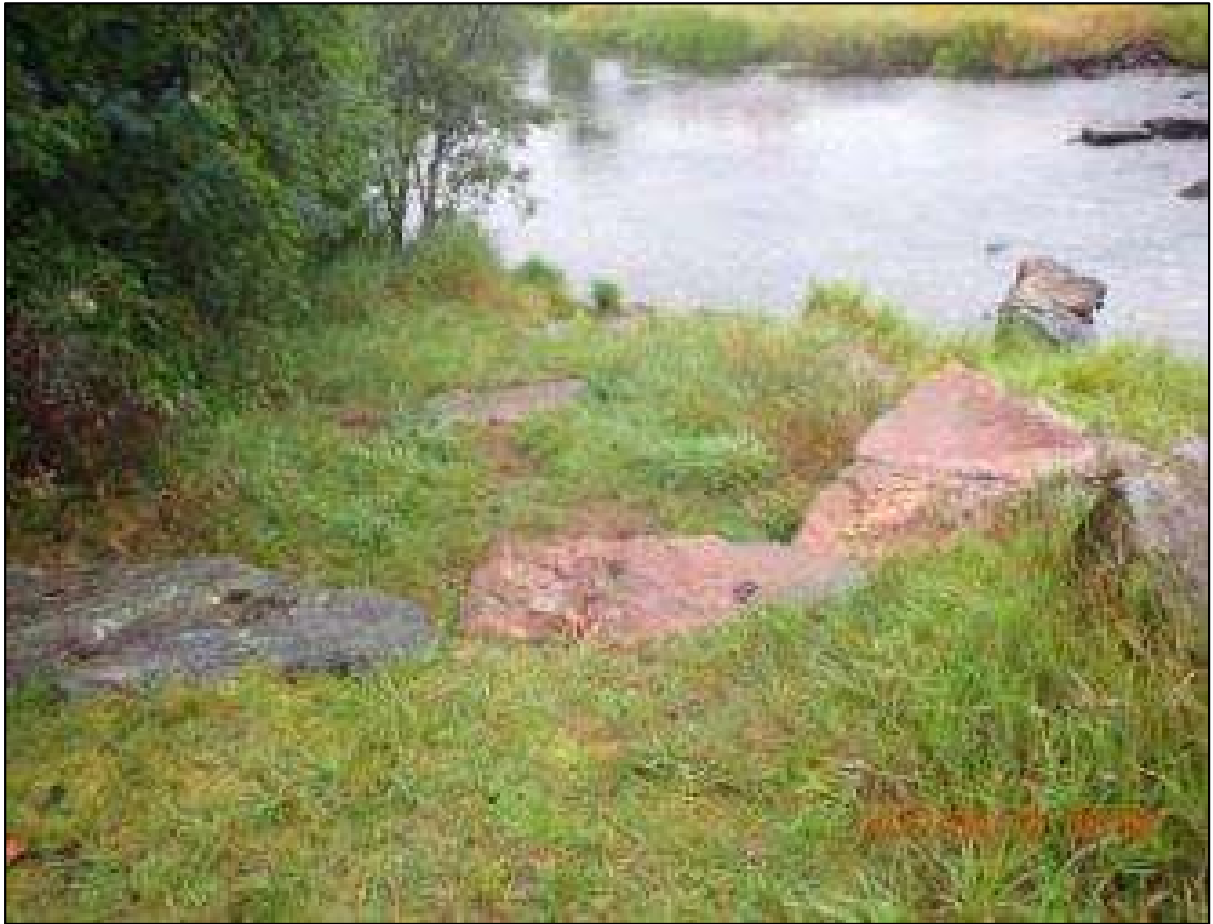
Figure 4.8.1.4.1-3 Path to Informal Tailwater Bank Fishing Area at the Hayward Project

This FERC-Approved recreation site is owned and operated by NSPW. The site is located approximately 270 feet downstream of the Take-Out and has a terraced approach to provide access to the river that is often utilized by anglers. The site shares a parking area with the Take-Out. There is no signage specifically identifying the site; however, there are directional signs for the canoe portage trail that passes by the site (EA Engineering, Science, and Technology, Inc., 2023). The site is shown in **Figure 4.8.1.4.1-3**. Additional photographs taken during the study are included in Appendix 3 of the Recreation Study Report included in **Appendix E-29**.

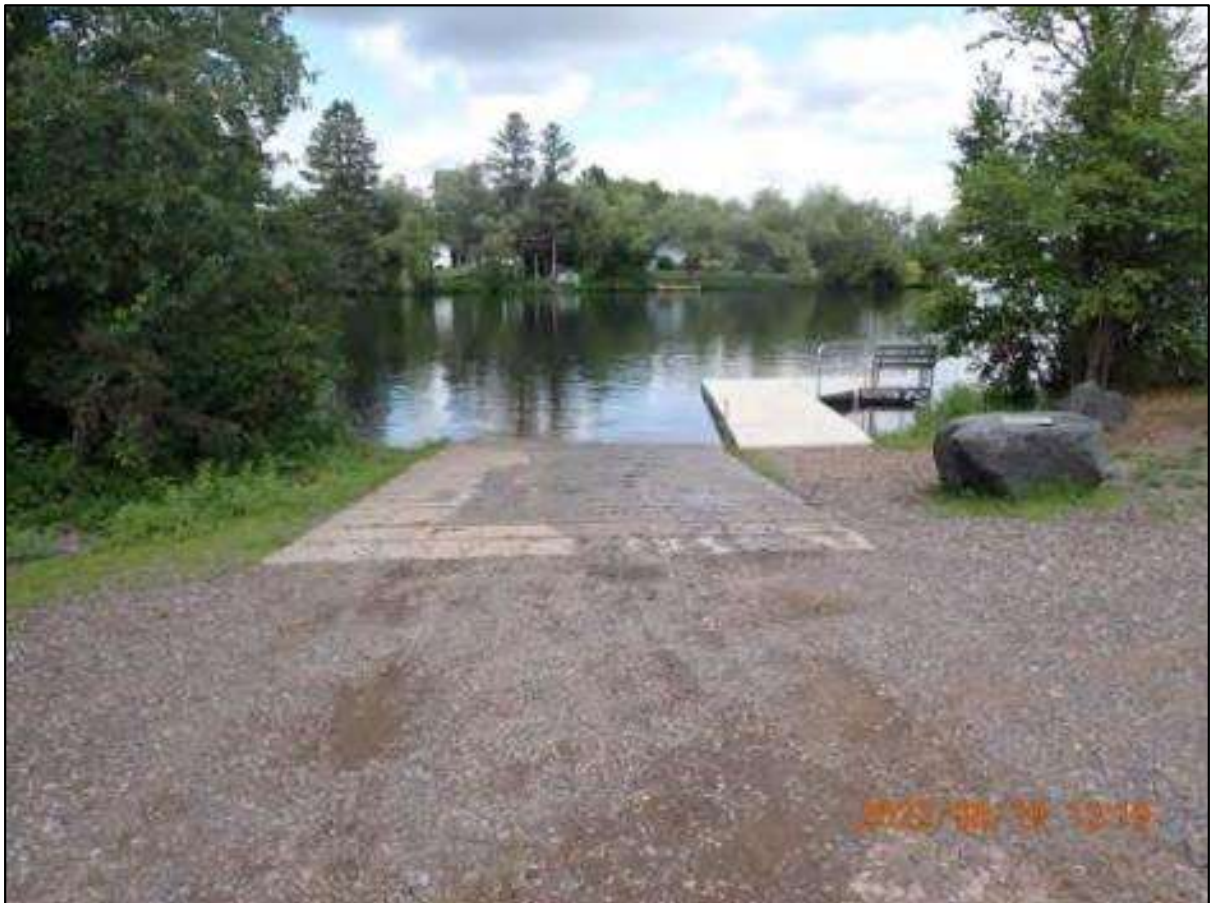
Figure 4.8.1.4.1-4 Hayward City Boat Landing and Dock on Lake Hayward

This non-project recreation site is owned and operated by the City of Hayward. Only the portion of the boat ramp extending below elevation 1,187.5 feet NGVD and the dock are included within the Project boundary. The site includes a single-lane boat launch with a cement launch pad and a paved approach and dock with a gravel approach. The City maintains a “Lifejacket Loaner” program to encourage lifejacket use on Lake Hayward. The site also features a large gravel parking lot that can accommodate 20 vehicles or 10 vehicles with trailers. The site also provides overflow parking for the Hayward City Beach (EA Engineering, Science, and Technology, Inc., 2023). The boat landing is depicted in **Figure 4.8.1.4.1-4**. Additional photographs taken during the recreation inventory are found in Appendix 3 of the Recreation Study Report included in **Appendix E-29**.

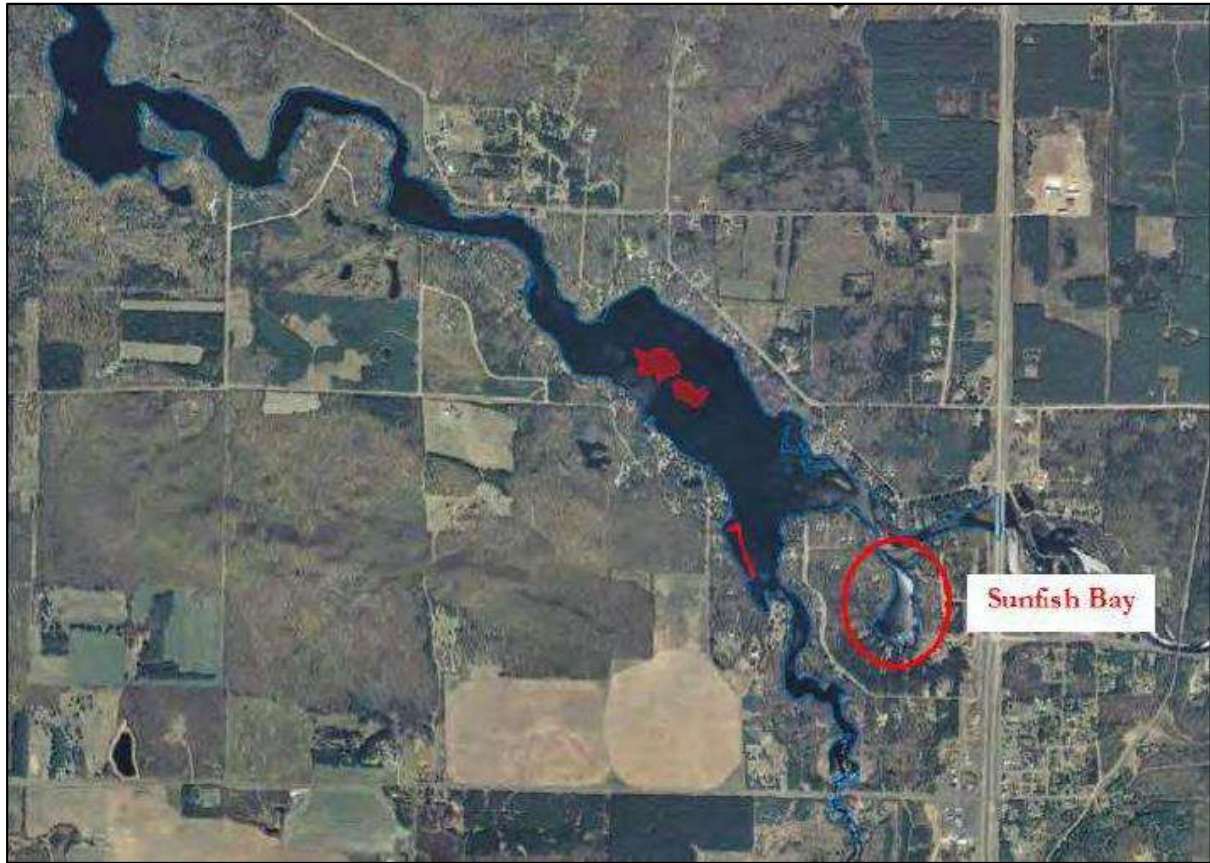
Figure 5.5.1.5.1-2 2020 EWM Beds on Trego Lake

EWM was first discovered in Trego Lake in 2019. In order to determine the extent of EWM, a bed mapping study was conducted in 2020. This survey identified three low-density EWM beds covering a total of 6.37 acres. All EWM was found in areas with water depths ranging from 3 to 5 feet. While no formal survey or mapping was conducted in 2021, EWM plants were observed in Sunfish Bay. Continued monitoring of the species, without any active management, was recommended in the Trego APMP (Lake Education and Planning Services, LLC, n.d.). **Figure 5.5.1.5.1-2** shows the EWM identified during the 2020 bed mapping study.

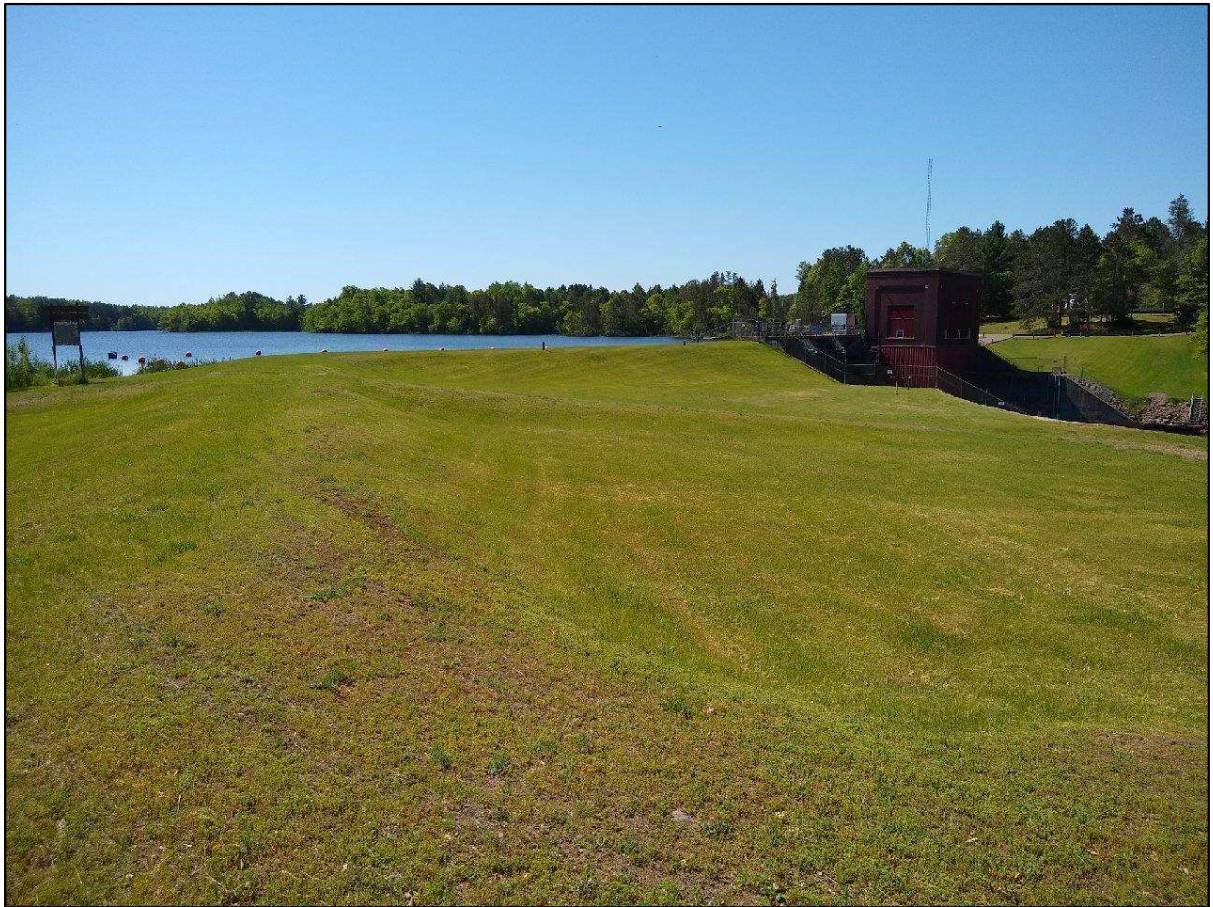
Figure 5.8.1.4.1-1 North Tailwater Access Canoe Portage Take-Out and Trail at the Trego Project

This Project recreation site is owned and operated by NSPW and provides access to the north side of the Trego Dam. More specifically, the site provides access to the tailwater for fishing and also features the canoe portage. The canoe portage take-out is located at the north end of the safety buoys. The portage trail extends approximately 325 feet to the downstream put-in, which is adjacent to the tailwater fishing access. The tailwater fishing access consists of a concrete retaining wall with safety rail along the river that serves as a fishing platform. Parking is available for approximately 8 vehicles along the gravel access road and along the shoulder of River Road. There is also a portable toilet at the site (EA Engineering, Science, and Technology, Inc., 2023). The site is shown in **Figure 5.8.1.4.1-1**. Additional photographs taken during the study are included in Appendix 3 of the Recreation Study Report.

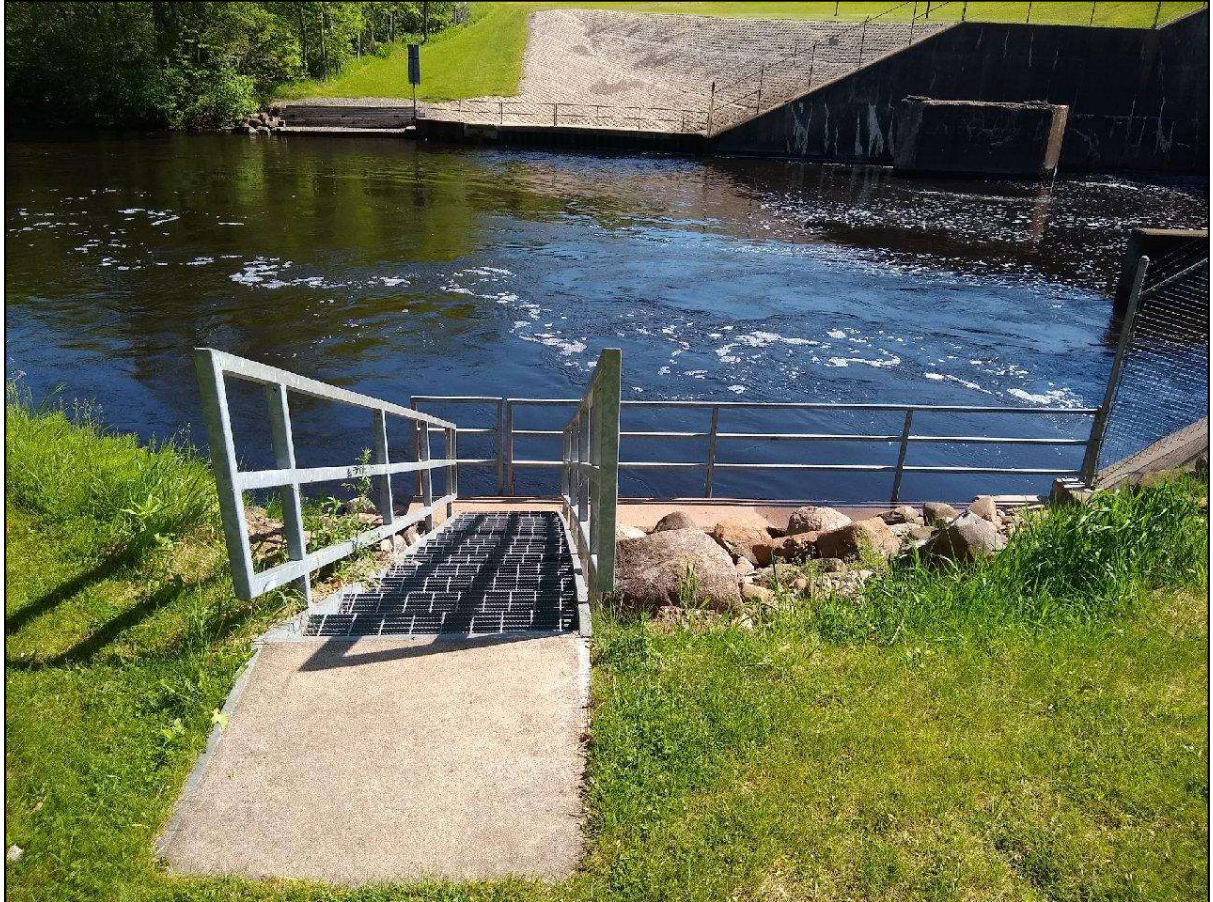
Figure 5.8.1.4.1-2 South Tailwater Access Stair and Fishing Area at the Trego Project

This Project recreation site on the south side of the Trego Dam provides fishing access to the tailwater area. There are two metal staircases leading to a concrete retaining wall with safety rails that serve as a fishing platform. A paved parking area is located at the end of Ricci Road that can accommodate up to four vehicles (EA Engineering, Science, and Technology, Inc., 2023). The site is shown in **Figure 5.8.1.4.1-2**. Additional photographs taken during the study are included in Appendix 3 of the Recreation Study Report.

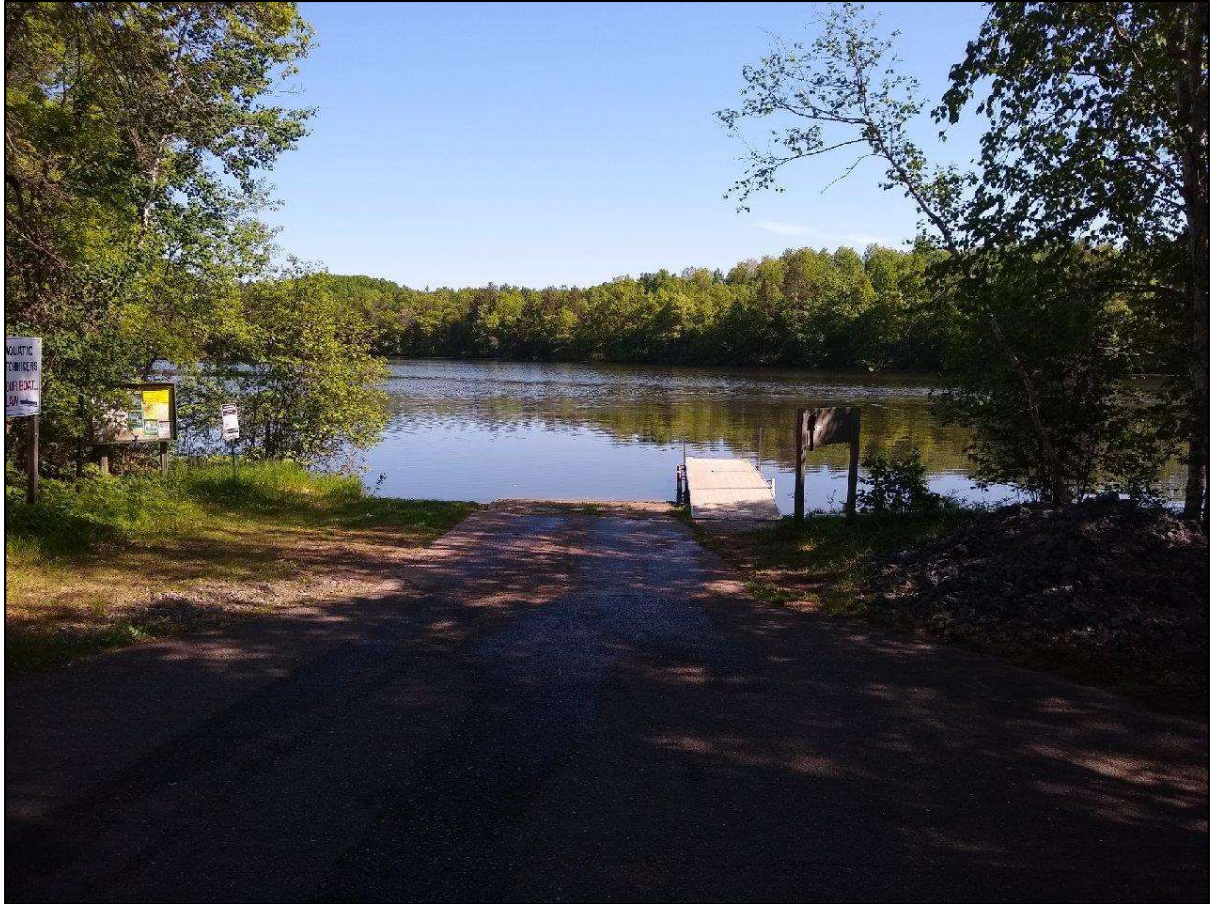
Figure 5.8.1.4.1-3 Town of Trego Boat Landing and Dock (Trego Landing Road) at the Trego Project

This non-Project site is owned and operated by the Town of Trego and is located at the end of Trego Landing Road. The site has a single lane boat ramp consisting of concrete-planks, a dock, regulatory signage, and parking along the side of Trego Landing Road that can accommodate eight vehicles or two vehicles with trailers. One of the parking sites is designated as barrier-free (EA Engineering, Science, and Technology, Inc., 2023). The site is shown in **Figure 5.8.1.4.1-3**. Additional photographs taken during the study are included in Appendix 3 of the Recreation Study Report.

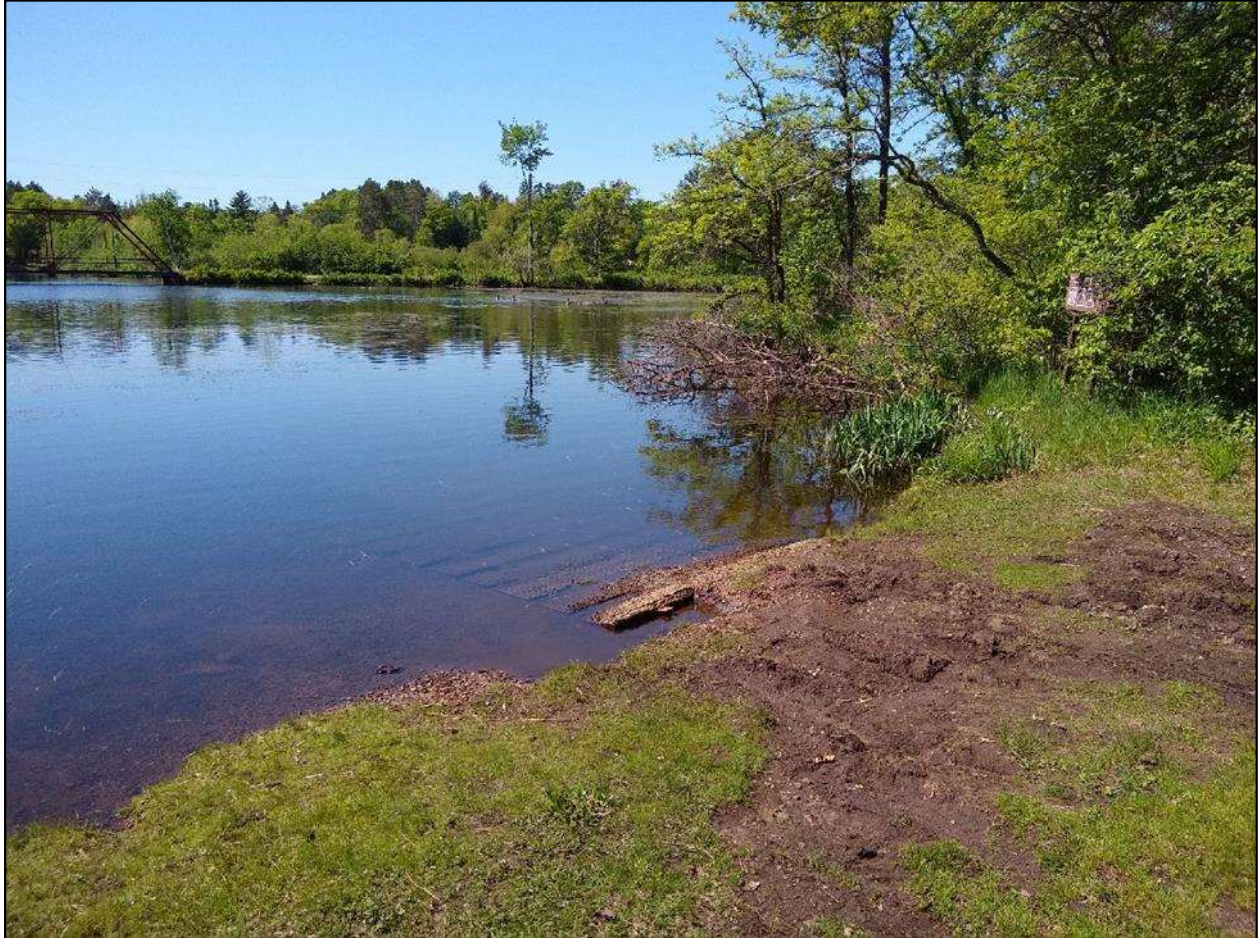
Figure 5.8.1.4.1-4 Town of Trego Park Boat Landing (Cash Road)

This non-project recreation site is owned by the Town of Trego and is located on the Namekagon River just upstream of the US Highway 53 Bridge at the end of Cash Road. The site has a single lane boat ramp consisting of concrete planks, regulatory signage and a gravel parking area that can accommodate a total of 20 vehicles or six vehicles with trailers (EA Engineering, Science, and Technology, Inc., 2023). The site is shown in **Figure 5.8.1.4.1-4**. Additional photographs taken during the study are included in Appendix 3 of the Recreation Study Report.
