**Gile Flowage Storage Reservoir Project
FERC Project No. 15055**

**Amended Exhibit E
Environmental Report**

Final License Application

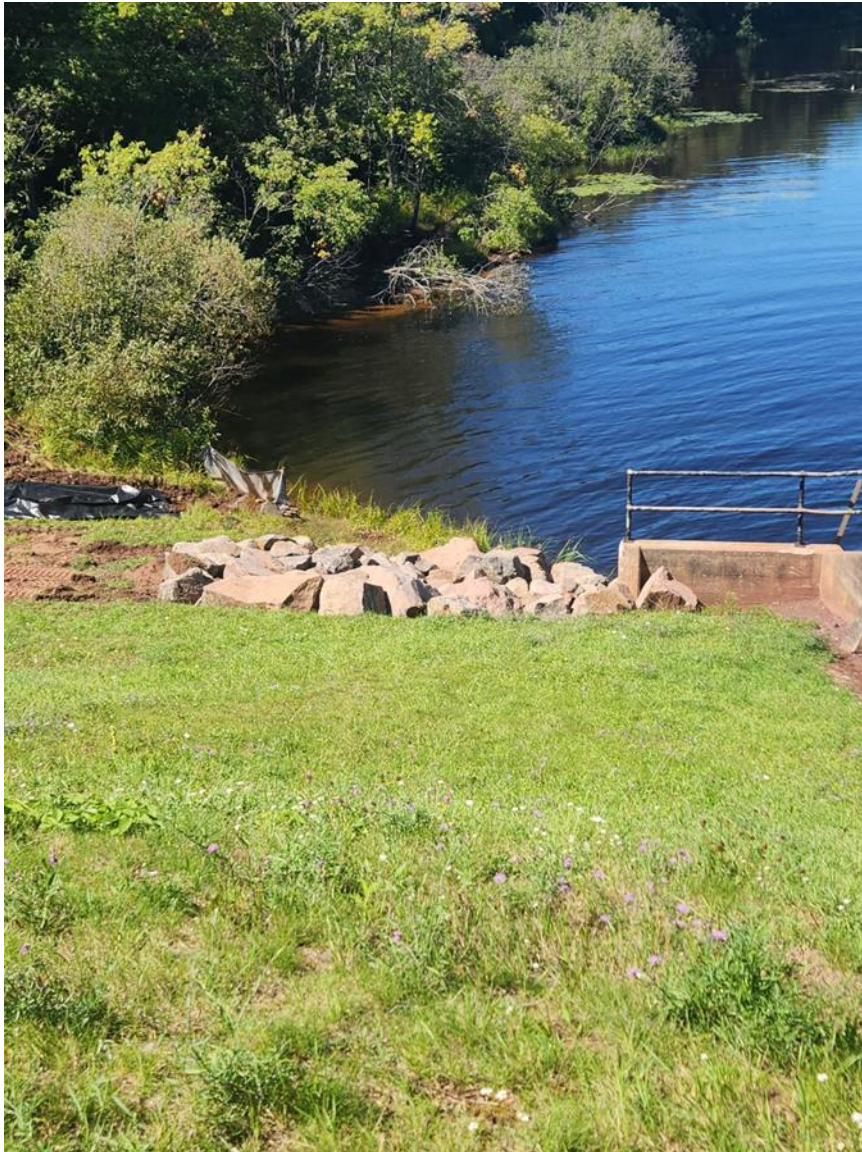
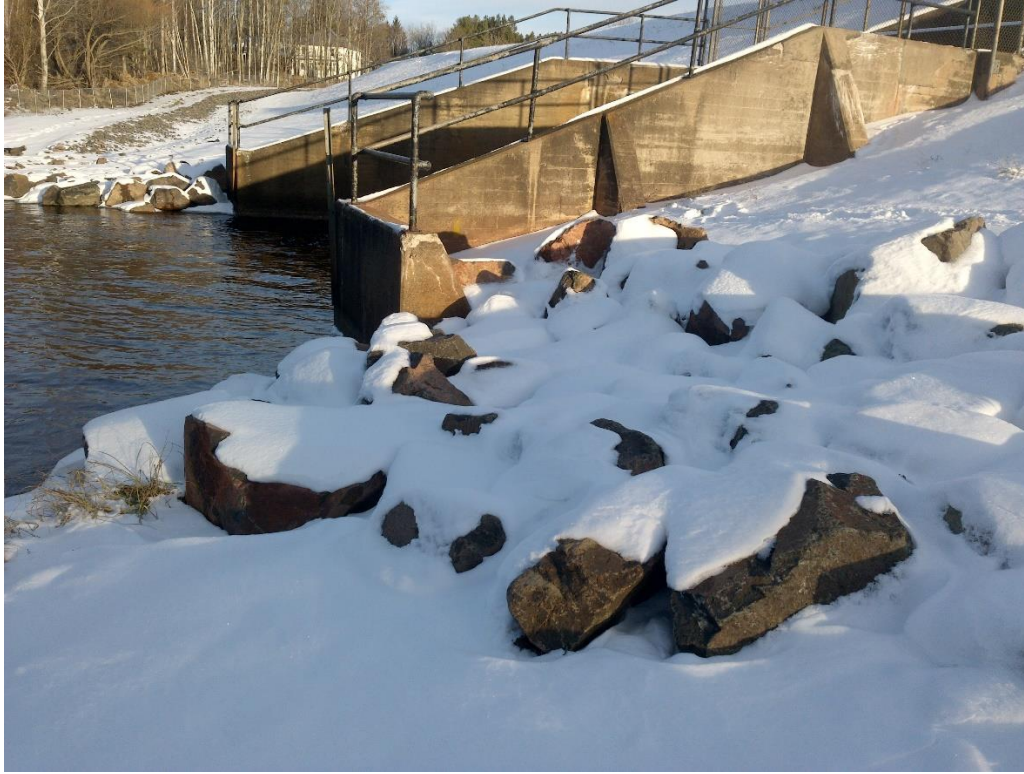
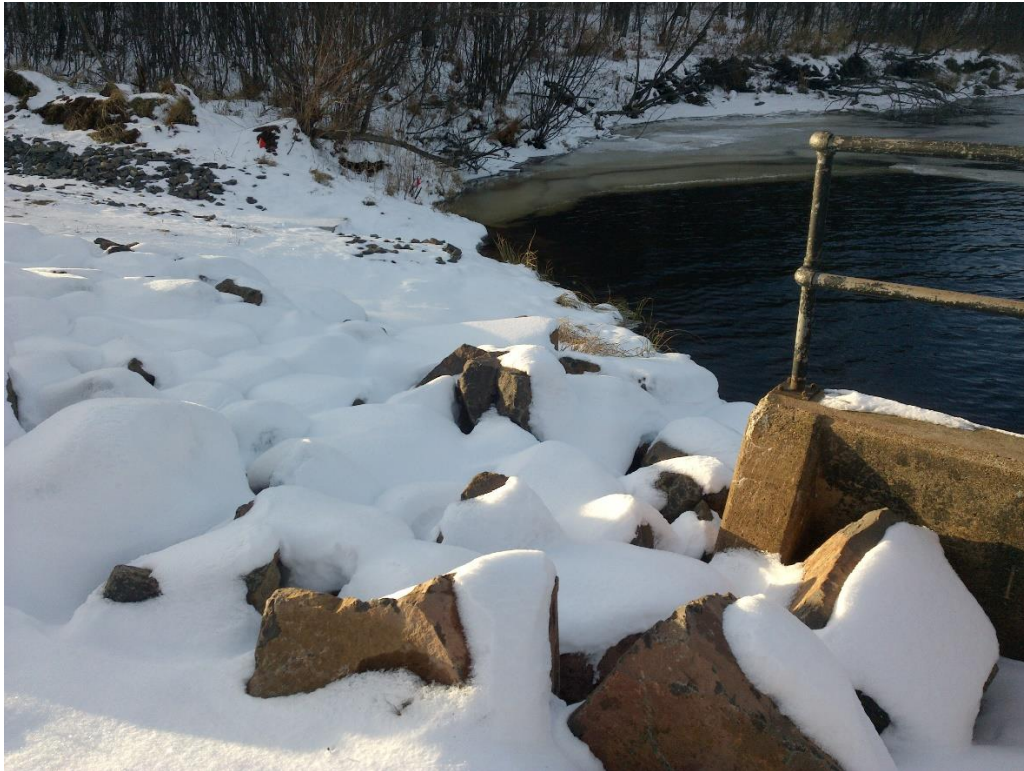
Figure 3.3.1.4-1 Completed Erosion Mitigation

In addition to the erosion sites documented along the reservoir shoreline, one additional erosion site was noted downstream of the dam in the tailwater area.¹⁶ The area is located on the west bank at the toe of

the water control structure, adjacent to the west wingwall downstream of the dam. It appears human traffic and possibly high flows have scoured the bank and exposed soil adjacent to the wingwall. This site was identified in the FERC's October 3, 2022 follow-up comments regarding their 2022 Annual Dam Safety Inspection, which required NSPW to address the erosion by August of 2023 (Federal Energy Regulatory Commission, 2022). The site was re-visited in July of 2023 and updated photographs prior to the repairs were included in the USR. NSPW completed the erosion mitigation in August 2023 through the placement of filter fabric and rock riprap. The results of the erosion mitigation are displayed in **Figures 3.3.1.4-1, 3.3.1.4-2, and 3.3.1.4-3.**
